# Causes and Remedies for the Degradation of Steam Generator Tubings in Korean Nuclear Power Plants

In-Gyu Park

*Division of Materials and Chemical Engineering  
Sun-Moon University*

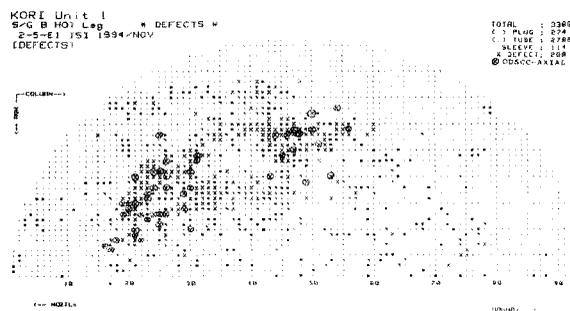
Fig. 1. Defect Tube configuration in retired Kori-1's S/G

were severely damaged as shown in Figure 1. S/G replacement decision was made by technical and economical evaluations.

It was revealed that pitting was occurred due to condenser leakage, high dissolved oxygen and copper oxides sludge. In order to prevent pitting, copper condenser tube was replaced with titanium in 1988. Hydrazine( $H_2NNH_2$ ) was used for water chemistry control to reduce dissolved oxygen.

PWSCC in Kori-1 was resulted from the Alloy 600 MA susceptibility, high temperature induced by superheating at sludge pile, and high residual stress at roll transitions. Since 1990, KHNP have performed chemical cleaning to remove the sludge, which could possibly mitigate the superheating effect.

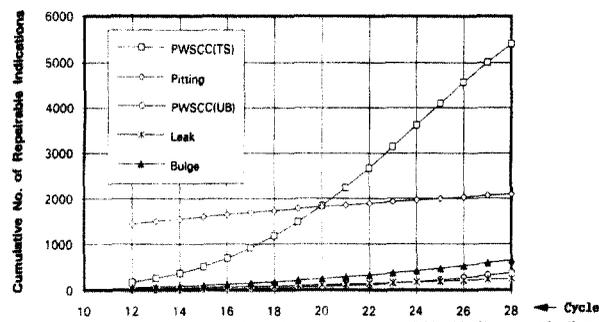
Figure 2 shows the results of S/G tube degradation

Fig. 2. Degradation predictions for retired Kori-1's S/G tubings<sup>2)</sup>

predictions.<sup>2)</sup> This Figure shows the projections for each degradation modes. Pitting degradation, which has been the most severe degradation mode in Kori-1, would be slowed down, and could be modeled at a reduced rate, due to the beneficial effects of the chemical cleaning. On the other hand, PWSCC(TS) would rapidly be increased and would be the major tube degradation mechanism in the future. The other degradations would be continued, at a relatively slow rate.

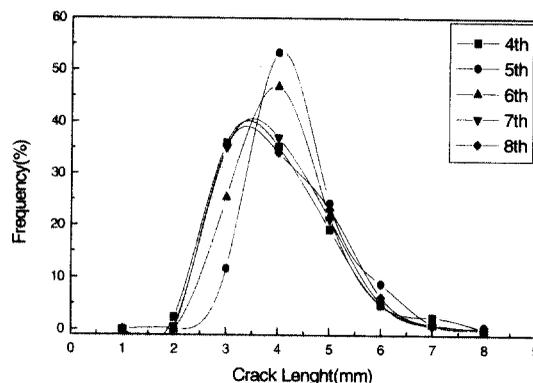
Fig. 5. Time history of the distribution of crack length in Ulchin-1<sup>9)</sup>

Figure 5 illustrates a typical time evolution of crack length distribution, which predict the deformation and shift of the initial distribution, over several successive operation cycles, as predicted by Hernalsteen's model<sup>8)</sup> The crack length distribution histogram has an overall bell shape. With time, the length distribution curve shifts towards the range of longer lengths.

However in Ulchin-1, the distribution curve skewed to the shorter crack lengths. This implies that the crack growth is retarded after shot-peening. Therefore, the number of short cracks were increased while the growth rate of long cracks were slowed down.
