Corrosion of Commercially Pure Titanium in a Sea Water Electro-Chlorination Equipment

Ki-Tae Kim

Korea Electric Power Research Institute
103-16 Munji-dong, Yuseong-gu, Taejeon 305-380, KOREA

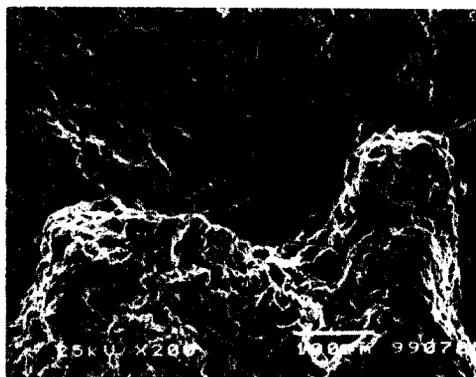
SEM images of corroded surface of a fastener specimen are shown in Fig. 3. The corroded surface, shown in Fig. 3(a), has a kind of layered structure, which is very easy

Fig. 3. SEM images of a corroded surface of a fastener specimen. (a) low magnification which shows layer type corroded surface, (b) high magnification reveals the micro pores

to be spalled off by small impact such as light hitting with a pair of tweezers. A higher magnification image shows that the corroded surface has many micro pores in it as shown in Fig. 3(b). Fig. 4 shows a different surface area of the same fastener specimen where corrosion barely occurred. This area also exhibit many pores. Therefore,

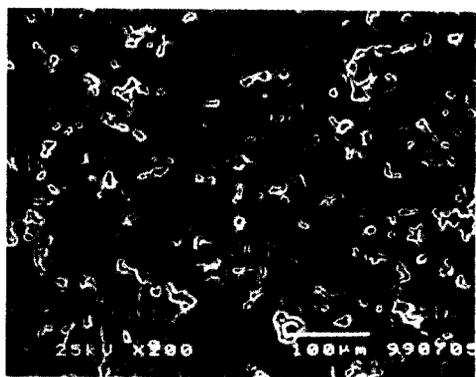
Fig. 4. SEM image of a barely corroded area surface of a fastener specimen. Micro pores exist even without corrosion.

it seems that the micro pores found in the fastener specimen are not the result of corrosion but the inherently existing defects of the specimen.

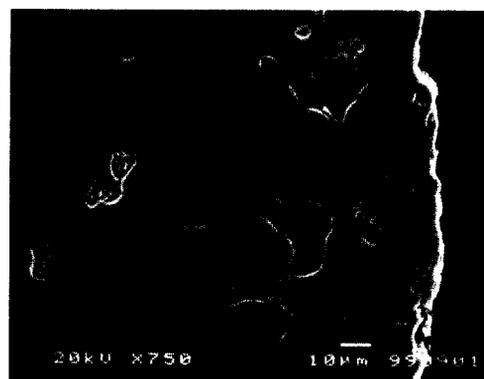
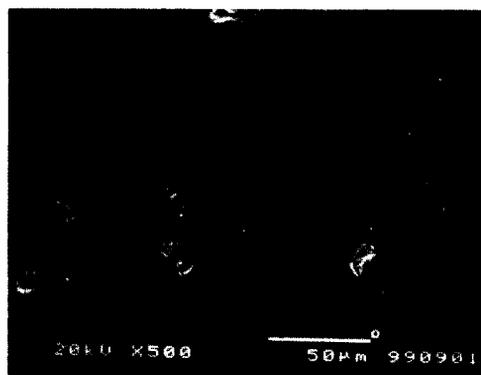
In order to ensure that the micro pores are pre-existing microstructural defects, a cross cut surface of the corroded fastener was examined using SEM. The SEM micrographs of this cross cut surface are shown in Fig. 5. These figures clearly reveal that there are many micro pores uniformly distributed across the whole thickness of the specimen. This means that the micro pores are inherently existing defects. Fig. 5(a) also indicates that there are many cracks developed at the near corrosion surface. The cracks are found within a narrow range of about 100 μm from the corrosion surface. Since the cracks are connecting between the micro pores, and growing mostly only in one direction, parallel to the surface, the corrosion surface looks like a layered structure as shown in Fig 3(a). The easy spalling off behavior of corroded surface also resulted from these cracks developed near the surface region.

Fig. 5. SEM images of a cross cut surface of the corroded fastener specimen.(a) near corrosion surface region, (b) inner area

usually have no such defects in it. In this corrosion failure case, therefore, considering the pore size and distribution, the Ti products are believed to be produced by the powder metallurgy techniques.

Fasteners or spacers produced by powder metallurgy technique are usually undergone a densification process,⁴⁾ such as HIP (Hot Isostatic Press), to eliminate the micro pores. But the microstructure of the corroded specimens indicates that the densification process for these specimens was omitted or improperly carried out.

1) The titanium fasteners and spacers that have micro pores in them should be replaced with the one which has not. This means that the wrought product should be used instead of power metallurgy products that have microstructural defects.

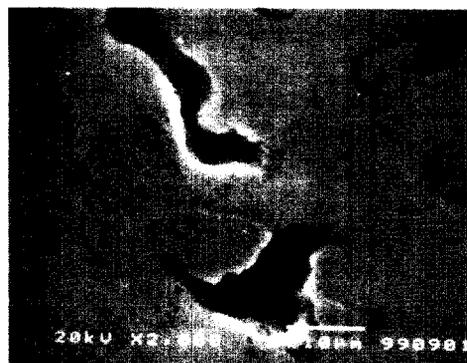
One of the micro pores found at the inner area is shown in Fig. 6. EDX (Energy Dispersive X-ray Spectroscopy) analysis result of the dark spots found within the micro pore is given in Fig. 7. The EDX analysis shows calcium (Ca) is existing in the micro pores. Calcium is usually found in the powder metallurgy products, because Ca is easily segregated during the degassing process.^{4),5)} The existence of Ca within the micro pores supports that the corroded specimens are not the wrought products but the powder metallurgy products.

Fig. 6. SEM image of micro pore found at inner area.

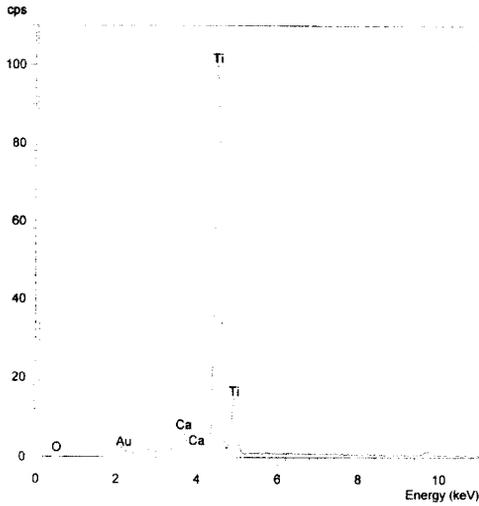
Fig. 7. EDX analysis result of the dark spot within the micro pore shown in Fig. 6.

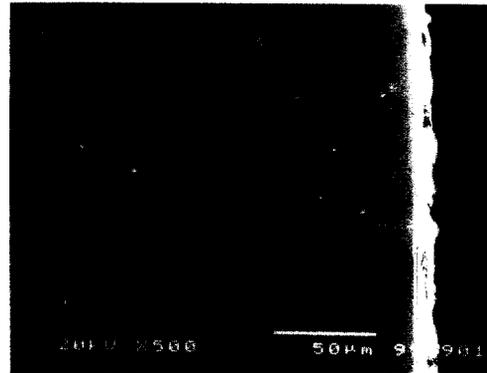
An examination using SEM on the uncorroded specimen cross cut surface is shown in Fig. 8. Quite contrary to the cross cut surface of the corroded specimen shown in Fig. 5, the microstructure reveals no micro pores. This means that this uncorroded specimen is not a powder metallurgy product, but a wrought product.⁶⁾ There has been no report of corrosion failure with this type of wrought Ti products so far at the KEPCO power plants.

Fig. 8. SEM images of a cross cut surface of the uncorroded fastener specimen. (a) near surface region, (b) inner area

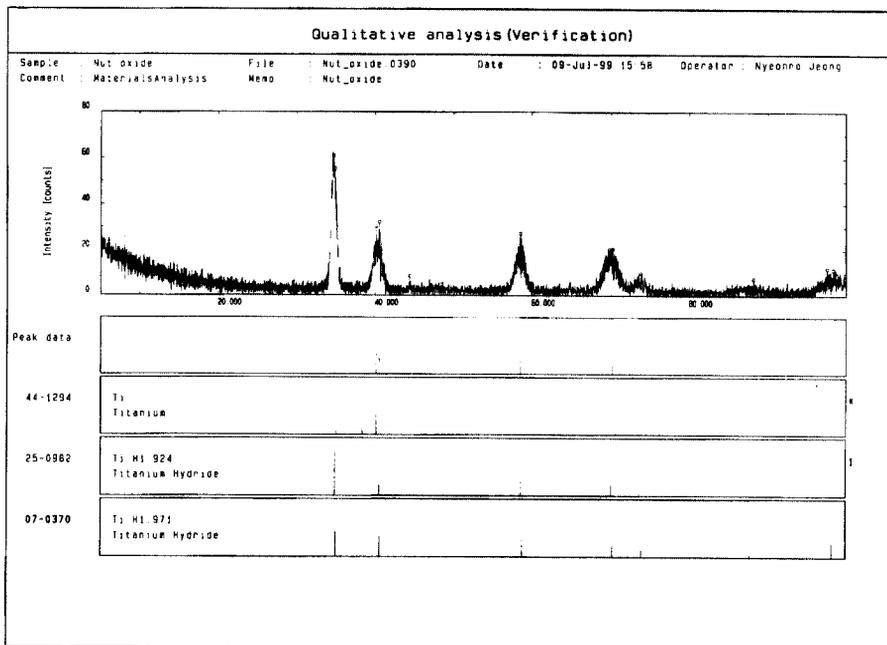
The result of XRD analysis on the corroded surface is shown in Fig. 9. Titanium oxide, TiO_2 , passive film, which is most usually found on the Ti surface, is not formed on the corroded surface. Instead of the Ti oxide, two types of titanium hydrides ($\text{TiH}_{1.924}$ and $\text{TiH}_{1.971}$) are unexpectedly found from the surface.

Titanium hydride is brittle and does not have corrosion resistant passive film properties which Ti oxide has. There-

fore, when titanium hydride is formed on the surface, the corroded surface shows brittle behavior and is easily spalling off into small pieces.⁷⁾ The reason of Ti hydride formation and the corrosion mechanism of Ti are discussed in the next section.

Fig. 9. XRD analysis of the corroded surface. Not the Titanium oxides, but the Titanium hydrides are found.

Therefore, the reason of Ti hydride formation is believed due to the hydrogen evolved at the cathodes during the electro-chlorination process of sea water.

2) Installation of hydrogen separator into the sea water electro-chlorination equipment, which can decrease the hydrogen concentration in the cell solution, can reduce or retard the corrosion. However, this can not be a permanent solution as far as there are microstructural defects.

3) As the hydrogen evolution rate is increased with the operation current of the equipment, care should be given to the maximum operation current, which sometimes exceed the normal operation range to increase the biocide concentration.
