# Failure Analysis of Welded Pipe in Water Supplies for Apartment

Galvanized Steel pipes have been widely used in industries and apartments. Unexpected early leakage has been found in an apartment. Tunneling corrosion or penetration was found in the water supply pipes. The chemical compositions of the pipes and properties of coating layer were evaluated. The pipes met the specification of KS D 3507. The cause of early failure was analyzed through the examination of macrostructures and microstructures. It was found that the pipes were failed by grooving corrosion, which resulted from galvanic corrosion of weld bead and matrix.

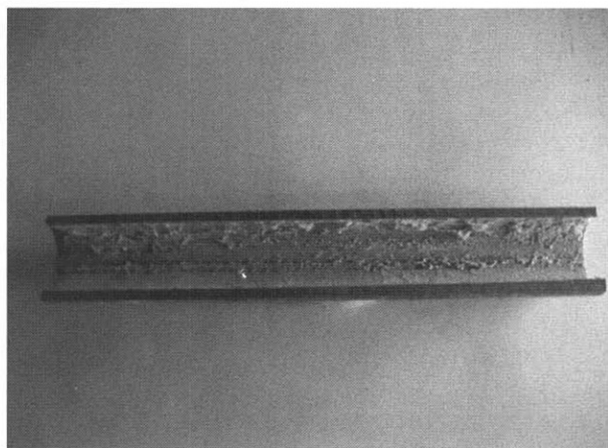
The appearance of the collected pipes were examined. In the pipes manufactured in A company, yellowish thin scale was formed over the galvanized layer. A slight or negligible corrosion was found at the weld inside the pipes. Comparing to the pipes, the pipes of B company, having leakage, were corroded severely. Some of them were penetrated(corroded completely away) through the pipe wall. The galvanized layer was rarely left inside the pipes. Thick reddish corrosion products covered the pipes and

**Fig. 1.** Appearance of ERW steel pipe made in A company.

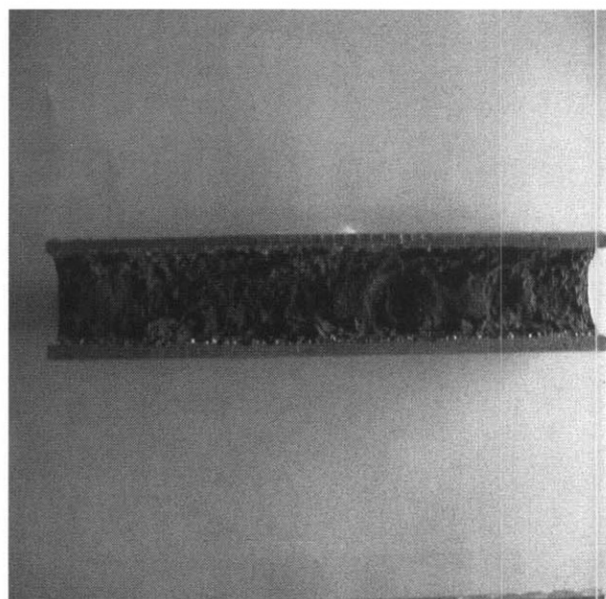
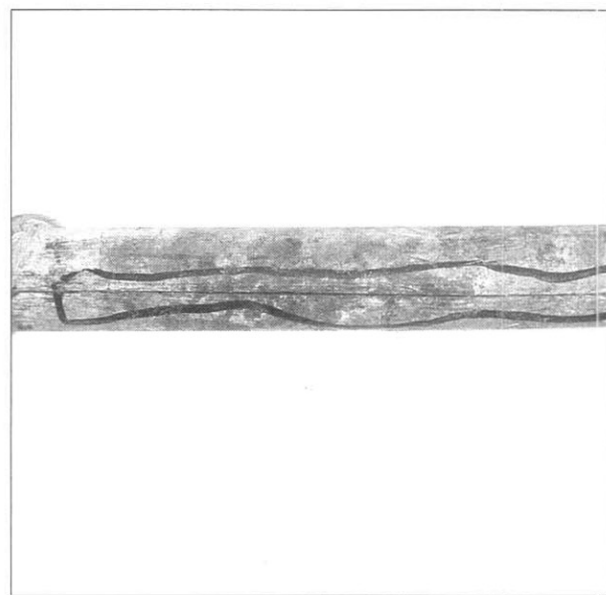
tubercles were scattered here and there. It should be noted that all the corrosion concentrated along the weld.

**Fig. 2.** Appearance of ERW steel pipe made in B company. (a) Inside scale, (b) Outward view

Since changing all the damaged pipes are time-consuming and not economical, inside coating is the most effective measure. After removing corrosion product, lining such as epoxy resin is appropriate to prevent a further corrosion and red water in the apartment.

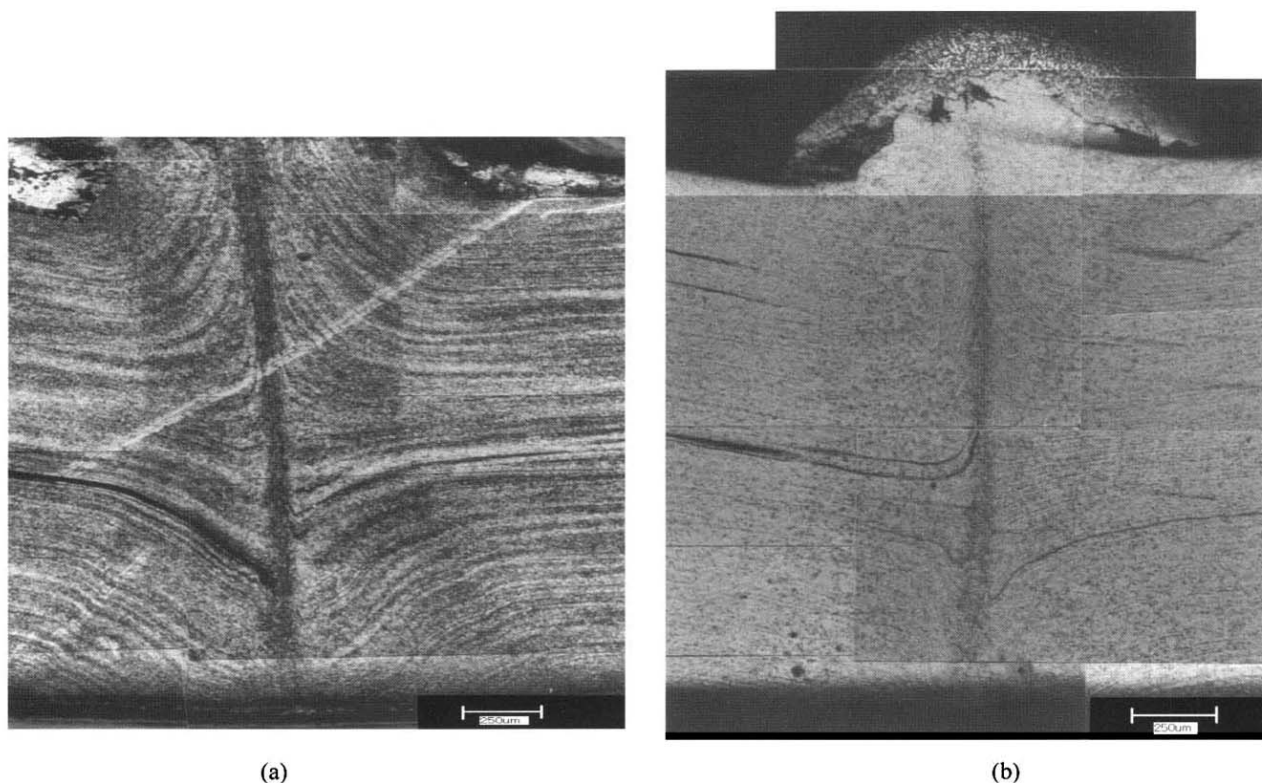
The bond layer of macrostructures could be the basis of determining the soundness of weld bead.<sup>8)</sup> The optimal bond thickness could not be formed at improper weld temperature or heat input. In Fig. 3, macrostructures of A and B companies are shown. In the Figs, bond layers of A and B company are well developed. Therefore, the possibility of underweld can be excluded. The only possi-

Fig. 3. Macrostructures of ERW Pipes a) A company, b) B company

bility which can cause the phenomenon is the grooving corrosion, i.e. electrochemically active weld bead can be preferentially dissolved compared to the matrix. The undesirable area ratio accelerated galvanic corrosion in this localized region. In this reason, not only weld bead but metal flow mark could be removed after corrosion in spite of proper bonding. As mentioned earlier, ERW pipes are susceptible to grooving corrosion. Especially, combination of highly corrodible water and chemical compositions with high sulfur above 0.005% make a condition to cause grooving corrosion. The cross section of pipes which suffer penetration or tunneling shows typical appearance of grooving corrosion. Moreover, the water quality in the pipes was analyzed to be corrosive. Therefore, the leakage could be ascribed to the combination of highly susceptible chemical compositions to grooving corrosion and corrosive water.
