## Failure Analysis of a Ball in the Nuclear Fuel Exchanger

† H. P. Kim, D. J. Kim, S. S. Hwang, M. K. Joung,  
Y. S. Lim, and J. S. Kim

*Nuclear Material Technology and Development Division  
Korea Atomic Energy Research Institute, P. O. Box 105, Yusong, Taejeon, KOREA*

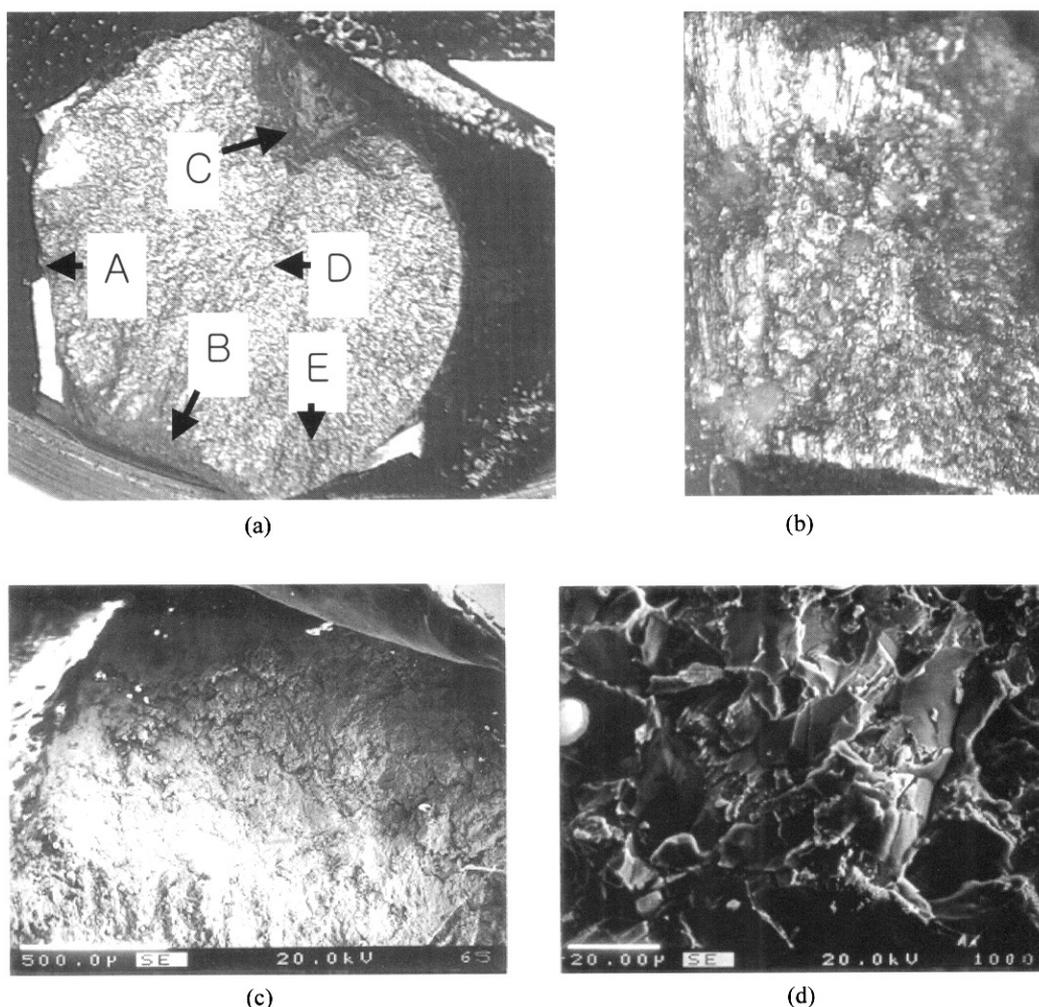
Fracture surface of failed latch ram ball is shown in Fig. 1. Parts marked as A and B represent the broken edges of the fracture surface. V groove (marked as C in Fig. 1) was observed in upper right region on the fracture surface. Brittle fracture was also observed some part (mark D) of the fracture surface. However, most of the fracture surface show abraded and pressed appearance, which may be attributed to the rubbing of the cracked ball during rotation of the ball in its position.

**Fig. 1.** Fracture surface of latch ram ball: (a) whole fracture surface; (b) magnification of V groove marked C in Fig. 1(a); (c) magnification of region marked D in Fig. 1(a); and (d) magnification of region marked E in Fig. 1(a).

The fracture surfaces of the failed ball (as shown in Fig. 1(b), Fig. 1(c), Fig. 2(b), and Fig. 2(c) appears to be located on well defined, low energy crystallographic plane, and may be termed as brittle fracture surface. The brittle fracture surface may be produced by transgranular stress corrosion cracking or mechanical overloading of brittle material. However, comparison of fracture surface of failed ball and sound ball after breaking test has revealed a number of similarities. For example, fracture surface of failed ball as shows in Fig. 1(b), Fig. 1(c), Fig. 2(b), and Fig. 2(c) are similar to the corresponding surface of sound ball as shows in Fig 7. Similarly, Area C (Fig 1(a), Fig 2(a)) and high magnification of the Area C of fracture surface of failed ball (Fig. 1(b)) correspond well to Area X (Fig. 6(b) and higher magnification of the Area X (Fig. 7(a)) of fracture surface of sound ball, respectively. The similarity was also observed between Area D (Fig. 1(a), Fig. 2(a) and higher magnification of the Area D (Fig. 3(b)) of fracture surface of failed ball and the corresponding Area Y (Fig. 6(b) and higher magnification

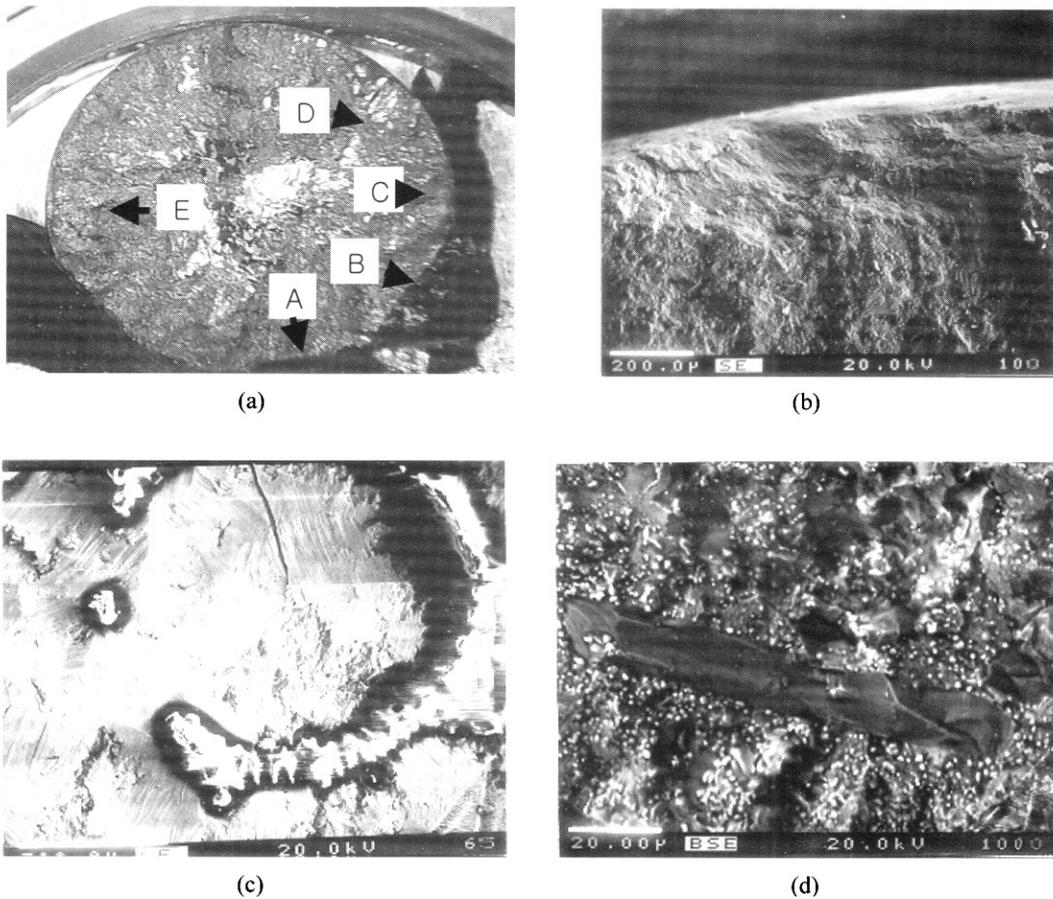
Fracture surface of failed C-ram ball is shown in Fig.

2. Part marked as A and B represents the broken edges of the fracture surface (as in Fig. 1 for latch ram ball bearing). Some part of the fracture surface (e.g. part D in Fig. 2) show brittle fracture appearance. However, most of the fracture surface (e.g. part E in Fig. 2) shows abraded and pressed appearance, which may be attributed to the rubbing of the cracked ball bearing during rotation of the ball bearing in its position. The phenomenon of abraded and pressed appearance was more extensive in case of C-ram ball and the latch ram ball.

**Fig. 2.** Fracture surface of C-ram ball: (a) whole fracture surface; (b) magnification of region marked C in Fig. 2(a); (c) magnification of region marked D in Fig. 2(a); and (d) magnification of region marked E in Fig. 2(a).

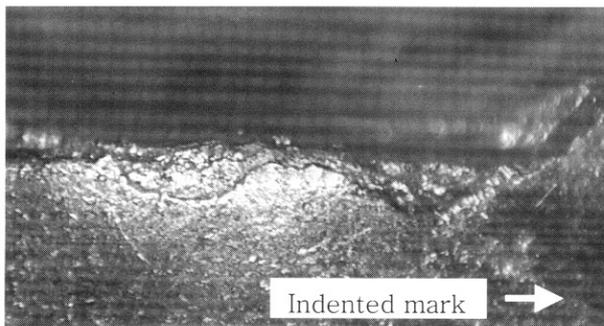
Some parts of the ball surface were indented by impact or mechanical overloading (Fig. 3). The indented marks can be discerned by naked eyes. Long acicular precipitate was found on the fracture surface of the ball (Fig. 2)

**Fig. 3.** Ball surface of C-ram ball with indented mark.

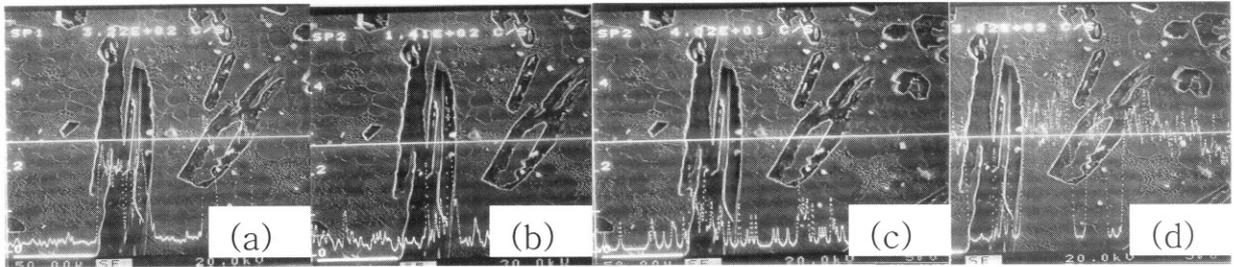
analysis of the precipitate is shown in Fig. 4. The acicular precipitate is Cr borocarbide as can be seen from carbon and boron content of the precipitate. Shape and distribution of the precipitate showed that it was formed by dendritic growth. Carbide content on the polished surface was high. The precipitate morphology in C-ram ball and EMPA analysis of the precipitate are shown in Fig. 5. Shape and distribution of the precipitate were essentially the same for both latch ram ball and C-ram ball, as may be expected from similarity in chemical composition and heat treatment of the both balls.

Fig. 4. EDS analysis of precipitate in latch ram ball bearing: (a) Cr; (b) B; (c) C; and (d) Ni.

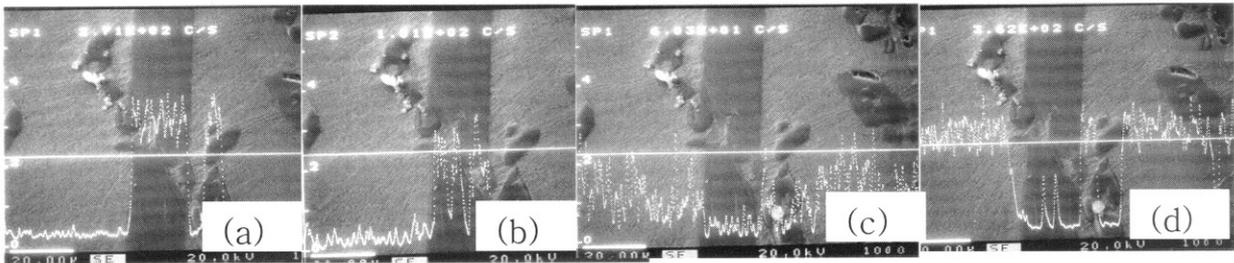
Fig. 5. EDS analysis of precipitate in C-ram ball bearing: (a) Cr; (b) C; (c) Fe; and (d) Ni.

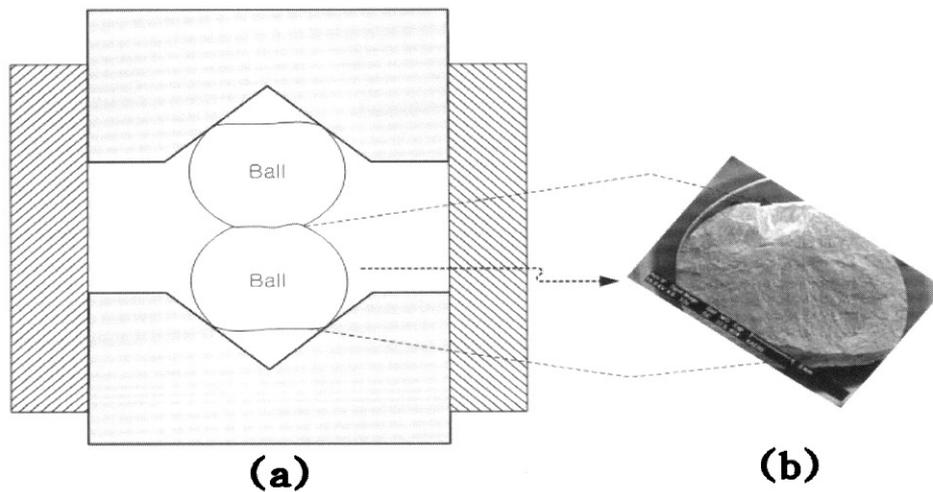
Fracture surface of a sound latch ram ball after breaking rest is shown in Fig. 6. It may be noted from the figure

that the edge of the ball in contact with a loading fixture has been shattered and the contact location between two balls have also crushed. Circular edge of the ball that shattered during breaking test was in line contact with a loading fixture, while the location between the two balls was in point contact. Therefore, compressive force at a location between the two balls is higher than at location in line contact with a loading fixture. Consequently, it seems that cracks would be preferentially initiated at a point contact location between the two balls because of higher compressive force. Fracture surface of the sound latch ram ball after breaking test could be classified into two regions according to appearance of fracture surface ;(i) region near the point contact between the two balls where cleavage fractures initiated and propagated on many parallel planes, trans-passing through grain boundaries (Fig. 7(a)) and (ii) region covering most fracture surface except a small region around point contact where cleavage fracture occurred along specific planes which are limited within grain (Fig. 7(b))

Fig. 6. (a) Schematic of ball shape after breaking test. (b) fracture surface after breaking test.

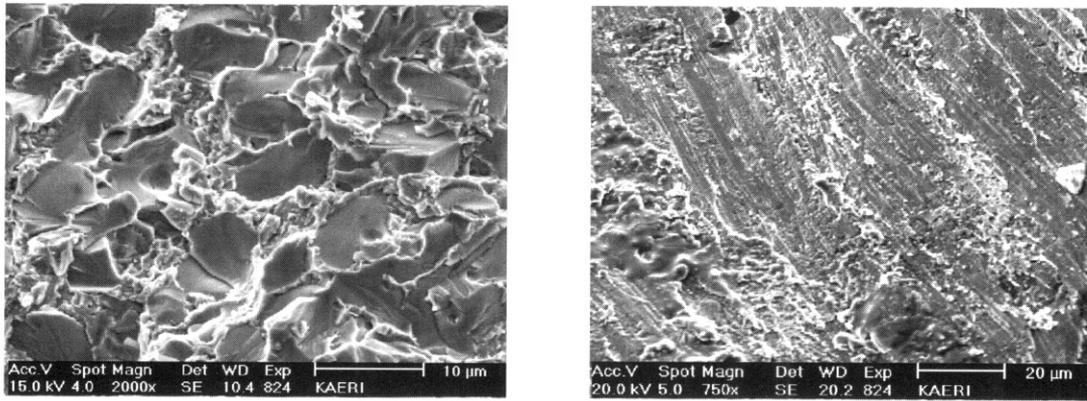
Fig. 7. Magnification of fracture surface: (a) A region of Fig. 6(b); and (b) B region of Fig. 6(b).

of the Area Y (Fig. 7(b)) of fracture surface of sound ball, respectively. A region near the point contact between the two balls shows that cleavage fractures initiated and propagated on many parallel planes. Other region covering most fracture surface with the exception of a small region around point contact shows that crack propagates, along specific plane in each grain. In addition, indented marks were observed at several locations of the fractured ball surface. Breaking force of the 9.5 mm diameter ball in fuel exchanger was 1/6 of the normal SAE 52100 ball. The ball in fuel exchanger was very brittle because it has many coarse precipitate in the matrix.

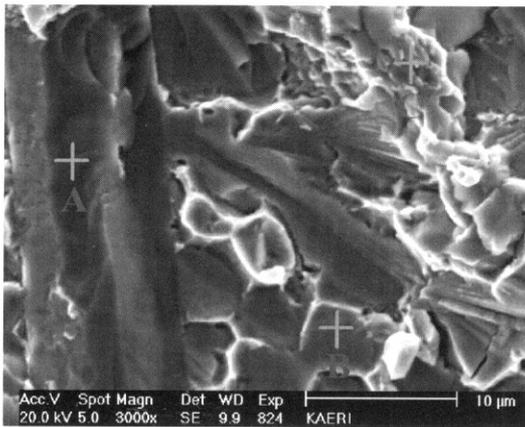
EDS analysis of acicular precipitate and matrix of a fracture surface of latch ram ball is shown in Fig. 8. Acicular precipitate consists of Cr borocarbide as in case of the failed latch ram ball. Major alloying elements in all the areas measured by EDS have almost the same chemical composition as measured by ICP method.

Element	Ni	Cr	Fe	Si
Spot A	14.23	82.20	3.57	
Spot B	90.02	6.58	2.50	
Spot C	88.15	6.64	3.43	1.78

Fig. 8. EDS analysis of precipitate (marked A) and matrix (marked B and C) on fracture surface of sound ball after breaking test.
