The Importance of Corrosion Control and Protection Technology in the Refinery

† Byong Mu Kim and Sung Lyong Oh

SK Corporation, 110 Kosa-Dong, Nam-Gu, Ulsan, Korea

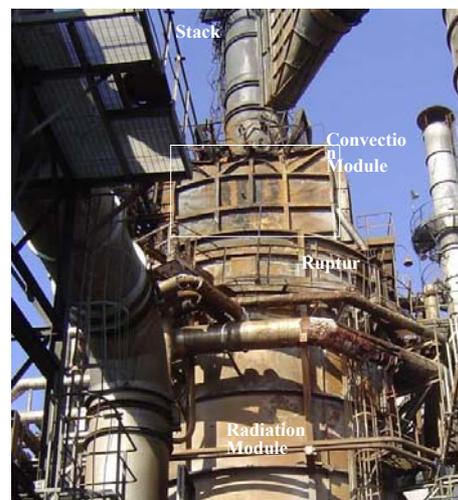
Fig. 2. Appearance of the fired prefractionator reboiler

A convection module casing of the heater and some connected piping were damaged by flame. Fig. 2 shows appearance of the heater after a fire caused by tube rupturing.

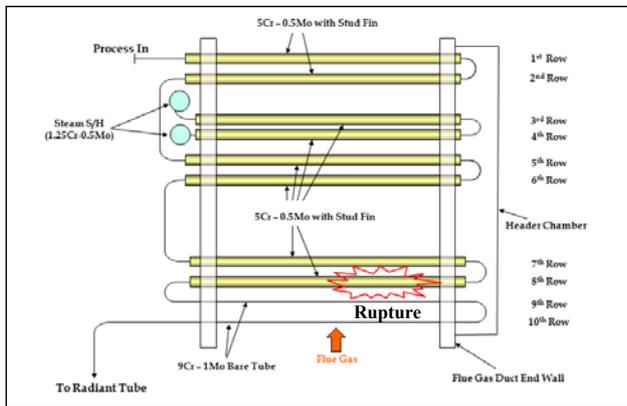
Fig. 3. Side view drawing of convection zone tube configuration

Fig. 3. shows a schematic drawing of side view of the damaged convection module. Rupture occurred at 8th row undermost tube row except two shock tube rows. Shock tube was a bare type tube with no stud fin and replaced with P9 (9Cr-1Mo Steel) from P5 4 years ago.

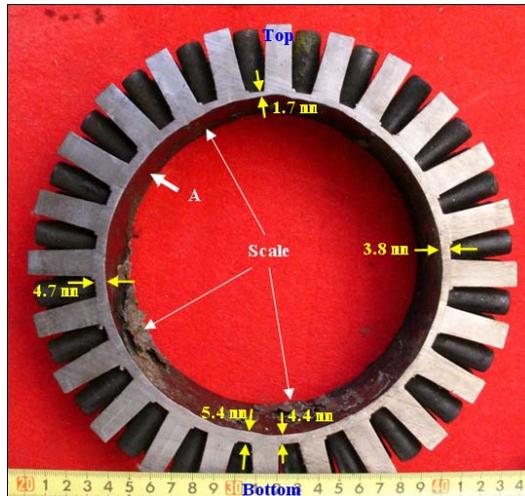
Fig. 7. Sectional view of the corroded tube

A sectional view of adjacent area of the ruptured position was cut for conforming corrosion contour and the sectional view is shown in Fig. 7. The corroded contour is same as that of the ruptured portion, that is, the top of the tube was most corroded such as in Fig. 7.

The corroded area was smooth face covered with black scale and no pit like damage.

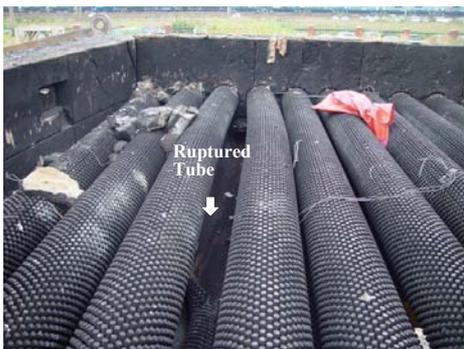
Fig. 4. Appearance of the failed convection module after dissection

Fig. 4 shows an appearance of the failed convection module after dissecting. The module casing and upper row tubes were deformed by a rupturing impact and some refractory was broken down. Top of the tube was ruptured along a longitudinal direction of the horizontal tube. There is considerable scale on the inner surface of the ruptured tube and no damage on the outside of the tube. Thickness of the ruptured lip was less than 1 mm and the ruptured

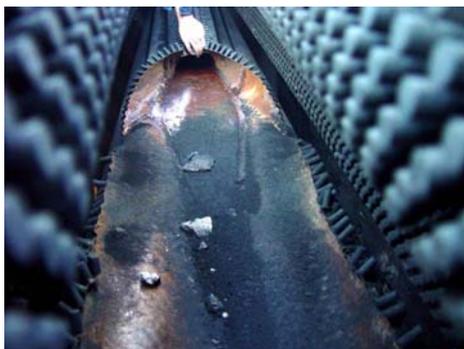
Fig. 5. Appearance of the ruptured tube in situ

length was about 2.5 m. A detailed appearance on ruptured tube was shown in Fig. 5 and Fig. 6.

Top of the ruptured tube was severely thinned and minimum thickness of top was less than 1.0 mm. But bottom side was 4.3 mm.

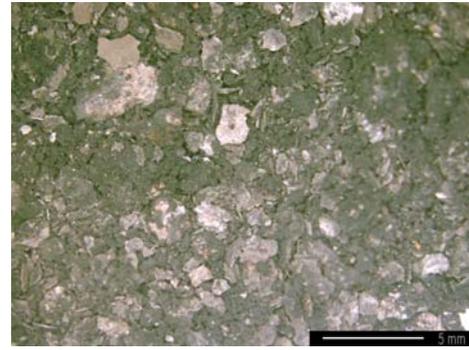
Fig. 9. Tube Inside Scale Sample

EDX (Energy Dispersive X-ray) analysis was conducted to define corrodent on the scale sampled from corroded surface. Fig. 9 shows appearance of the sampled scale seems typical black flake.

When the result of the analysis is considered, the scale was presumed as FeS components formed by corrosion.

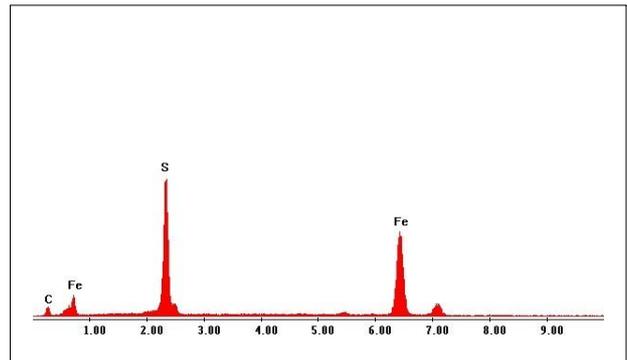
Fig. 10. Scale EDX Spectrum

Analyzed EDX spectrum was shown in Fig. 10

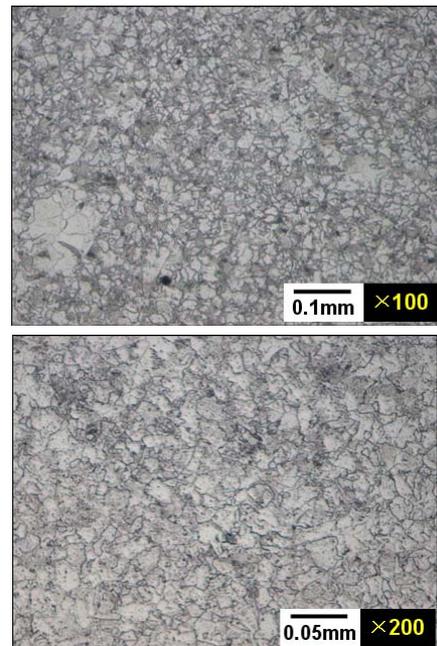
Fig. 11. Tube base metal microstructure

Cr-carbide was scattered in ferrite matrix due to long term operation at high temperature, there was no defect such as crack or creep void.

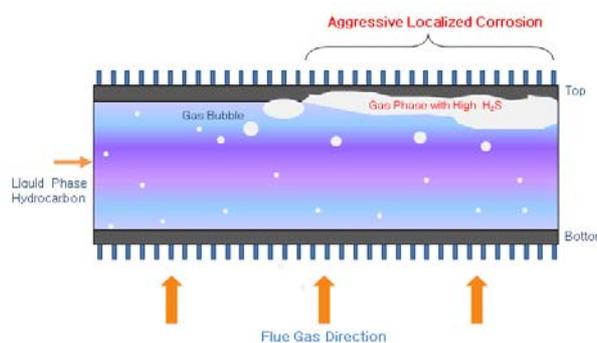
Fig. 12. Rupture Tube

Phase changing occurring in convection zone makes gas phase pocket at the top of the convection tube and H₂S can be concentrated in the gas pocket. In addition the gas pocket obstructs heat transfer from flue gas so tube metal temperature (TMT) was increased. That condition could make severe localized corrosion.

It is accord with the result of thickness measurement that upper row tubes showed minimum thickness at the bottom side but 8th and 9th row tubes had minimum thickness at the top of the tube.

Fig. 12 shows schematic drawing of phase changing effect that make severe corrosive environment

It was decided that the cause of the tube rupture was H₂S-H₂ Corrosion i.e. high temperature sulfidic corrosion due to H₂S concentrated gas phase.

- Convection and Radiant zone tube material was replaced with 347stainless steel because there was little difference between P5 and P9 material in H₂S-H₂ corrosion resistance.
- Access door was installed to inspect tubes that located in flue gas duct casing.
- Periodic Inspection plan was set up and done for connected line piping, columns and heaters. Some pipes thinned by H₂S-H₂ corrosion were found and replaced with stainless steel pipe.
- Applying advanced NDT (Nondestructive Technology) Worldwide survey was done to search advanced NDT

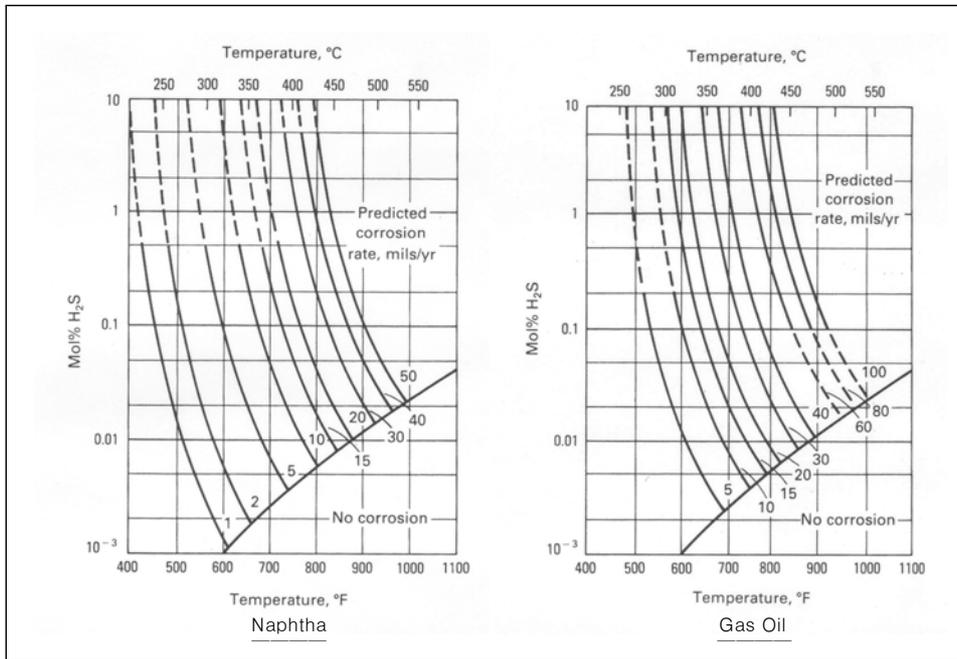
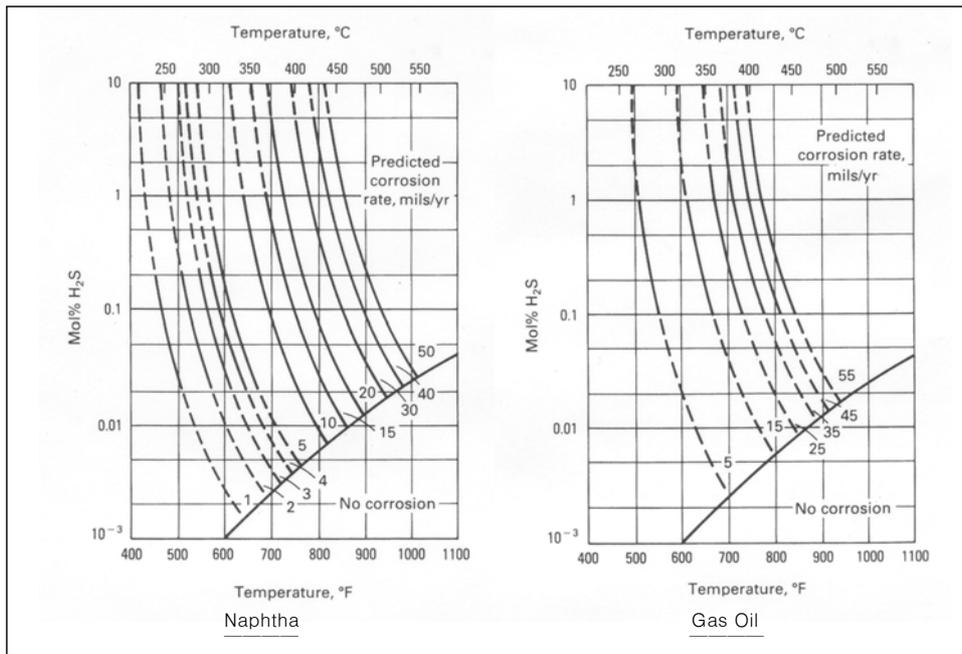
corrosion rate according to H₂S contents and temperature for 5 Cr-0.5 Mo steel and 9 Cr-1 Mo steel in Fig. 13 and Fig. 14 respectively. Estimated H₂S concentration from Couper-Gorman curves was 2,000~3,000 ppm according to operation conditions and corroded rate.
