Localized Corrosion of Zn-Plated Carbon Steel Used as a Fire Sprinkler Pipe

The failure of a Zn-plated carbon steel pipe that served as a fire sprinkler was investigated in terms of the pipe's corrosion products. The pipes leaked through holes formed beneath the tubercles. The formation of oxygen concentration cell involves colonization of metal surface by aerobic bacteria or other slime formers, and anodic reaction beneath tubercle is accelerated by the presence of SRB, leading to the formation of hole beneath tubercle.

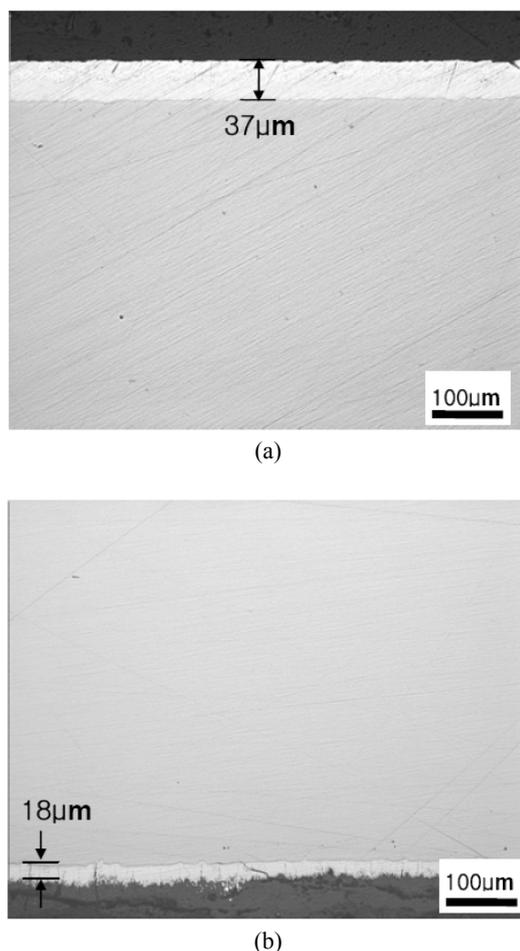
Figures 1(a) and (b) show typical cross-sections of a fire sprinkler pipe. The external and internal surfaces of the pipe were Zn-plated for corrosion protection by a sacrificial anode, and the thicknesses of the Zn layers outside and inside of pipe were approximately 37 and 18 μm , respectively, as shown in Figs. 1(a) and (b).

Fig. 1. (a) Cross-section near external surface of pipe and (b) cross-section near internal surface of pipe.

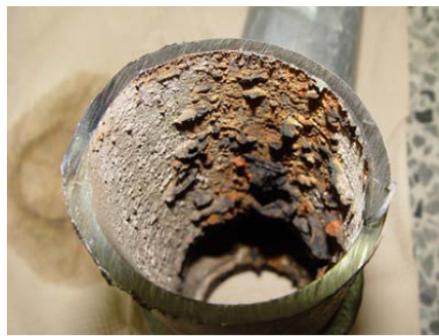
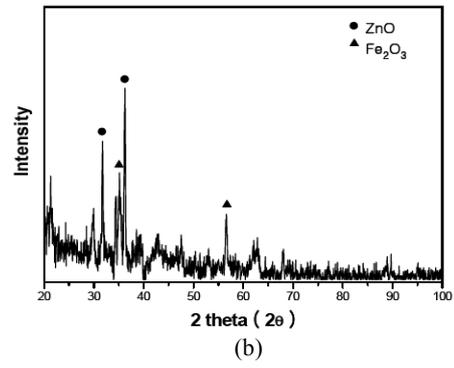
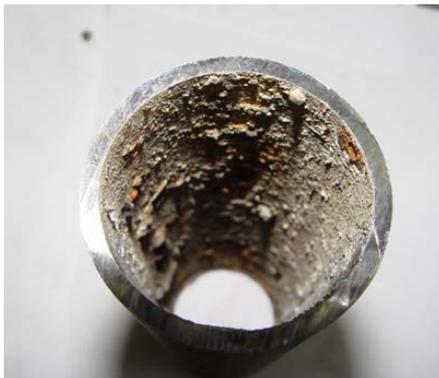
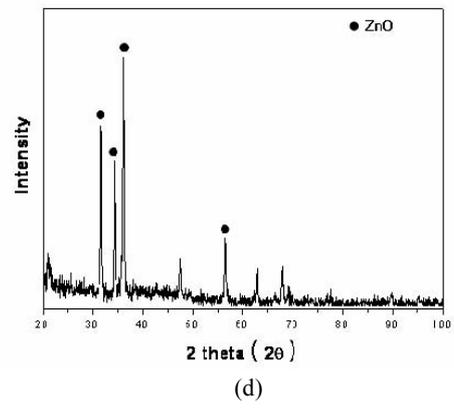
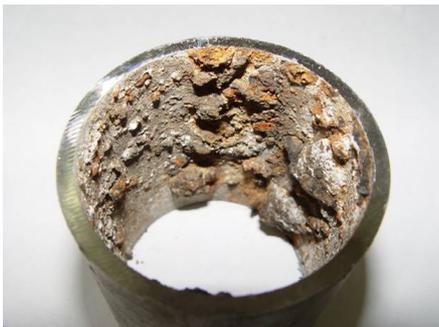
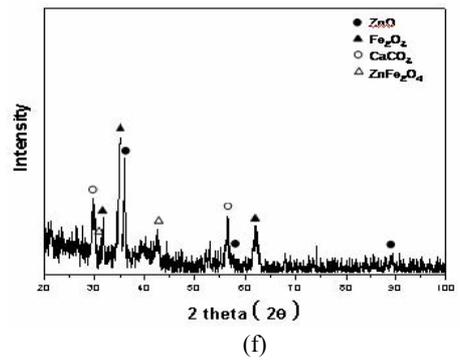
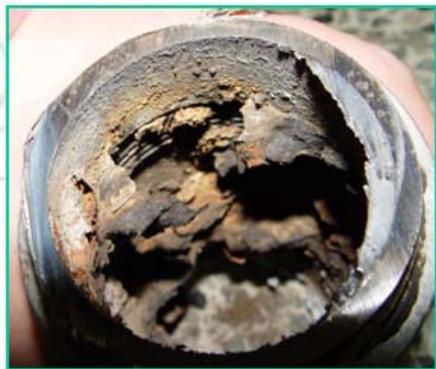
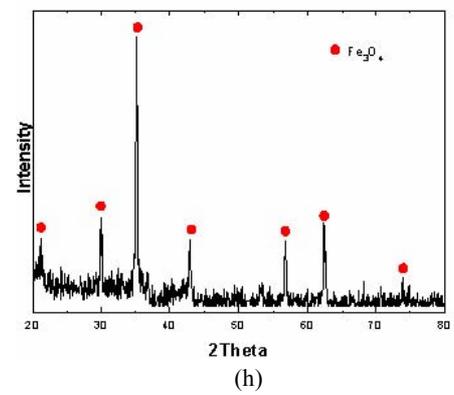
Figures 2 (a), (c), (e) and (g) show samples obtained from various positions in the building. The corrosion products were carefully collected from the internal surfaces of pipes, and the XRD analyses were performed to identify the corrosion products formed at each pipe. ZnO and Fe_2O_3 were detected in the corrosion products shown in Fig. 2 (a), ZnO in Fig. 2 (c), Fe_2O_3 , ZnO, CaCO_3 and ZnFe_2O_4 in Fig. 2 (e), and Fe_3O_4 in Fig 2 (g) (see Fig. 2 (b), (d), (f) and (h) for XRD analysis results). Although various compounds were identified, the major corrosion products were Fe_2O_3 (brown), Fe_3O_4 (black) and ZnO (white). The most internal surface of pipe is covered with ZnO, and in some regions, brown or black colors of tubercles are observed as shown in Fig. 1(a) and (e).

Fig. 2. XRD patterns for various corrosion products observed inside of pipe.

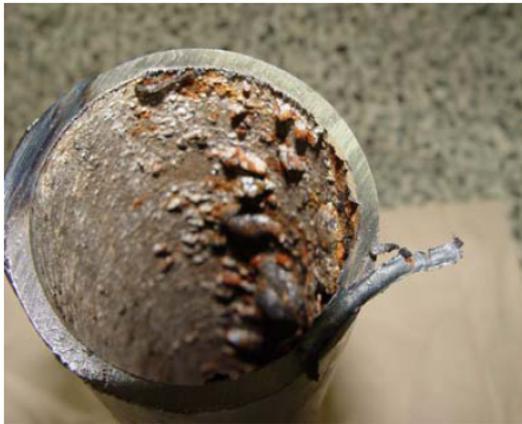
The degree of corrosion inside of pipes covered with ZnO or tubercles is compared. Figure 3(a) shows tubercles formed on the internal surface of the pipe. To investigate the degree of corrosion near the tubercles, the cross-section was observed as shown in Fig. 3(b). The thickness of the Zn layer in approaching to tubercles decreases due to a loss of the Zn layer and localized corrosion occurred at the tubercles (as shown in Fig. 3(b)). To further observe the localized corrosion beneath the tubercles, the tubercles were physically removed, and the tubercle-removed region was observed using an optical microscope. Figure 3(c) (dotted circle) shows the hole formed beneath the tubercle that causes the water leakage of a sprinkler. In contrast, localized corrosion in pipe covered with ZnO does not occur although the thickness of the Zn layer of the pipe decreases to $< 10 \mu\text{m}$ as shown in Fig. 4. From this fact, it is concluded that the failure of a sprinkler pipe is attributed to the formation of tubercles, in particular, the hole formed beneath a tubercle.

Fig. 3. (a) macroscopic view for cross-section, (b) cross-section near a tubercle in fire sprinkler pipe that was in use for 13 years and (c) hole observed beneath a tubercle after that tubercle was physically removed.

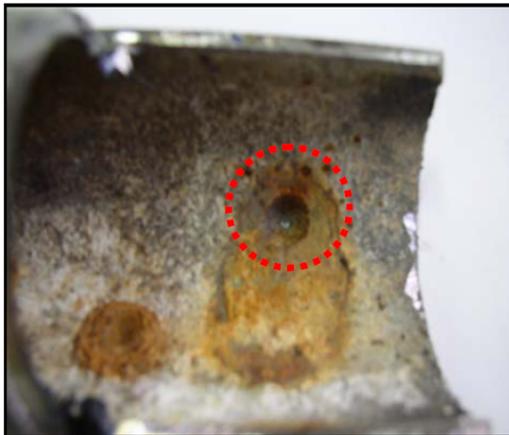
(c)

The present study addresses the failure mechanism of a fire sprinkler pipe (KSD 3507) serviced for 13 years. The water leakage of the fire sprinkler is caused by the hole formed beneath a tubercle which is grown by oxygen concentration cell. The oxygen concentration cell is formed by aerobic bacteria or other slime formers, and the localized corrosion below tubercles is accelerated by SRB, resulting in the formation of hole beneath tubercle.

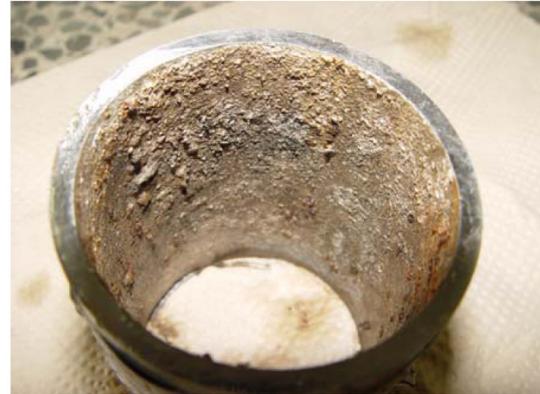
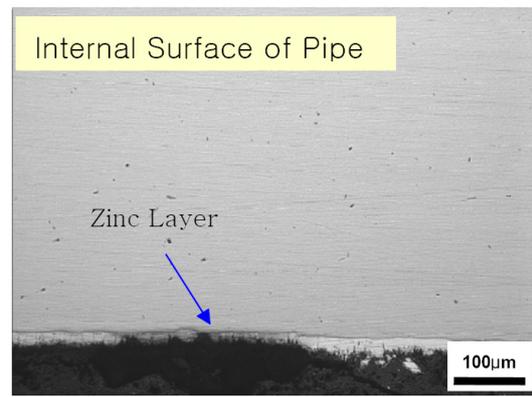
Fig. 4. (a) Macroscopic view and (b) cross-section of a pipe covered with ZnO.

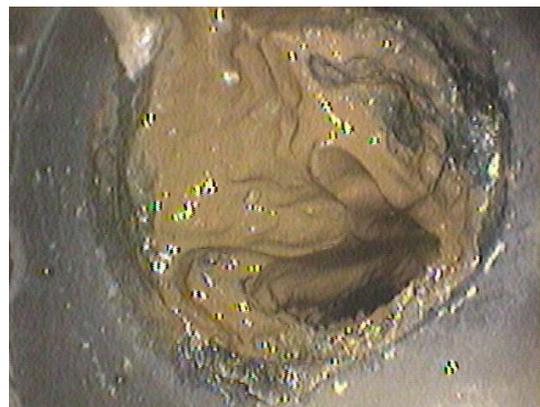
In this study, it is important to clarify the cause for the formation of oxygen concentration cell. Figure 5 shows a large amount of slime observed inside of pipes. It has been well known that the slime is formed by oxy-

gen-consuming aerobic bacteria or other slime formers.⁶⁾
⁷⁾ Thus, the presence of the slime indicates that the formation of oxygen concentration cell in this study involves

Fig. 5. Slime formed inside of pipe.

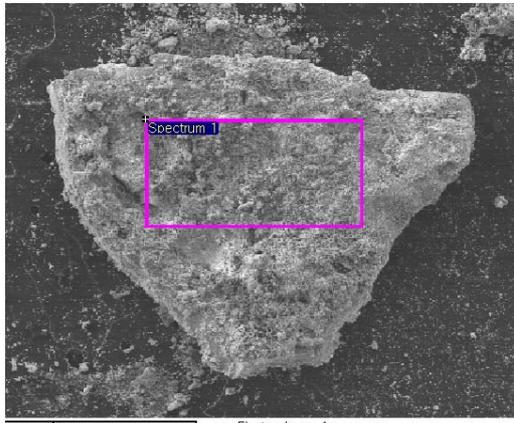
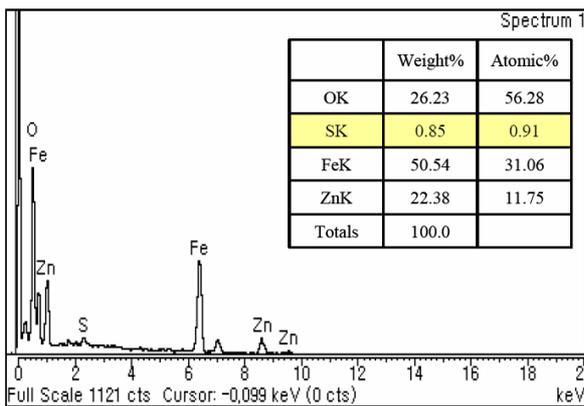
colonization of metal surface by aerobic bacteria or other slime formers. Figure 6 shows the EDS analysis to confirm the presence of impurity elements in corrosion products. High sulfur contents were detected, as shown in Fig. 6(b), where we interpret this as resulting from the byproducts of the corrosion reactions. The possible corrosion reaction

Fig. 6. (a) FESEM micrograph of the corrosion product and (b) EDS analysis of the corrosion products shown in (a).

is the formation of iron sulfide or hydrogen sulfide via sulfur-reducing bacteria (SRB).⁶⁻⁸⁾ Considering the presence of slime on the internal surface of pipe, sulfur in corrosion products and tubercles consisting of iron oxides,

it is concluded that the failure of a fire sprinkler pipe is attributed to the formation of oxygen concentration cell by aerobic bacteria or other slime formers and corrosion acceleration by SRB.
