Identification of the Failure of VFD Heat Sink at Fossil Power Plant

The water cooling system for VFD (Variable Frequency Drive) of a fossil fuel power plant was reported to be shut down due to a water leak at the metal connection of the heat-sink to the hoses. In order to identify the cause of the failure, the system was visually inspected, and corrosion products were analyzed with SEM equipped with EDX. The failure was observed repeatedly at the nipples of certain location, suggesting galvanic corrosion. In a U-shaped heat sink with two nipples, for inlet and outlet, only one nipple was corrosively damaged at the tip, while the other was not. Most of the corrosion products were observed at the sound nipple and in the filter, identified as $\text{Cu}(\text{OH})_2$. Some other corrosion products, composed of mostly Cu_2O , were found at the corrosively attacked nipple. A fair amount of Cl was also detected on the surface of the damaged nipple. It was concluded that galvanic corrosion was occurred due to a current leakage over the whole system, and the damage was accelerated by the accumulated chlorine ions in the cooling water.

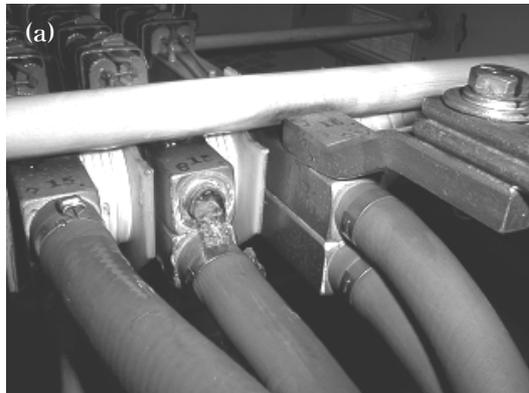
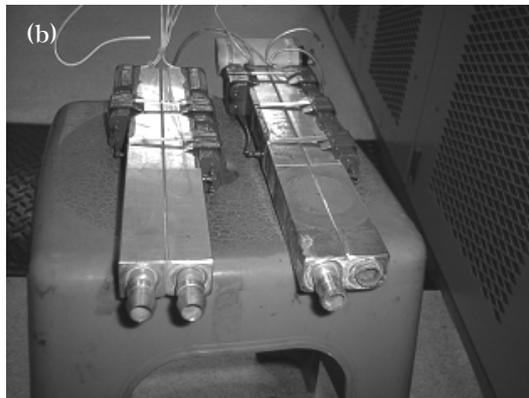
Fig. 2 shows a couple of the U-shaped heatsinks, as assembled into the system (a) and as detached therefrom (b). Fig. 2 shows that one of the heatsink was partly damaged at the connection and disconnected from the hose, leading to a leak. It can be seen that a damaged nipple of the heatsink, outlet nipple in this case. The failure was found repeatedly at the nipples of certain location throughout the whole system consisting of 9 U-shaped heatsink modules. Furthermore, there were no heatsink modules

Fig. 2. A couple of U-shaped heatsinks showing the failure at the connection: (a) as assembled into the system; (b) as detached therefrom.

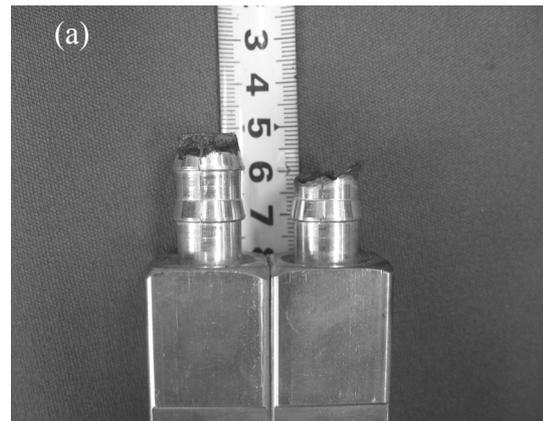
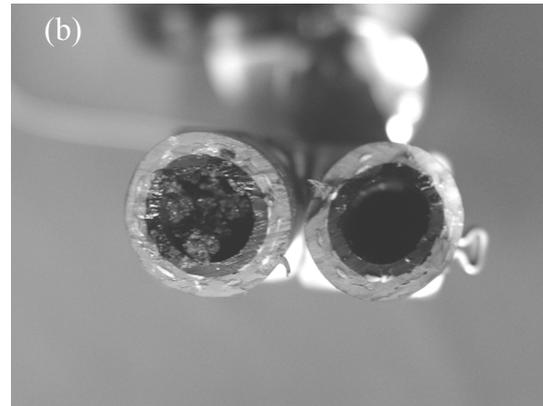
where the inlet and outlet nipples were damaged concurrently. This suggests a kind of galvanic corrosion. From a closer inspection, as shown in Fig. 3(a), it can be seen that one of the nipples maintains its original shape with some color change at the tip, while the tip of the other nipple was severely eroded away. Inside of the sound nipple and hose attached to this nipple were almost stuffed by corrosion-products, while that of the eroded was relatively clean, as shown in Fig. 3(b). The inside of the heat-sink remained unattacked, by an inspection using an endoscope, as shown in Fig. 4. Some corrosion-products were in blue-green color in the filter, seemingly originated from the corrosion of the nipple, as shown in Fig. 5.

Fig. 3. A closer inspection of the nipples (a) and hoses (b).

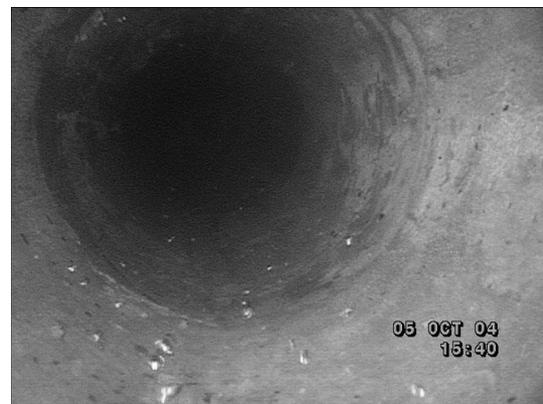
Fig. 4. The inside of the heatsink inspected using an endoscope.

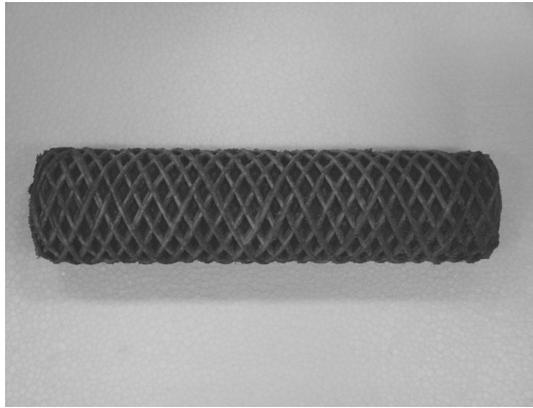
Fig. 5. Corrosion-products in blue-green color found in the filter.

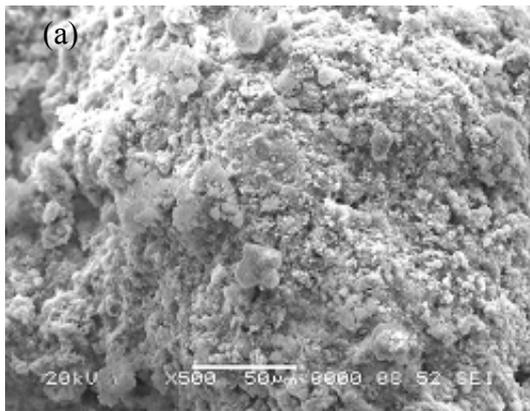
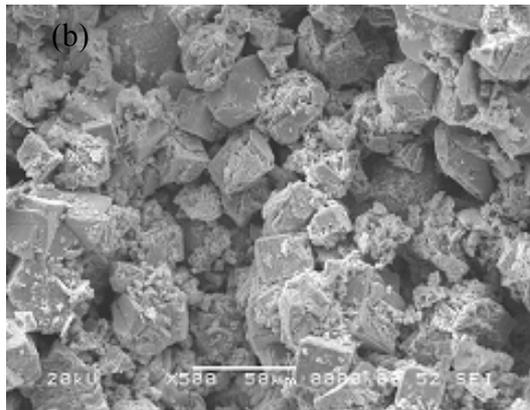
Fig. 6 shows the morphology of the corrosion-products taken by SEM accumulated (a) at the inlet and (b) outlet side. As shown, the corrosion-products have different

Fig. 6. The morphology of the corrosion-products taken by SEM : (a) inlet and (b) outlet.

morphologies. Smaller grains are agglomerated at the outlet side, while bigger crystal-like grains are well adhered on the inlet side.

difference in the composition between the inlet and outlet side. From Tables 1 and 2 (from the atomic %), the corrosion-products accumulated at the inlet is expected to be in the form of $\text{Cu}(\text{OH})_2$, and those at the outlet side Cu_2O .²⁾⁻⁵⁾ Those at the filter have almost the same chemical composition as those of inlet, as listed in Table 3.

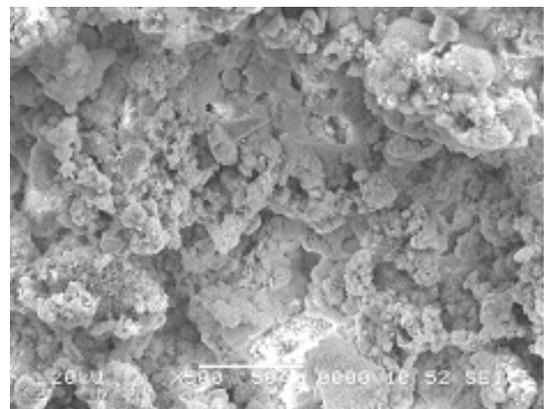
Fig. 7. The morphology of the corrosion-products at the filter.

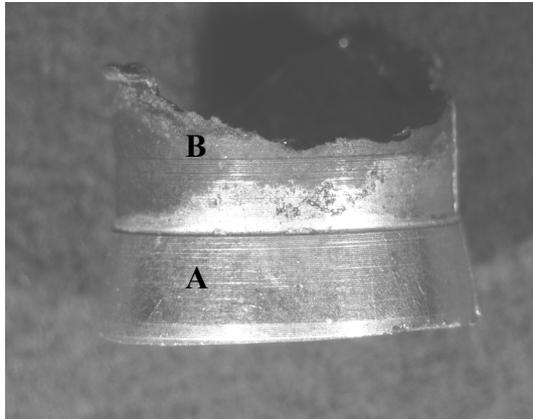
As shown in Fig. 8, some part of the tip of the eroded outlet nipple lost its original color. The color has been changed from metallic white into black-brown. In this part, a corrosive element, Cl, was detected in a considerable amount.(Table 4)

Fig. 8. The morphology of the eroded outlet nipple: metallic white (A) and black-brown (B).
