Investigation of shinning Spot Defect on Hot-Dip Galvanized Steel Sheets

LIU Yonggang and CUI Lei

Auto Sheet Strategic Business Unit, Maanshan Iron & Steel Co. Ltd., Maanshan, Anhui Province, 243000, China
(Received April 22, 2014; Revised August 28, 2014; Accepted August 28, 2014)

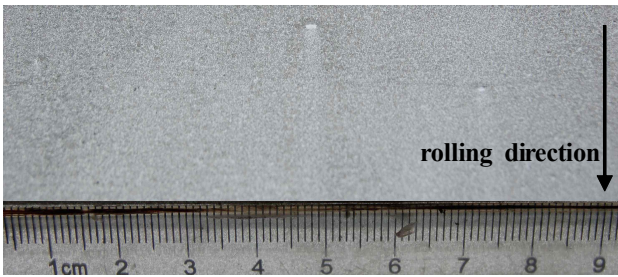
The sample of shinning spot defects as shown in Fig. 1. was obtained from continuous galvanizing line (CGL). The shinning spot defect is usually about 1mm long and 0.5mm wide which looks lighter than the normal area, and the length direction is perpendicular to rolling direction. The chemical composition of base steel which usually exist shinning spot defect is shown in Table 1 and the coating weight is usually under 60g/m² per side. The surface and cross-sectional morphologies of the coating and the interface morphology after GI coating removed by 25%HCl solution with an addition of the inhibitor ((CH₂)₆N₄) were investigated using a ZEISS Imager.A2m optical microscope (OM) and XL30 scanning electron microscopy (SEM), and the chemical of the defect

Fig. 1. Shinning spot defects observed on GI coatings.

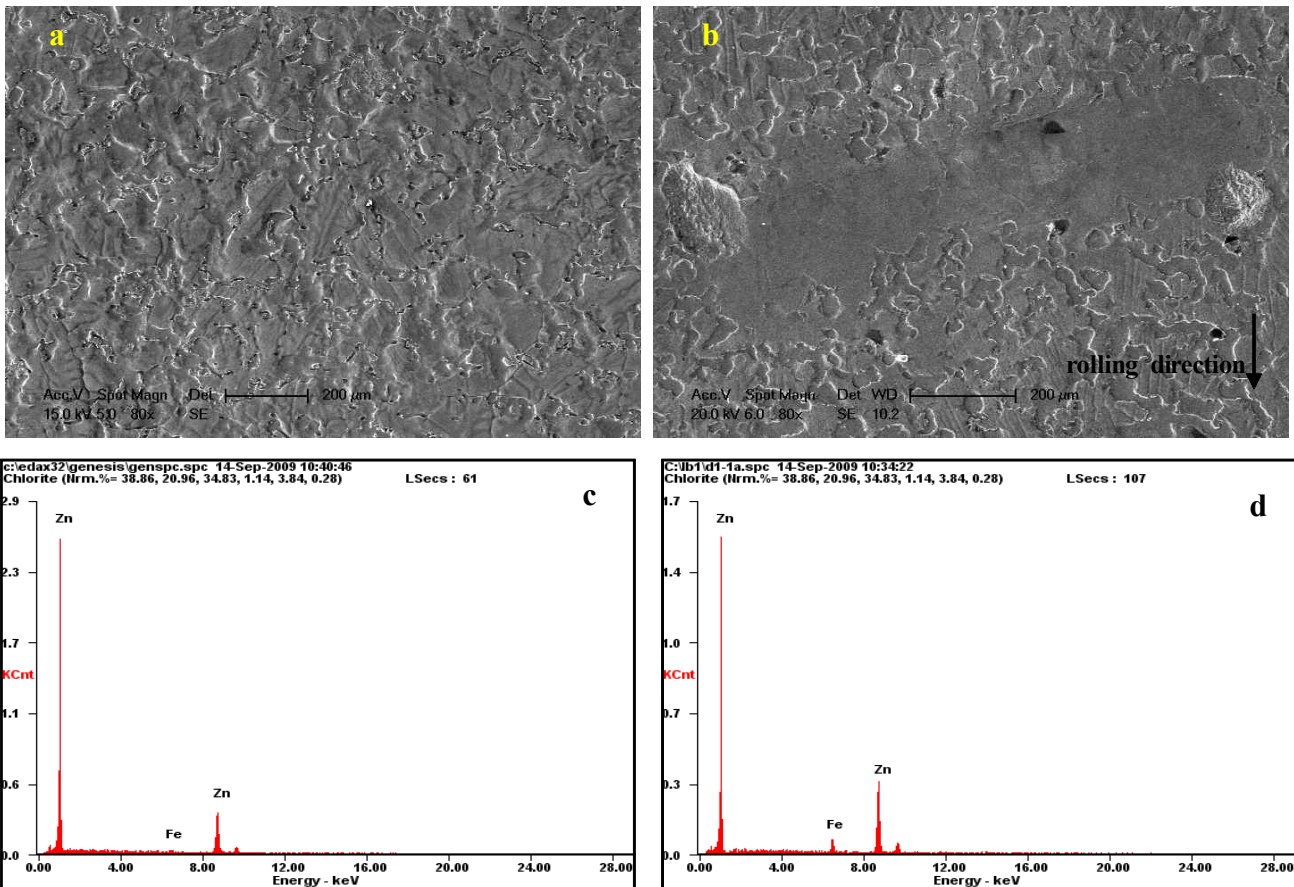
Both the surface morphology and EDS analyses of the GI coating observed on the shinning spot defect and normal area are shown in Fig. 2. Being different from the rough surface of normal area which made by skin-pass-mill, the surface of shinning spot defect is much flatter. On the upper side of shinning spot defect, the boundary between shinning spot defect and normal area is very clear; while on the other side, the boundary is unclear and the surface gradually transition from flat to rough (Fig. 2b). All the shinning spot area seems like lower than normal area. The results of EDS showed that the chemical composition of both the shinning spot defect and normal area are iron and zinc. The iron content of shinning spot defect is 6.3 wt%, which is higher than normal area where the iron content is 2.73wt%.

Fig. 2. The surface morphology and EDS analyses of the GI coating: a) normal area; b) shinning spot defect; c) EDS analyses of normal area; d) EDS analyses of shinning spot defect.

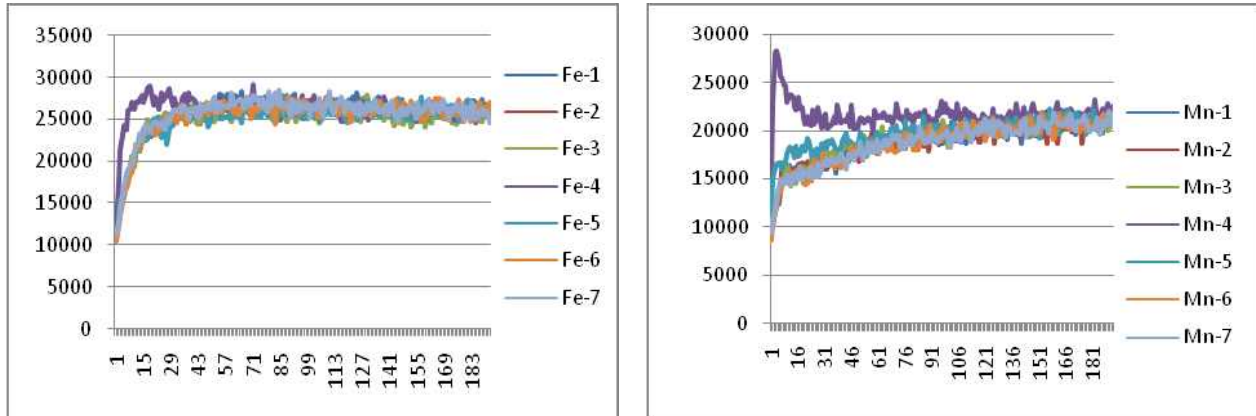
Fig. 3. The LIBSOPA results.

The LIBSOPA results of normal and defect are shown in Fig. 3. The point 4 was defect area, and other points were normal area. Being different from normal areas, the iron and manganese content is obvious higher.

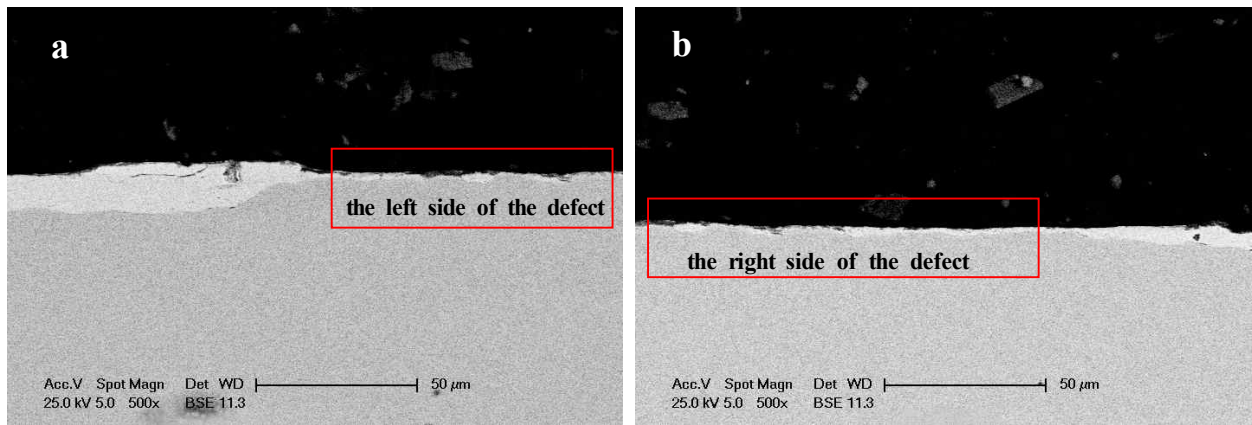
Fig. 4. The cross sectional morphology of the GI coatings and substrate: a) the left side of shinning spot defect; b) the right side of shinning spot defect.

The cross sectional morphologies of the GI coatings and substrate observed on the shinning spot defect are shown from Fig. 4a) and b). The coating thickness of shinning spot defect is about 2μm, which is much thinner than normal area where the coating thickness is about 10μm. This can explain why the iron content of shinning spot defect is higher than normal area which is shown in Fig. 2 and Table. 2. Contrasted the shinning spot defect with normal area, it can be found that the coating surface of shinning

spot defect is lower than normal area. Between the left side of shinning spot defect and normal area, a clear step on coating surface can be found where the coating thickness thinned quickly, while on the other side of shinning spot defect, the coating thickness thickened gradually. This is in agreement with the surface morphology in Fig. 2b).

The substrate directly under the shinning spot defect is higher than substrate under normal area, and on the left side of the substrate under shinning spot defect, a quickly raised step can be found which corresponds to the coating step where the coating thickness thinned quickly. While on the other side, the substrate declined gradually. The substrate beside the quickly raised area seems like a little

lower than normal substrate area and the coating thickness here is $17\mu\text{m}$, which is thicker than normal area where coating thickness is $10\mu\text{m}$.

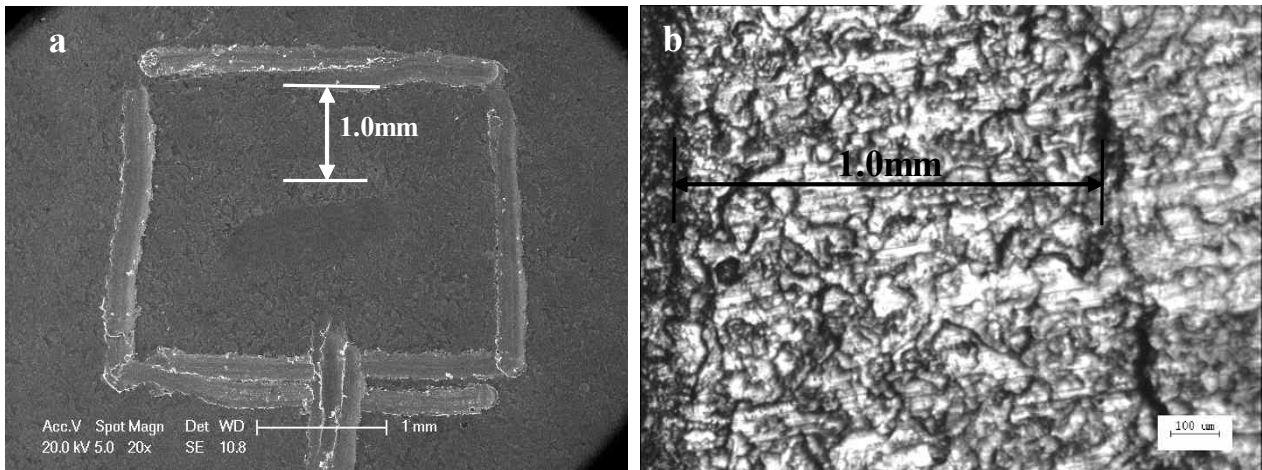
Fig. 5. The surface morphology before (a) and after (b) zinc coating been removed.

From the results above, it can be confirmed that the substrate under the shining spot defect may be exist defect. The interfaces of the coating/substrate after zinc coating been removed by HCl with addition of inhibitor are shown in Fig. 5b) which investigated by OM because morphology investigated by SEM is very unclear. Before zinc coating been removed, a square sign has been made around the shining spot defect in order to determine the position of the substrate defect, which is shown in Fig. 5a). Contrast the deposition of the substrate defect with the shining spot defect, it can be found that the substrate under the clear boundary between shining spot defect and normal area on coating surface exist defect like 'scratch'.

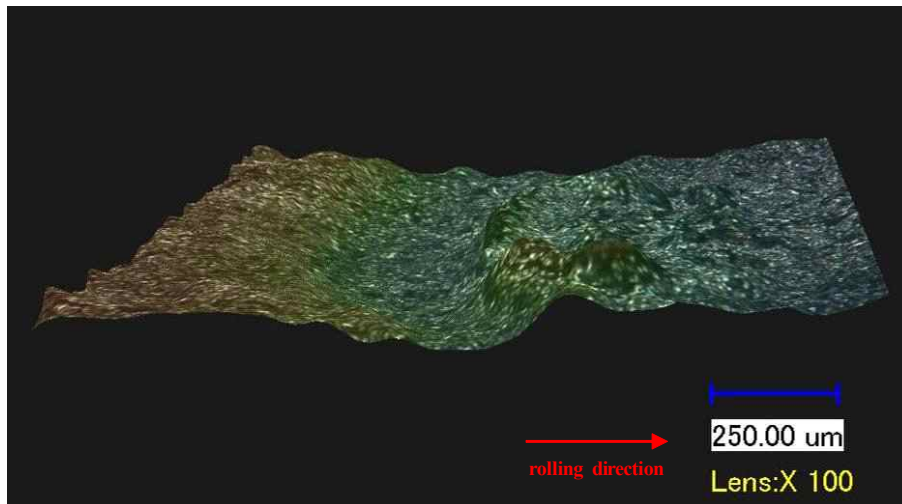
Fig. 6. Three dimensional surface morphology of substrate after zinc coating been removed.

In order to show the defect more visually, a three dimensional surface morphology is shown in Fig. 6. The substrate defect contains a dent and a adjacent raised area. Draw a comparison between Fig. 6, Fig. 4b) and Fig.5b), it can be confirmed that the shining spot defect on coating surface is exactly on the top of the raised areas and the clear boundary between shining spot defect and normal area justly corresponds to the boundary between dent and raised area on substrate. The coating thickness above the dent of substrate is higher than normal area.

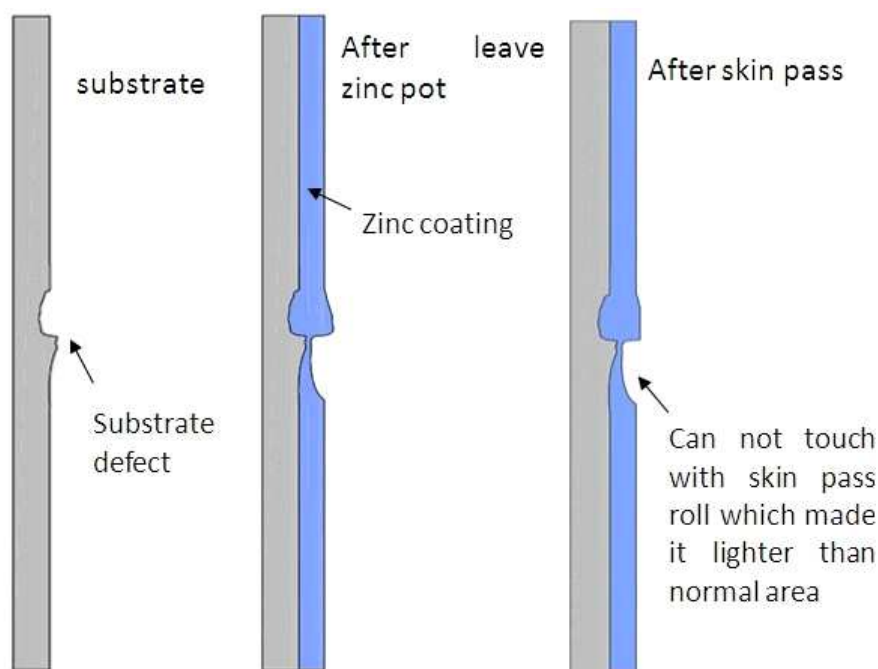
Fig. 7. Schematic diagram of the formation mechanism of the shinning spot defect.

is obvious higher than normal area. The formation mechanism of the shinning spot defect investigated in this paper is shown in Fig. 7. When there is a defect which contains a dent and adjacent raised area like Fig. 6 where wet ability may be poor, zinc liquid will be hold together above the dent area while it will be very limited at the raised area due to surface tension and greatly raised substrate when steel sheet leave zinc pot. So a clear boundary formed due to the obvious difference of coating thickness. While on the other side of the raised area on substrate surface, the zinc liquid gradually returned to normal range due to gravity and gradually declined substrate. After skin pass, the zinc coating on the raised area can not touch with skin pass roll because where the zinc coating is lower than normal area, which cause the zinc coating surface at the raised area still keeping flatten while normal coating surface being rough. The different coating morphologies have different effects on the reflection of light and cause the shinning spot defect lighter than normal coating area in the end.

flatter than normal area. It is the difference of the coating surface that leads to brightness difference between these two areas. The coating thickness of shinning spot defect is much lower than normal area. The defect area can not touch with skin pass roll which result in shinning spot defect flatter than normal area. It can be confirmed that the shinning spot defect was caused by substrate defect. So as a matter of fact, the substrate surface quality is of paramount importance for producing a high quality coating.
