# Cause Analysis of Flow Accelerated Corrosion and Erosion-Corrosion Cases in Korea Nuclear Power Plants

Y. S. Lee<sup>1†</sup>, S. H. Lee<sup>1</sup>, and K. M. Hwang<sup>2</sup>

<sup>1</sup>Korea Hydro & Nuclear Power Co., LTD, Central Research Institute

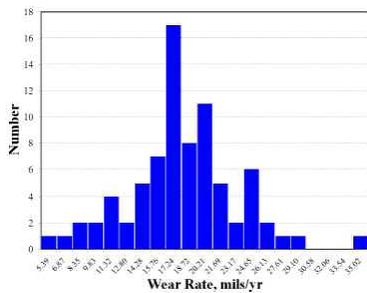
Fig. 2. EPRI TPM evaluation result.

As shown in Fig. 2, it was identified that pipe wall thinning goes along resulting from EPRI TPM (Total Points Method) evaluation using 3 cycles UT data. In order to analysis wall thinning cause, numerical simulation was performed using CFD (Computational Fluid Dynamics) code, FLUENT. Fig. 3 shows the water flow distribution, radial water velocity distribution, and turbulence intensity

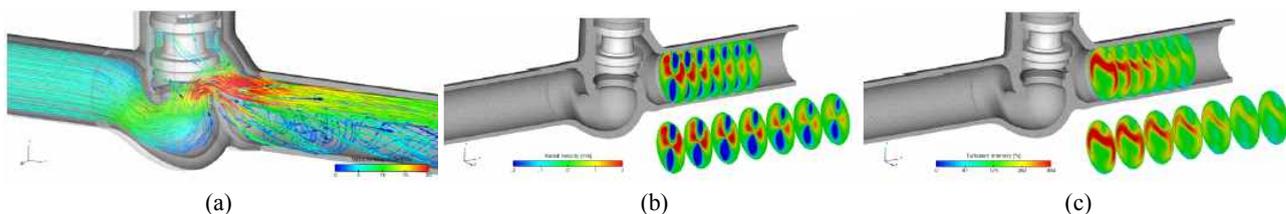
Fig. 3. Numerical simulation results of the check valve and downstream pipe ; (a) Water flow distribution, (b) Radial water velocity distribution, (c) Turbulence intensity distribution.

distribution as the numerical simulation results of the check valve and downstream pipe. Water flow is faster at upper side of the check valve and downstream pipe than the other side. Radial velocity is also faster and turbulence intensity is higher at upper side of the check valve and downstream pipe than the other side. Wall thinning was generated by internal water flow shape of swing type check valve upstream of the pipe. Internal water flow shape of some check valve can evoke wall thinning of downstream pipe. It is concluded that the main cause of the wall thinning for the downstream pipe of the check valve is FAC caused by the water vortex flow due to internal flow shape of the check valve.

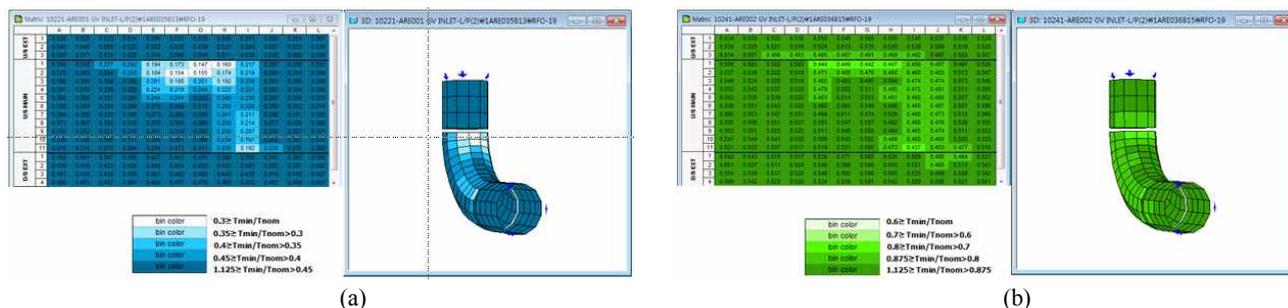
Fig. 4. UT data distribution of the elbow and pipes at (a) SG1 and (b) SG2.

Analyses of UT data were performed to find the wall thinning difference between two elbows installed in SG1 and SG2 lines. Fig. 4 shows UT data distribution of the elbows and pipes at SG1 and SG2. The elbow of SG1 was being thinned at the intrados and was thinner than the upstream pipe. The elbow of SG2 was little thinned and had the similar thickness with the upstream pipe.

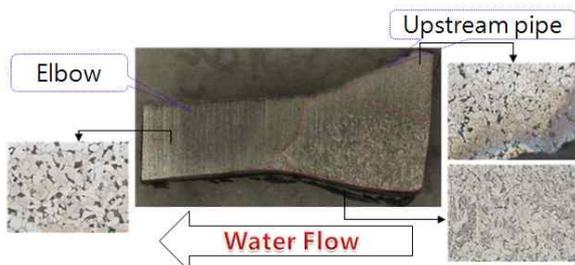
Fig. 5. OM image at SG1 elbow and upstream pipe.

OM (Optical Microscope) image observation was performed to investigate thickness difference between SG1 elbow and upstream pipe. Fig. 5 shows the microstructure image of the upstream pipe, the weld area, and the elbow for the direction of water flow. As the protruding part exists at the upstream pipe by thickness difference, it is possible for pipe wall to be thinned by the protruding part of the upstream pipe. Or, if welding bid had existed at the weld area, it is possible for pipe wall to be thinned by welding bid. Fig. 6 shows Isometric drawing of SG1 elbow line. As the control valve (242VL) is located in the upstream of the elbow, it is also possible for pipe wall to be thinned by the control valve. To investigate wall thinning cause of the elbow by the control valve, the welding bid, and the protruding part of the upstream pipe, CFD numerical simulations were performed.

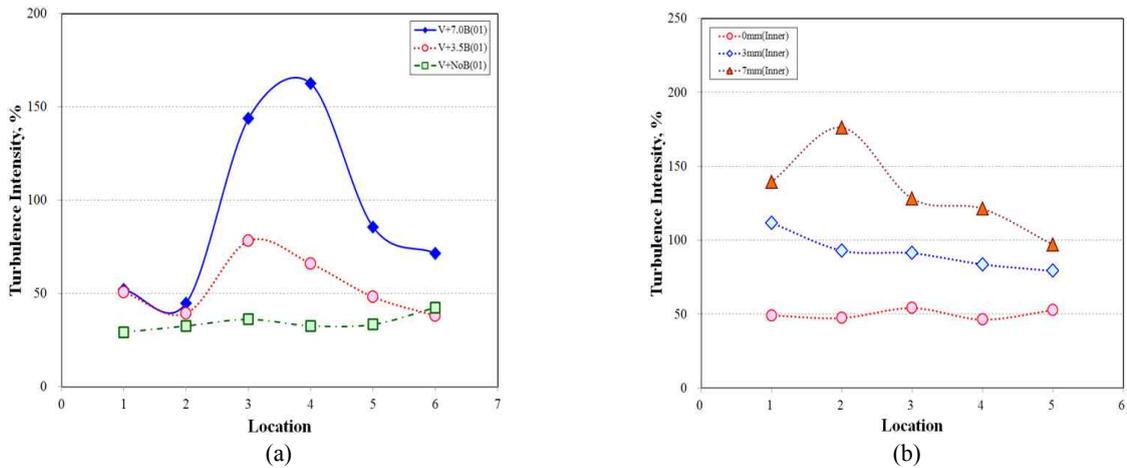
Fig. 7 (a) shows numerical analyses results for wall thinning affected by the welding bid, where V+7.0B means existing of 7.0mm bid at the downstream elbow of valve. Fig. 7 (b) shows numerical analyses results for wall thinning affected by the protruding part of upstream pipe. The welding bid affects elbow wall thinning. The thickness difference by the protruding part of upstream pipe also affects elbow wall thinning. The main cause of the wall thinning for the downstream elbow of the control valve is FAC due to the water vortex flow by the welding bid or the thickness difference.

Fig. 7. Numerical simulation results of the elbow wall thinning ; (a) Turbulence intensity by the welding bid and (b) Turbulence intensity by the thickness difference.

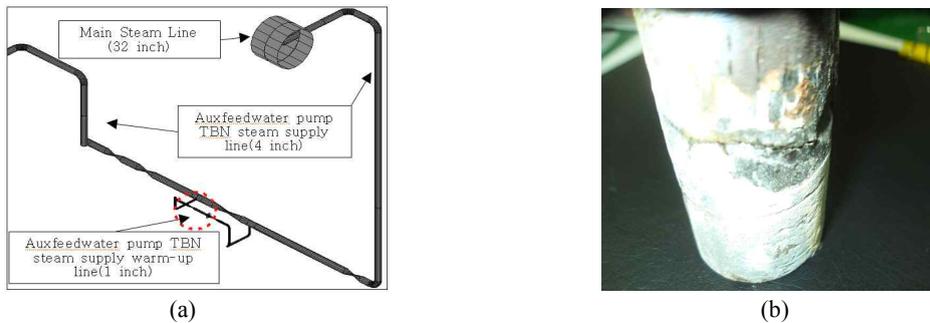
Fig. 8. Diagram and picture of small bore pipe line ; (a) 3D of small bore pipe line and (b) Failure picture of small bore pipe.

Steam leak was founded in a small bore pipe (SA106 Gr. B, Class3) located in the downstream of the orifice at SG A in main steam system. The function of the pipe is warming-up the auxiliary feedwater pump turbine with main steam and flowing steam goes to the condenser as shown in Fig. 8. The pipe was replaced and the same pipe at SG B and the other plants were inspected. All

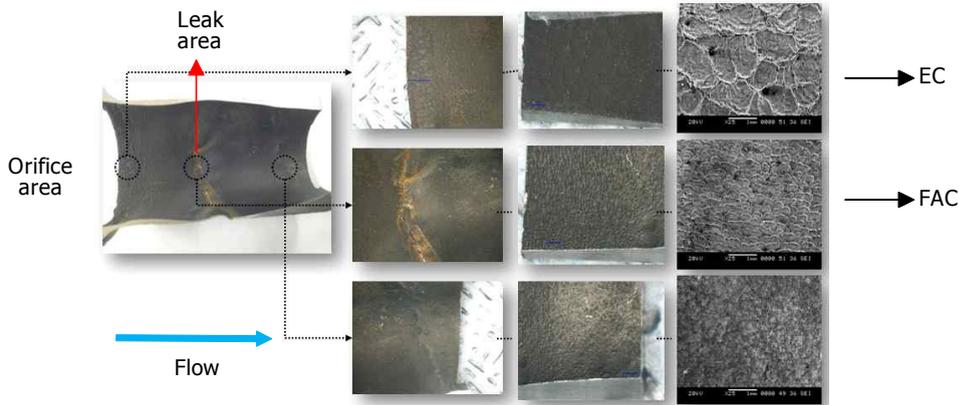
Fig. 9. Surface of small bore pipe.

generator moisture separator re-heater and power up-rate. Fig. 9 shows surface analyses results by stereoscopy and SEM for three areas from the orifice. At the near surface of the orifice, damaged shapes by erosion were observed. At the near leak area, the FAC degradation like orange peel shape was observed. And, at the farther area of the orifice, surface damages were not nearly observed.

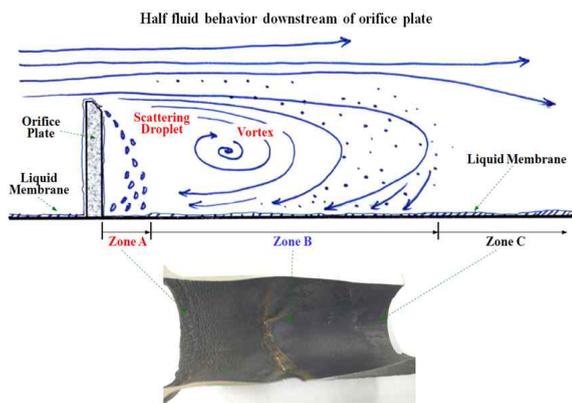
Fig. 10. Fluid behaviour for the downstream pipe of the orifice.

The main cause for the leak on the downstream pipe of the orifice is EC due to the liquid droplet and FAC due to the water vortex flow presented by wet steam as

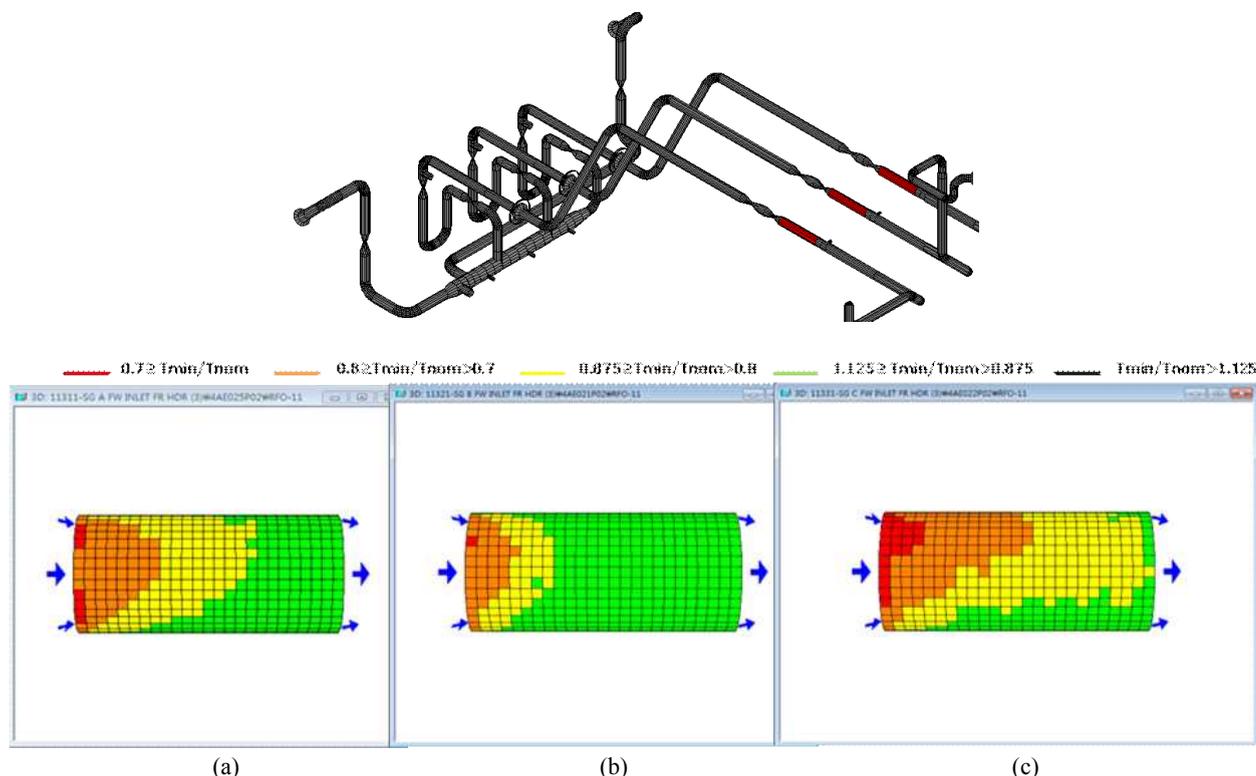
Wall thinning was founded at the downstream pipes of the feedwater check valve. The similar pipes were also thinned and replaced. Adjacent pipe areas of check valve were thinned as shown in Fig. 11. This case is very similar to the case 1.

Fig. 11. Thickness changing rate distributions for the downstream pipe of the check valve ; (a) A straight pipe at SG A, (b) A straight pipe at SG B, (c) A straight pipe at SG C.

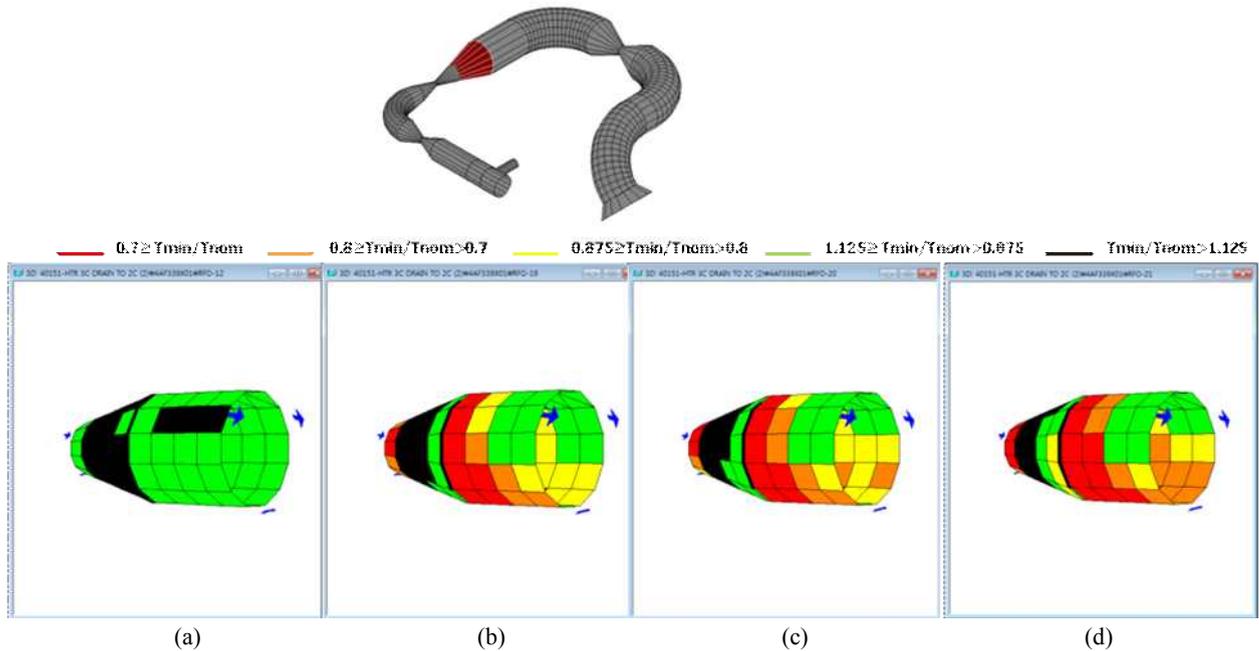
Wall thinning was founded at the pipe and expander located in the downstream of the control valve. As time goes on, value of the measured wall thickness is below 70 % compared to that of the nominal thickness as shown in Fig. 12.

Fig. 12. Thickness changing rate distributions for the downstream pipe of the control valve with inspection times (RFO) ; (a) RFO12, (b) RFO19, (c) RFO20, (d) RFO21.

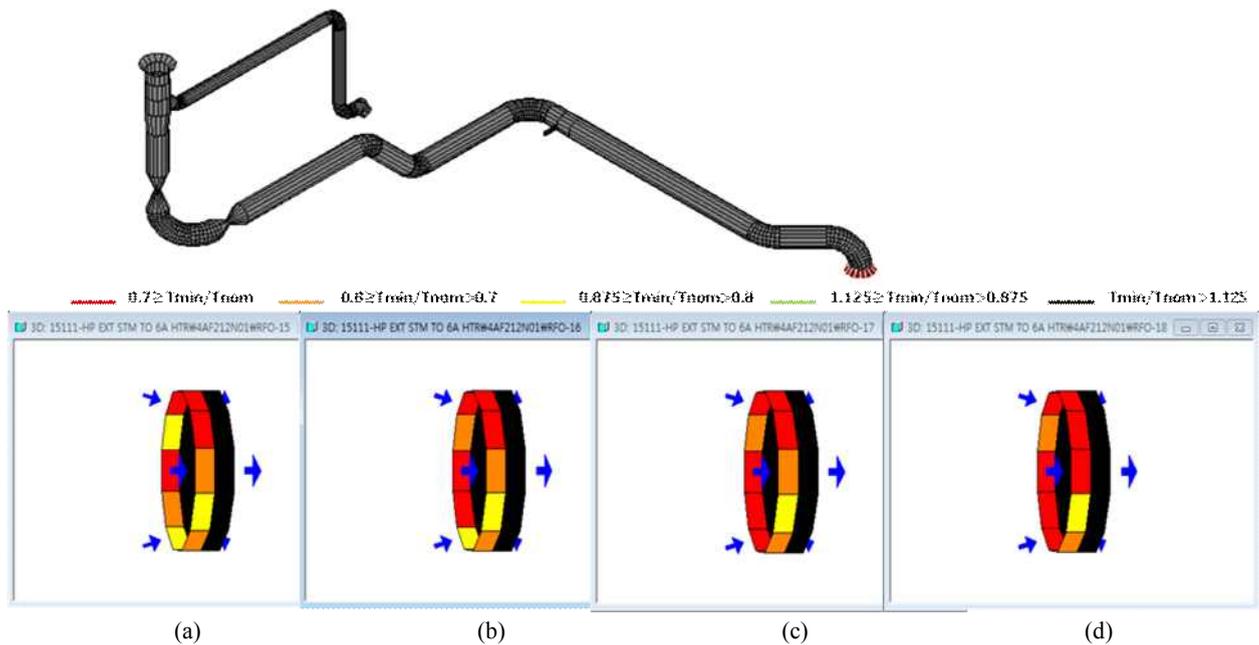
Wall thinning was founded at the carbon steel nozzle located in the downstream of low alloy steel elbow. As time goes on, value of the measured wall thickness is below 70 % compared to that of the nominal wall thickness as shown in Fig. 13. This is FAC due to entrance effect.

Fig. 13. Thickness changing rate distributions for the carbon steel nozzle with inspection times (RFO) ; (a) RFO15, (b) RFO16, (c) RFO17, (d) RFO18.
