Stress Corrosion Cracking of Heat Exchanger Tubes in District Heating System

Sangwon Cho¹, Seon-Hong Kim¹, Woo-Cheol Kim², and Jung-Gu Kim^{1,†}

The purpose of this paper is to present failure analysis, of the heat exchanger tube in a district heating system. SS304 stainless steel is used, as material for the heat exchanger tube. The heat exchanger operates in a soft water environment containing a small amount of chloride ions, and regularly repeats operation and standstill period. This causes concentration of chloride ions on the outer surface of the tube, as well as repeat of thermal expansion, and shrinkage of the tube. As a result of microscopic examination, cracks showed transgranular as well as branched propagation, and many pits were present, at the initiation point of each crack. Energy dispersive spectroscopy analysis showed Fe and O peak, as well as Cl peak, meaning that cracks were affected by Cl ion. Failure of the tube was caused by chloride-induced stress corrosion cracking by thermal stress, high temperature, and localized enrichment of chloride ions.

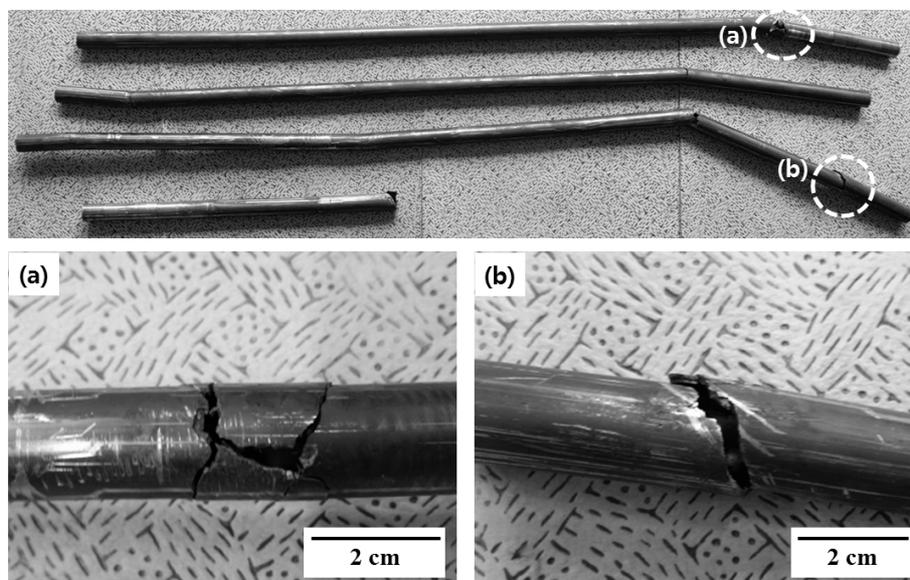
**Fig. 1** Photographs of the failed tubes; (a) circumferential and longitudinal direction crack, and (b) circumferential direction crack.

The failure tubes are shown in Fig. 1 and Fig. 2. Failure of the tube occurred in the whole area of the tubes, and the cracks were formed both the circumferential and longitudinal directions. Cracks appeared not only at the end of the tube connected to the shell but also throughout the tube. The size of the cracks varied from micron scale to complete rupture. Cracks were mostly formed in the circumferential direction, and a few cracks did occur in the longitudinal direction (Figs. 1a and 1b). The fractured surfaces were almost matched with each other, and plastic deformation could not observe. Brown oxide and orange

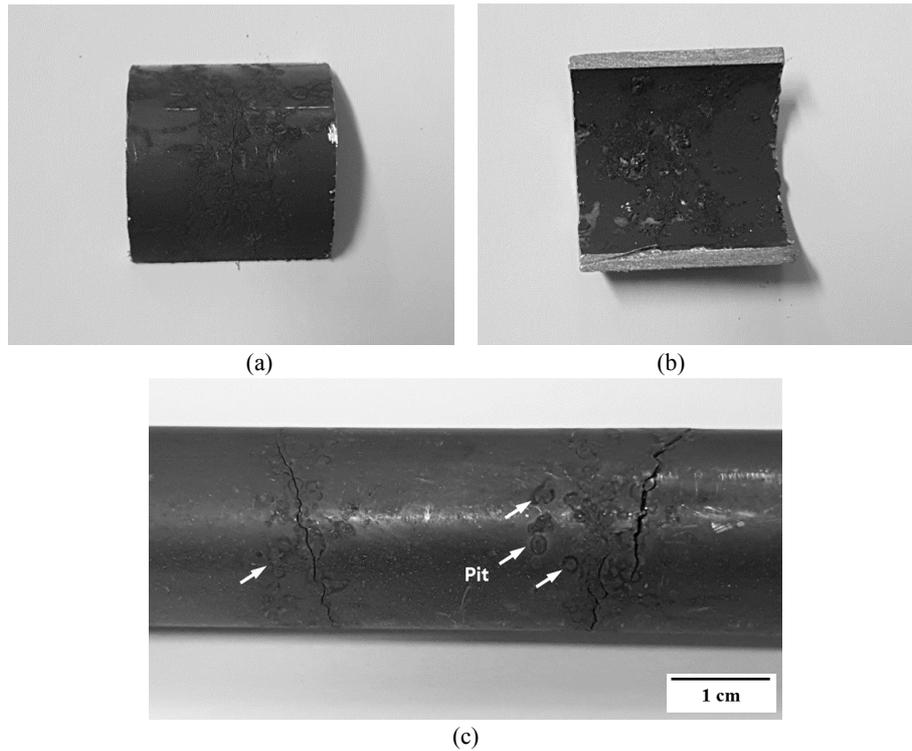
Fig. 2 Corrosion products formed on the tube surface; (a) outside of the tube, (b) inside of the tube, and (c) pits adjacent the crack.

oxide were observed on the outside and inside of the tube, respectively (Figs. 2a and 2b). Many pits were found adjacent to the cracks formed on the tube surface (Fig. 2c). These pits could act as a crack initiation point due to the stress concentration, pitting corrosion could cause tube failure.

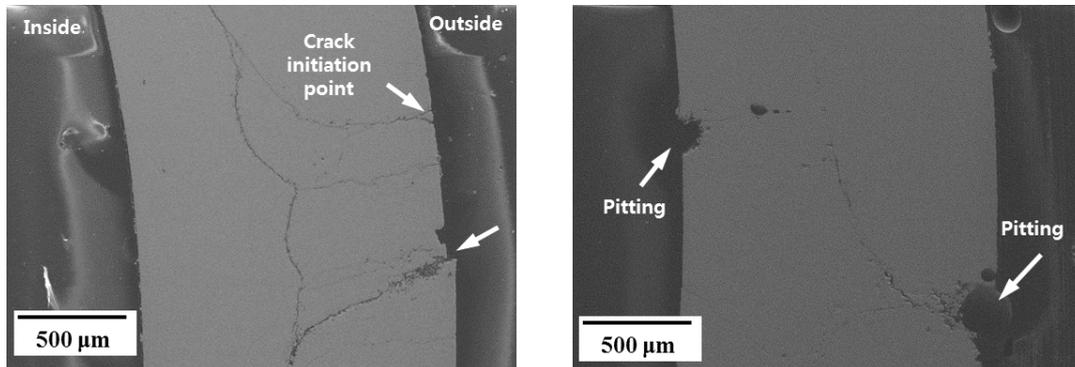
Fig. 3 Cross-sectional views of the failed tubes.

The cross sections of the failed tubes are shown in Fig. 3. Pits were found on both sides of the tubes. Pits at the outer side of the tube were deeper than those at the inner side. Most of the cracks started from the outside of the tube. At the crack initiation site, the pits were observed,

which verifies that pits acted as initiating points of the cracks. In Fig. 4, the numerous cracks had transgranular branched shape and sharp tip which are typical forms of SCC [7].

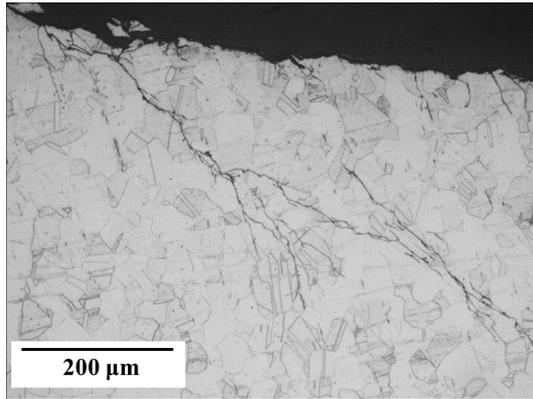
Fig. 4 Microstructure of the outer side of the failed tube wall.

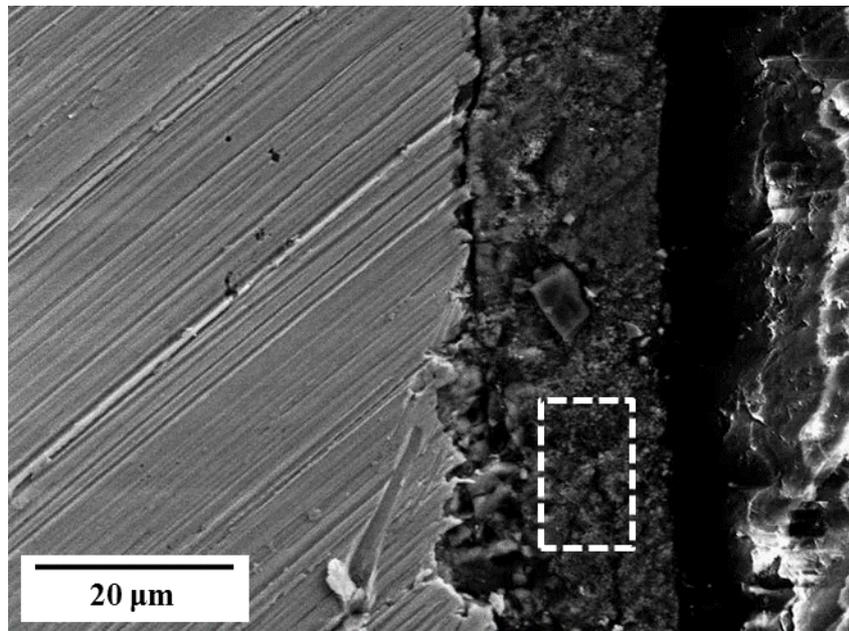
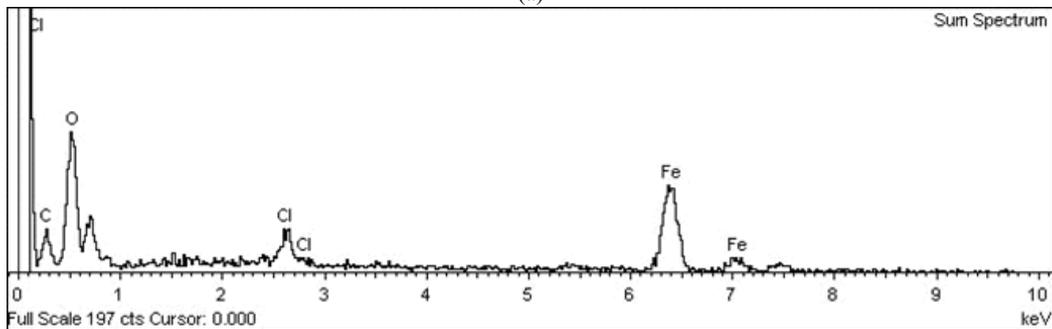
Fig. 5 shows the SEM image and EDS data of the corrosion product adjacent to the crack on the outer surface of tube. The corrosion products were formed with a maximum thickness of about 20 μm. The EDS analysis shows not only Fe and O peak but also Cl peak. The enrichment of Cl ion means that cracks were affected by chloride ion. Although the steam and district heating water only

contain a small amount of chloride ion, chloride can locally concentrate on the surface of the tube due to the repetition of the operation and standstill period of the heat

exchanger [9-13]. This may lead to chloride-induced pitting corrosion and cracking.

Fig. 5 (a) Corrosion products formed on the cracks and (b) EDS spectra of the corrosion product.

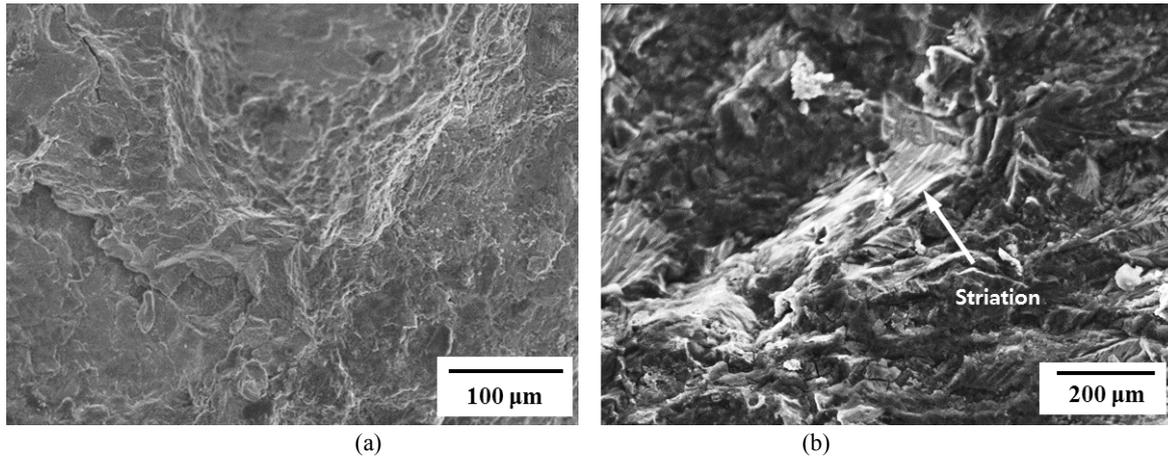
Fig. 6 shows SEM fractographs of the failed tube. The interior of the crack was divided into two areas with and without corrosion products (Figs. 6a and 6b), and the fracture mode possesses both cleavage and quasi-cleavage appearance. Striations are observed on the fracture surface with corrosion products, which is an evidence of corrosion fatigue cracking (CFC) [7,14]. The fracture was caused by corrosion cracking accelerated by fatigue of the tube. Generally, the boundary between SCC and CFC phenomenon is not clear, but CFC often regarded as a subset of SCC in the same environment [15,16], so they can occur at the same time. When SCC and CFC occur together, SCC propagation rate is faster than that of CFC and thereby SCC has the most significant influence on the life time

Fig. 6 SEM fractographs of the fracture surface; (a) a region without corrosion products, and (b) a region with corrosion products.

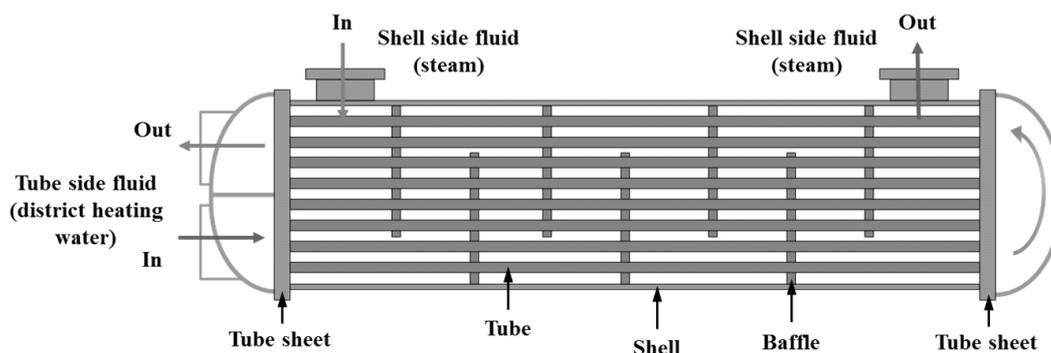
Fig. 7 shows the shell-tube heat exchanger. The tube and shell are welded to the tube sheet and the designed tube and shell length is 4,500 mm (at 25 °C). As shown in Table 1, the tube and shell are made of SS304 and A516 gr 60 materials. Since the tube and shell having different materials are fixed to the tube sheet, thermal stress is generated in the tube and shell according to the temperature change. In accordance with the onset of deformation, the stress applied to the tube is calculated by the following equations, and the information related to thermal stress calculation is listed in Table 3.

L_0 is the length of the shell or the tube at a given temperature, σ is the thermal stress and E is the Young's modulus. If the length of the shell is longer than the tube, tensile stress is generated to the tube. As a result, a tensile stress of 46.9 MPa and a compression stress of 127.9 MPa are generated in the tube during the operation period and the standstill period of the heat exchanger, respectively. Although the stress generated in the tube is a small value to be failed, but it is sufficient to induce SCC. SCC can occur with relatively low stress (~98 MPa) for the SS304 [17].
