Investigation into the Corrosion Mechanism of High-Voltage Cables in Eco-Friendly Vehicles

Keywords: Corrosion, Eco-Friendly vehicle, High-Voltage cable, Corrosion mechanism, Surface characterization

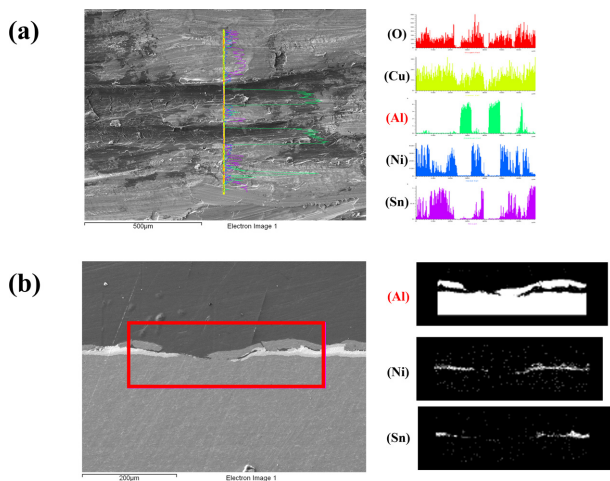
Fig. 3. Wear test results: (a) surface, (b) cross-section

shows SEM and EDS analyses of the worn surface, and Fig. 3b shows the corresponding cross-sectional SEM and EDS results. The surface EDS analysis as shown in Fig. 3a reveals a clear exposure of Al in the fretted region, indicating that the Sn plating layer has been worn off due to repeated mechanical contact. Similarly, as shown in Fig. 3b, cross-sectional EDS mapping within the red-line highlighted area also confirms localized exposure of the Al base material, verifying that the wear penetrated beyond the protective Sn coating. From three repeated test cycles, the average wear depth of the aluminum substrate was measured to be approximately 11.8 μm, indicating significant mechanical degradation of the connector material under vibration loading. These findings strongly suggest that vehicle-induced vibration during operation can lead to mechanical failure of the Sn coating, resulting in direct contact between the Al connector and Cu ground terminal. Such a dissimilar

metal interface creates an ideal condition for galvanic corrosion, particularly in moist or conductive environments. As a result, progressive aluminum erosion and pitting corrosion may occur over time.

Given these material limitations, structural reinforcement of the connector is proposed as a more practical and scalable solution. Specifically, mechanical designs that employ bolted or clamped retention can minimize micro-gaps at the contact interface and suppress relative movement that leads to fretting [21]. Increasing the contact normal force through latch redesign or spring preload can further enhance mechanical stability. In addition, sealing strategies such as precision-fitting connector tubes, dual O-ring configurations, and over-molded grommets can be employed to prevent moisture or electrolyte ingress [22]. For example, both main power and ground connection interfaces shall incorporate O-ring seals made of fluorocarbon material, compressed to 20–25% of their cross-sectional diameter within precision-machined grooves. By eliminating environmental triggers and maintaining mechanical tightness, the risks of galvanic and stray current corrosion can be greatly reduced. Additional measures, such as composite or duplex coatings (e.g., Sn–Ag, Sn–Bi), nanocrystalline Sn layers with enhanced wear resistance, and integrated leakage current sensing (e.g., Hall sensors), may further improve durability and enable early detection of insulation degradation.

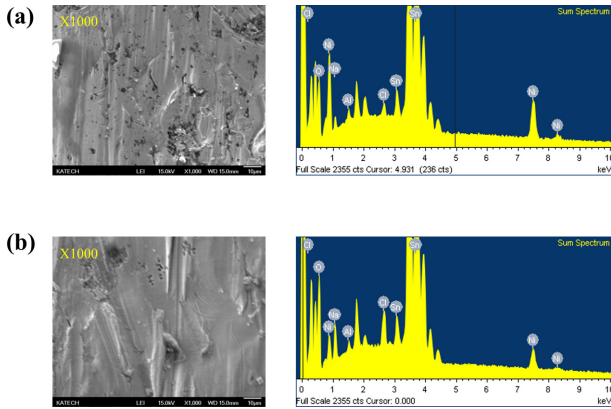
Fig. 4 through Fig. 7 present SEM and accompanying EDS results obtained from the connector surface after combined corrosion test conditions from 1 to 4 as listed in Table 1. For each specimen, three random sites were examined on both the left- and right-hand sides of the connector, such as Fig. 4a and Fig. 4b respectively, and the averaged elemental compositions (wt%) are summarized in Table 5. Under condition 1 as shown in Fig. 4, the connector surfaces showed no evidence of fretting or corrosion without electrical current and vibration operation. The major detected element was Sn, accounting for more than 75 wt%, with minor traces of Ni, likely from the under-plating layer beneath the Sn coating. It was indicated that the Sn layer remained fully intact and corrosion did not initiate under these inert conditions since Al and O were not detected on the surface. Similarly, where a 10 mA DC current was applied without vibration as shown in Fig. 5, the EDS results were similar to the result of condition 1. The absence of Al and O signals, along with the preservation of a high Sn content, indicated that electrical bias alone did not compromise the integrity of the protective coating or induce any measurable corrosion activity.

Fig. 4. Combined corrosion test – condition 1: (a) left side, (b) right side

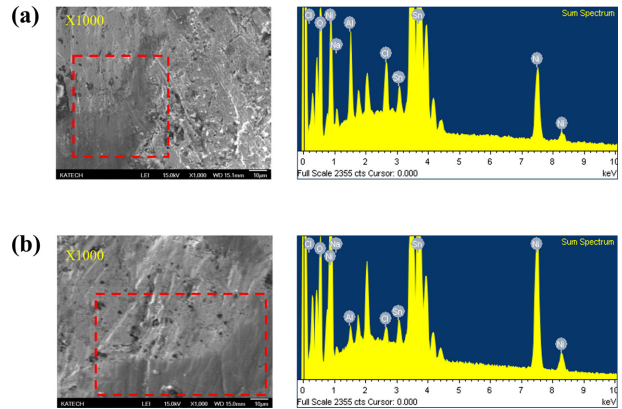
In contrast, Fig. 6 resulted in significant surface changes when vibration was operated to the HV cable. SEM images revealed localized wear regions with fretting damage, particularly in the red dashed zones as shown in

both Fig. 6a and Fig. 6b. EDS spectra from these regions revealed the emergence of more than about 3 wt% of Al and increased O content, indicating that the Sn layer had been mechanically disrupted, ultimately exposing the underlying Al substrate. The presence of oxygen is attributed to the formation of Al_2O_3 , a typical by-product

Fig. 6. Combined corrosion test – condition 3: (a) left side, (b) right side

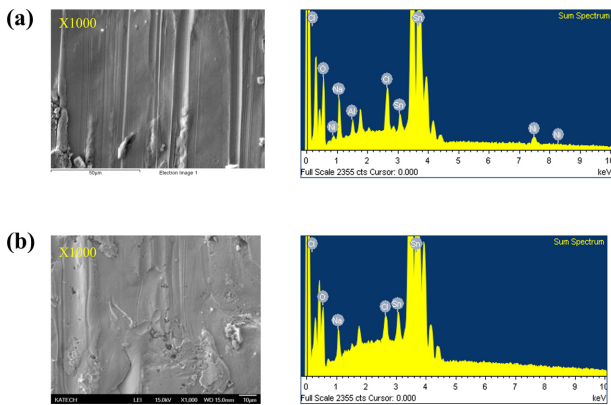
Fig. 5. Combined corrosion test – condition 2: (a) left side, (b) right side

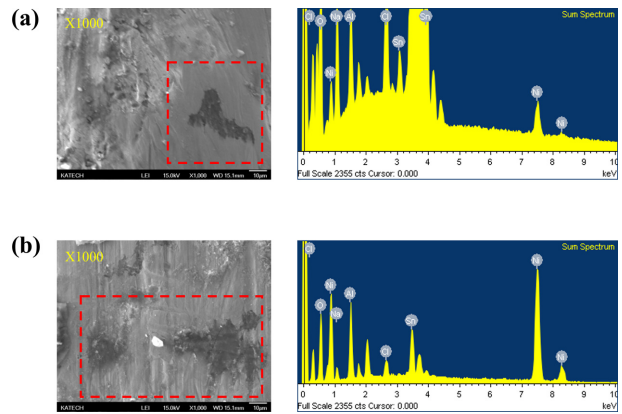
of galvanic corrosion when Al is exposed to a conductive environment. Further degradation was observed under condition 4 as shown in Fig. 7, which combined mechanical vibration with DC electrical bias. In this case, the Al content increased by approximately 2 wt% relative to condition 3, while O content exhibited an increment

Fig. 7. Combined corrosion test – condition 4: (a) left side, (b) right side

exceeding about 10 wt%, suggesting that the presence of current accelerated oxide formation and substrate degradation. These findings point to a synergistic effect between mechanical abrasion and electrochemical activation, promoting both galvanic and stray current corrosion mechanisms.

These findings demonstrate that mechanical fretting is the primary initiator of coating failure, while concurrent DC bias amplifies corrosion kinetics once the Al-Cu dissimilar interface is exposed. Consequently, both galvanic and stray-current mechanisms act synergistically under realistic vehicle braking scenarios. Once exposed, the presence of electrical bias significantly amplifies corrosion kinetics, accelerating the deterioration process. These results emphasize the critical role of maintaining coating integrity and mitigating vibrational stress to prevent premature failure of HV connectors under realistic operating conditions.

These findings highlight the necessity of mitigating vibration-induced mechanical wear and controlling stray current pathways. Structural improvements such as vibration-resistant fastening, equivalent sealing of both power and ground connections, and prevention of electrolyte ingress are essential to enhance the long-term reliability and operational safety of HV cable systems in electric mobility applications.
