Effect of Precipitate on the Electrochemical Potentiokinetic Reactivation Behaviors of Stainless Steels and Nickel Base Alloys

Tsung-Feng Wu, Tzu-Sheng Chen, and Wen-Ta Tsai

*Department of Materials Science and Engineering
National Cheng Kung University*

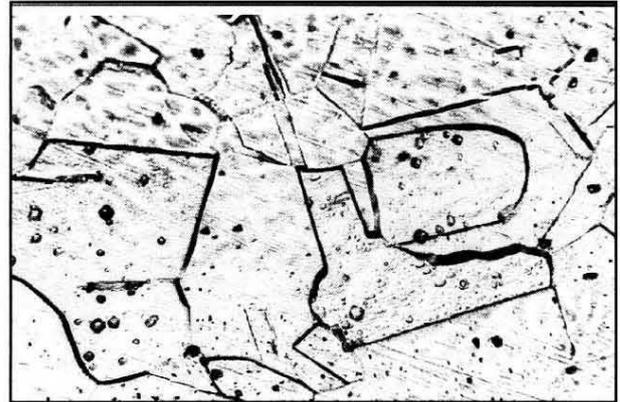
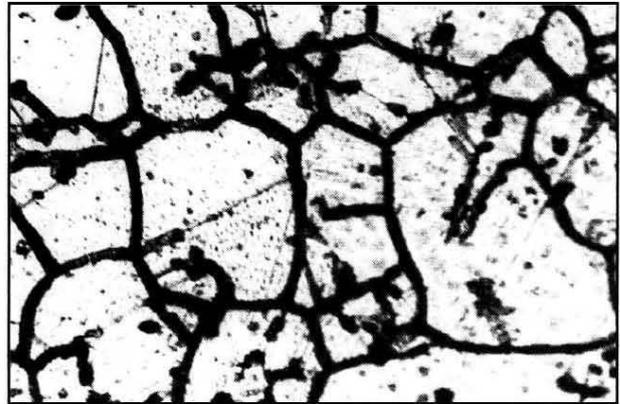
Fig. 1. Micrographs of 304 SS with different thermal treatments after oxalic acid etch test, (a) 304-SA (1100°C/0.5h) (b)304-15 (SA+650°C/15h)

The optical micrographs for the solution annealed (SA, 1100°C/0.5h) and thermal treated (SA + 650°C/15h) 304 SS and 347 SS, after oxalic acid etch test, are shown in Figs. 1 and 2, respectively. For 304 SS, as expected and

demonstrated in Fig. 1, the step structure was revealed in solution annealed 304 SS while ditch structure in 304 SS with 650°C/15h thermal treatment. In fact, thermal treatment at 650°C for 15h resulted in a sensitized microstructure in 304 SS. However, only step structure was observed in both 347 SS specimens, either solution annealed or thermal treated at 650°C/15h (Fig. 2). Clearly, the alloying of Nb sufficiently prevented sensitization of austenitic stainless steel.

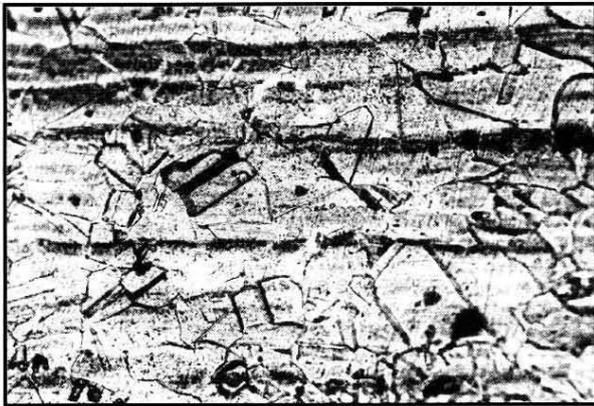
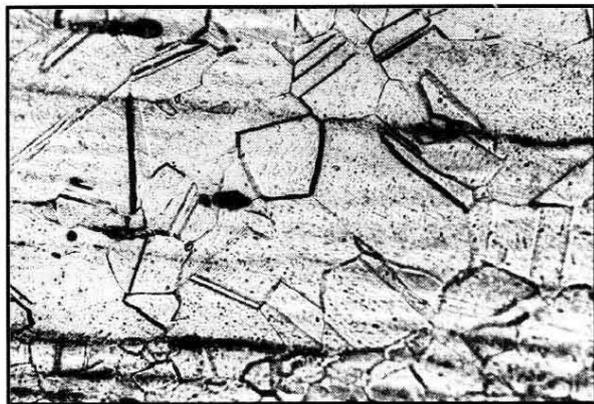
Fig. 2. Micrographs of 347 SS with different thermal treatments after oxalic acid etch test, (a) 347-SA (1100°C/0.5h) (b)347-15 (SA+650°C/15h)

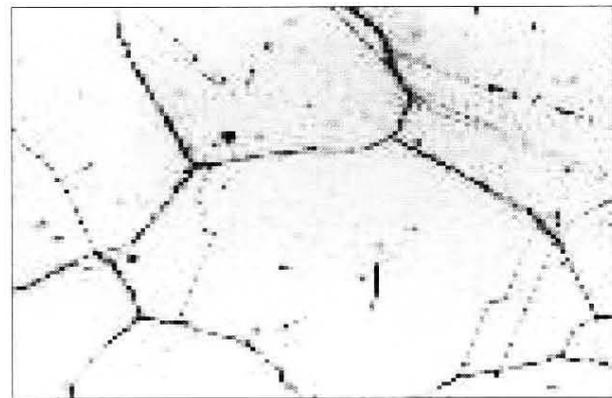
Fig. 3. Metallogrphs showing carbide precipi- tation of Alloy 600 with different thermal treatments, electrolytically etched in $\text{H}_3\text{PO}_4 : \text{H}_2\text{O} = 8 : 1$ electrolyte, (a) 600-SA (1150°C/1h) (b)600-15 (SA+704°C/15h)

The precipitation of carbide and its distribution in Alloy 600 were examined by electrolytical etched etching in $\text{H}_3\text{PO}_4 : \text{H}_2\text{O} = 8 : 1$ electrolyte. Fig. 3 shows that carbide precipitation was negligible for Alloy 600 with solution annealing treatment. Extensive grain boundary carbide precipitation, however, was observed for the specimen heat treated at 704°C/15h. Regardless of the heat treatment, fine, rectangular precipitates were observed in both specimens. These precipitates were identified as TiC from energy dispersive soectrosopy as well as from their shape and tincture of orange color.

704°C for 15h after solution annealing, however, grain dropping out of the surface resulting from grain boundary corrosion was seen. By comparing with those in Fig. 3, the result indicated that intergranular corrosion was related to grain boundary carbide precipitation. Apparently, Alloy 600 subjected to 704°C/15h thermal treatment was sensitized.

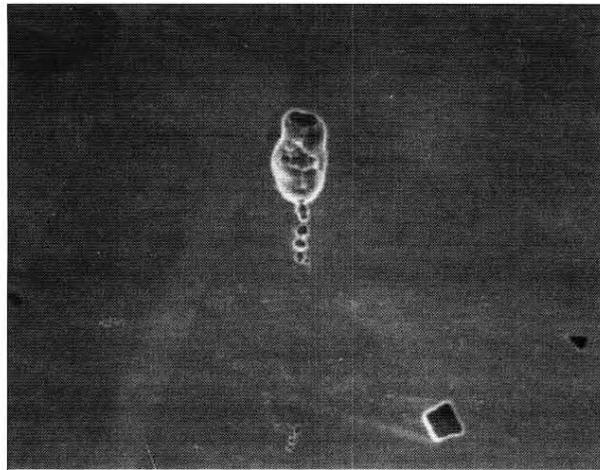
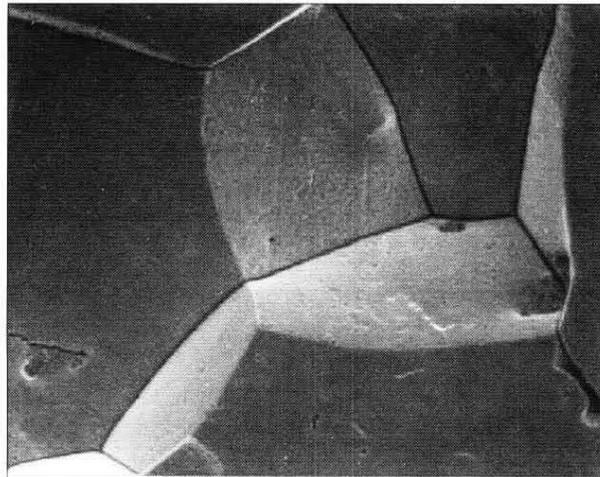
Fig. 4. SEM micrographs showing the surface appearances of Alloy 600 with different thermal treatments after modified Huey test, (a) 600-SA (1150°C/1h) (b)600-15 (SA+704°C/15h)

The degree of sensitization of Alloy 600 was examined by chemical test. The morphologies of Alloy 600 with different thermal treatment after modified Huey's test were shown in Fig. 4. Intergranular corrosion was not found in the solution annealed (1100°C/1h) Alloy 600, indicating not being sensitized. For the specimen aged at

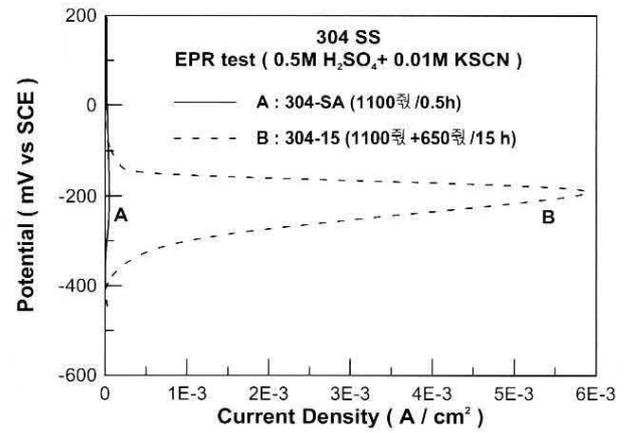
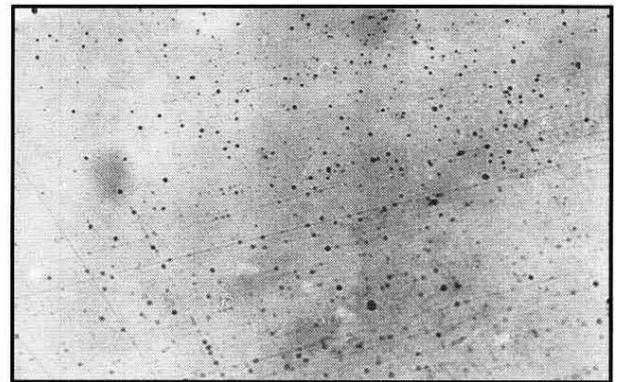
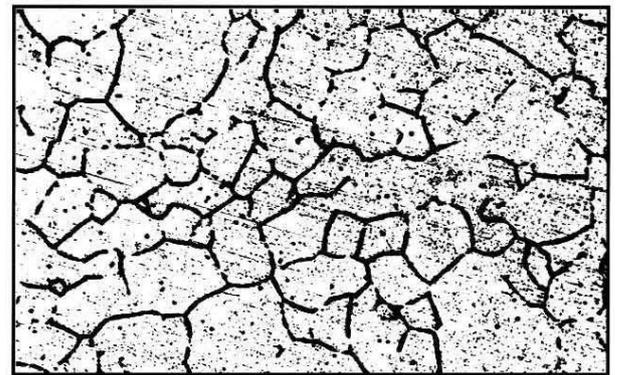
Fig. 5. Morphologies and polarization curves of 304 SS with different thermal treatment after SL-EPR test in 0.5M H₂SO₄ + 0.01M KSCN solution, (a) polarization curves, morphologies of (b)304-SA and (c) 304-15.

Fig. 5(a) shows the SL-EPR polarization curves of 304 SS with different heat treatments, which were conducted in 0.5M $\text{H}_2\text{SO}_4 + 0.01\text{M}$ KSCN solution. It was obvious that a humped reactivation curve appeared in the sensitized 304SS while not in solution annealed 304 SS. The surface appearances of these two specimens after SL-EPR test were depicted in Figs. 5(b) and (c). Almost no corrosion,

except some pits, was seen on the solution annealed 304 SS after EPR test. However, apparent grain boundary corrosion was found on the sensitized 304 SS. The results were no different from those reported in the literature.^(6),20)

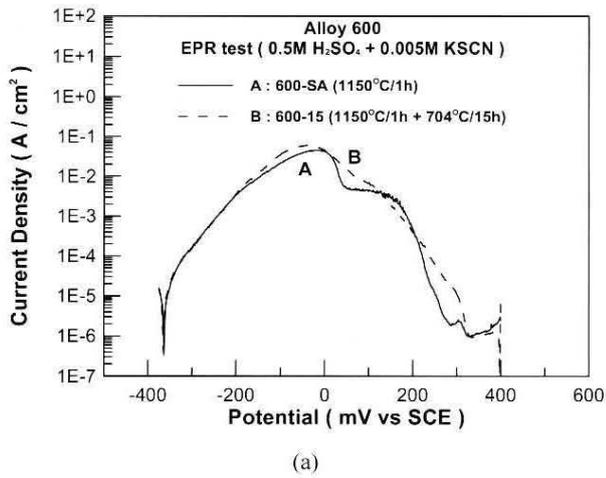
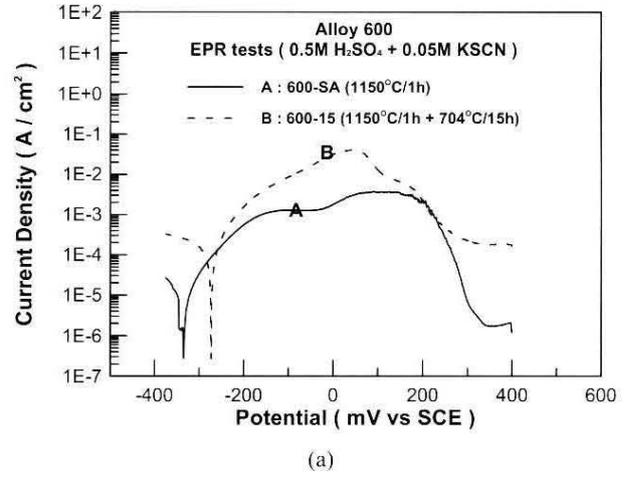
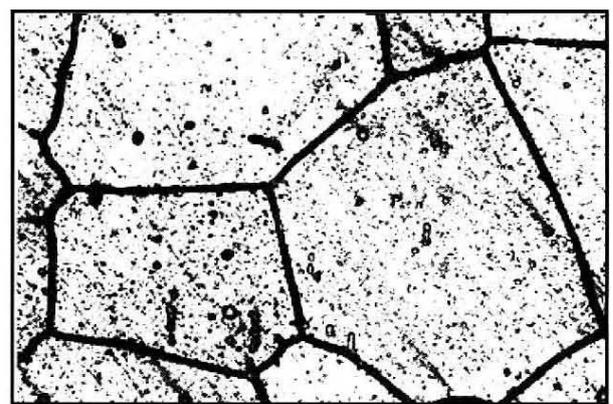
Fig. 6. Morphologies and polarization curves of Alloy 600 with different thermal treatment after SL-EPR test in 0.5M H₂SO₄ + 0.005M KSCN solution, (a) polarization curves, morphologies of (b)600-SA and (c) 600-15.

Fig. 7. Morphologies and polarization curves of Alloy 600 with different thermal treatment after SL-EPR test in 0.5M H₂SO₄ + 0.05M KSCN solution, (a) polarization curves, morphologies of (b)600-SA and (c) 600-15.

Fig. 6(a) illustrates the SL-EPR polarization curves of Alloy 600 with different heat treatments, which were conducted in 0.5M H₂O₄ + 0.005M KSCN solution. Notably, regardless of the heat treatment, a hump with two peaks appeared in each reactivation polarization curve. This differs significantly from that occurred in the “clean” 304 SS where no reactivation hump was discovered

for the non-sensitized alloy (Fig 5(a)). Despite the similarity in the reactivation curves for both specimens, the

morphologies were not exactly the same. As can be seen as in Fig. 6(b) severe matrix corrosion was observed in the non-sensitized Alloy 600. For sensitized Alloy 600, intergranular corrosion, which still could be distinguished from matrix corrosion, was depicted in Fig. 6(c).

The effect of KSCN concentration on the reactivation behaviors was explored. The SL-EPR polarization curves and morphologies after tests in 0.5M H₂SO₄ + 0.05M KSCN solution were demonstrated in Fig. 7. The reactivation polarization curves could be distinguished between sensitized and non-sensitized specimens which were different with those in Fig. 6(a) (in 0.5M H₂SO₄ + 0.005M KSCN). Two apparent reactivation peaks (about +150 and -150 mV/SCE, respectively) were seen in such electrolyte for non-sensitized Alloy 600, while three peaks for sensitized Alloy 600. It seemed to imply that there might be two separated reactions in reactivation process for non-sensitized Alloy 600, while three for sensitized specimen. The additional peak for sensitized Alloy 600, revealed in at +30 mV/SCE, was considered being contributed by intergranular corrosion. The morphologies depicted in Figs. 7(b) and (c), after SL-EPR tests in 0.5M H₂SO₄ + 0.05M KSCN solution, showed less degree of matrix corrosion compared with those conducted in 0.5M H₂SO₄ + 0.005M KSCN solution, as can be seen in Figs. 6(b) and (c).

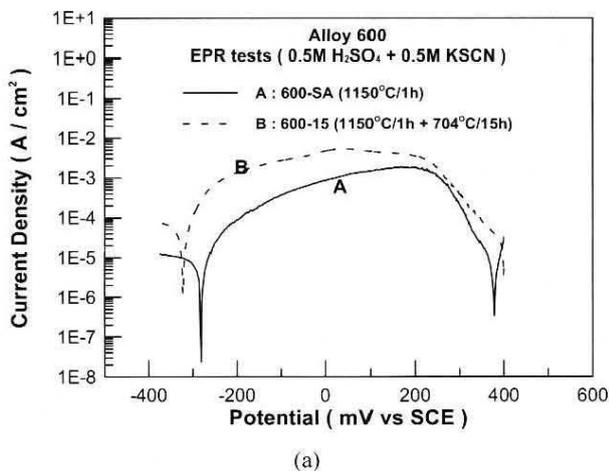
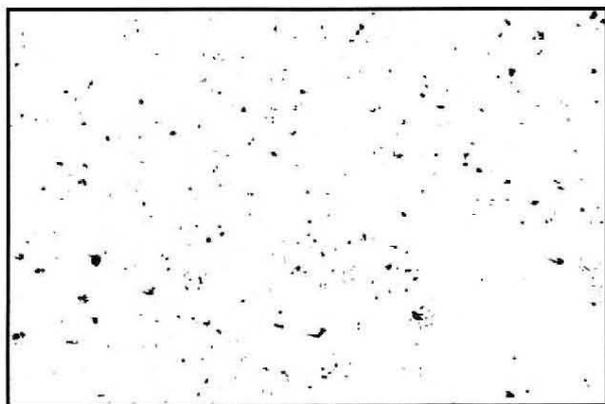
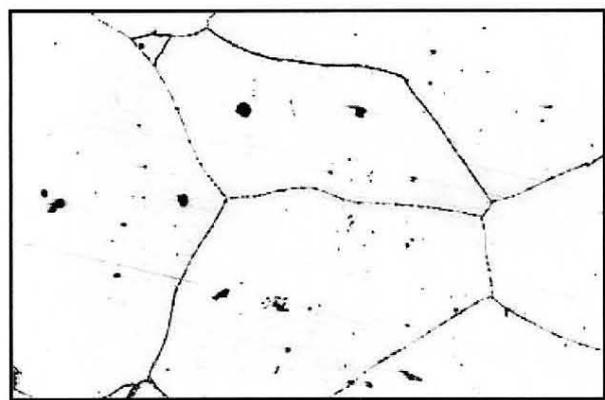
Fig. 8. Morphologies and polarization curves of Alloy 600 with different thermal treatment after SL-EPR test in 0.5M H₂SO₄ + 0.5M KSCN solution, (a) polarization curves, morphologies of (b)600-SA and (c) 600-15.

Fig. 8(a) shows the SL-EPR polarization curves in 0.5M H₂SO₄ + 0.5M KSCN solution. At such a high concentration of KSCN, though there still exhibited wide anodic humps for both heat treated Alloy 600, the respective peaks as revealed in Figs. 6(a) and 7 (a) became less distinguishable. Nevertheless, the sensitized Alloy 600 had a higher anodic current density, compared with the solution annealed specimen, and the maximum appeared around +30 mV. The associated micrographs after EPR tests are shown in Figs. 8(b) and (c) for the non-sensitized and the sensitized Alloy 600, respectively. Grain boundary corrosion was seen for the sensitized alloy. As can be seen as in Figs. 8(b) and (c), matrix corrosion was reduced as the concentration of KSCN was increased to 0.5 M.

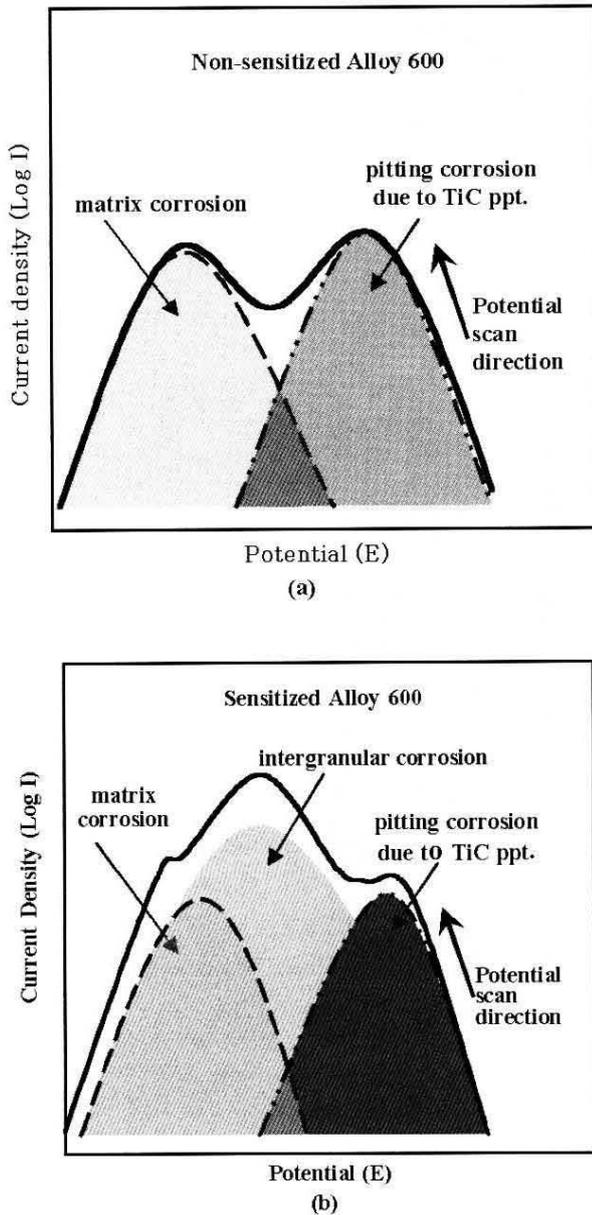
Fig. 9. Schematic deconvolution diagram of the reactivation polarization curves of Alloy 600 with different thermal treatment in $H_2SO_4 + KSCN$ solutions, (a) non-sensitized Alloy 600 (b) sensitized Alloy 600.

Coupled with reactivation termination test,¹⁵⁾ the reactivation polarization curves were dissociated into two or three partial reactions depending on whether Alloy 600 was sensitized or not. Fig. 9(a) illustrates a schematic diagram, which indicates that the reactivation polarization curve consisted of pitting corrosion at relative higher anodic potential and matrix corrosion at lower anodic potential within the solution annealed or non-sensitized Alloy 600. The occurrence of pitting corrosion was generally associated with the precipitates such as TiC, etc., present in the matrix. For sensitized Alloy 600, an inter-

mediate peak associated with intergranular corrosion and having the highest anodic current density existed in the deconvolution diagram (Fig. 9(b)). With proper adjustment of electrolyte composition, the contribution to the total reactivation current density from intergranular corrosion, as a result of chromium carbide precipitation along the grain boundaries, can be distinguished from the matrix and localized corrosion for the sensitized Alloy 600.

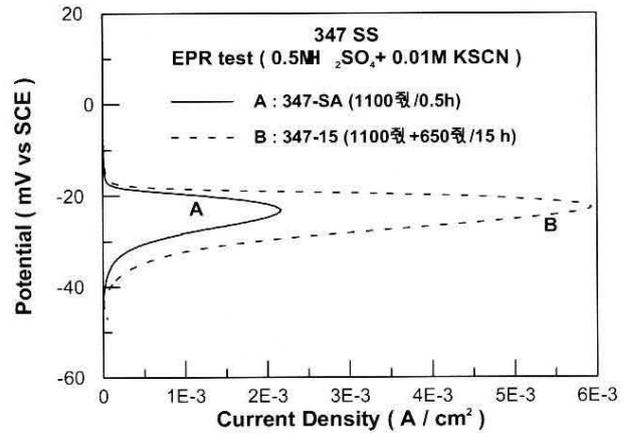
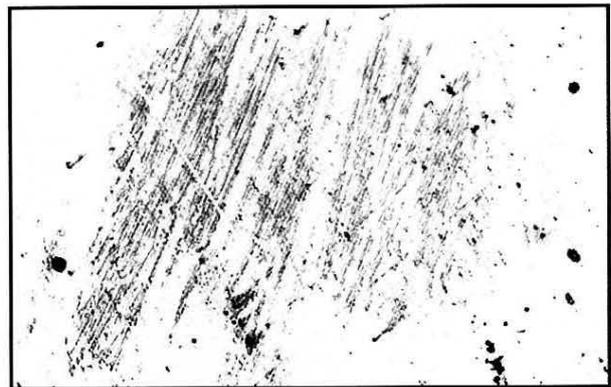
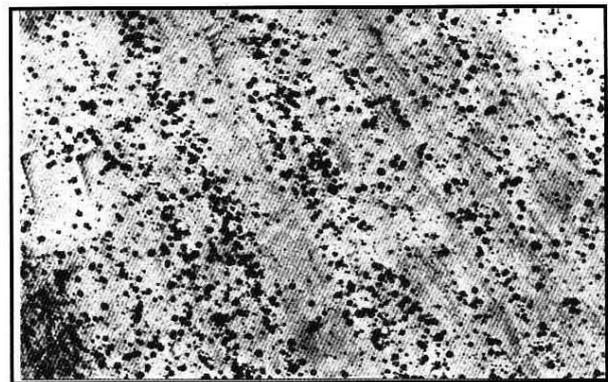
Fig. 10. Morphologies and polarization curves of 347 SS with different thermal treatment after SL-EPR test in $0.5M H_2SO_4 + 0.01M KSCN$ solution, (a) polarization curves, morphologies of (b)347-SA and (c) 347-15.

0.01M KSCN solution, are shown in Fig. 10(a). An apparent reactivation hump appeared in each SL-EPR curves. It was interesting to note that an anodic peak with significant magnitude was observed for the solution annealed 347 SS, which was quite unusual as compared with that of the solution annealed 304 SS (Fig. 5(a)). Furthermore, as mentioned early, thermal treatment at 650°C for 15h did not cause a sensitized microstructure for the Nb-stabilized 347 SS. However, a peak still existed in the reactivation curve. The reactivation peaks appeared in Fig. 10(a) should not be attributed to grain boundary corrosion. The micrographs showing the surface morphologies, after SL-EPR tests, of 347 SS subjected to solution annealing and 650°C/15h heat treatment, respectively, did not reveal any evidence of grain boundary corrosion. Only pits were seen on the specimen surfaces, as revealed in Figs. 10(b) and (c). The reactivation peaks, appeared in Fig. 10(a), were thus believed to associate with pitting corrosion. Similar observation on the contribution of pitting corrosion to the SL-EPR curve had been reported by Majidi and Streicher.²⁰⁾ Detail microscopic examination further indicated that pitting corrosion occurred around NbC precipitates. The results indicated that SL-EPR might not be adequate to detect the degree of sensitization of 347 SS.

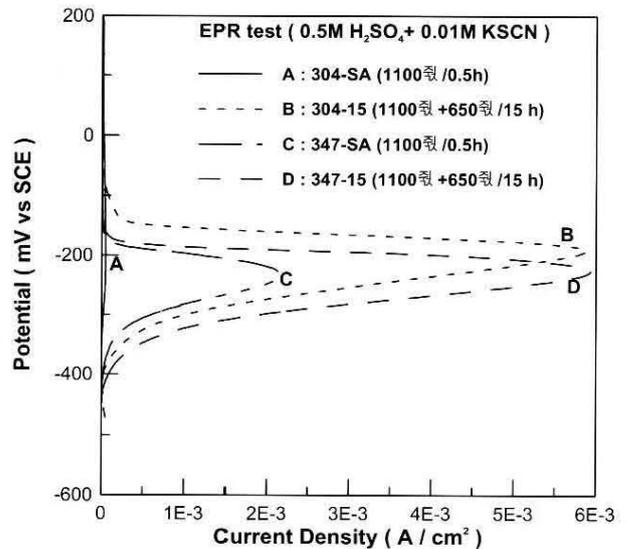
Fig. 11. SL-EPR polarization curves of 304 SS and 347 SS with different thermal treatments in 0.5M H₂SO₄ + 0.01M KSCN solution.

By superimposing Figs. 5(a) and 10(a), it was found that the reactivation peak for grain boundary corrosion was different from that of pitting corrosion, (see Fig. 11). The potential associated with pitting corrosion was higher than that of grain boundary corrosion. The potential sequence with respect to the occurrence of pitting corrosion and grain boundary corrosion was similar to that found in Alloy 600 in SL-EPR test. The contribution to the anodic reactivation current density from grain boundary corrosion or pitting corrosion as a function of potential is demonstrated in the schematic diagram in Fig. 12. Unlike that of Alloy 600, the contribution from matrix corrosion for austenitic stainless steel was insignificant. No peaks associated with matrix corrosion were observed in the SL-EPR curves of the austenitic stainless steels determined in this investigation.

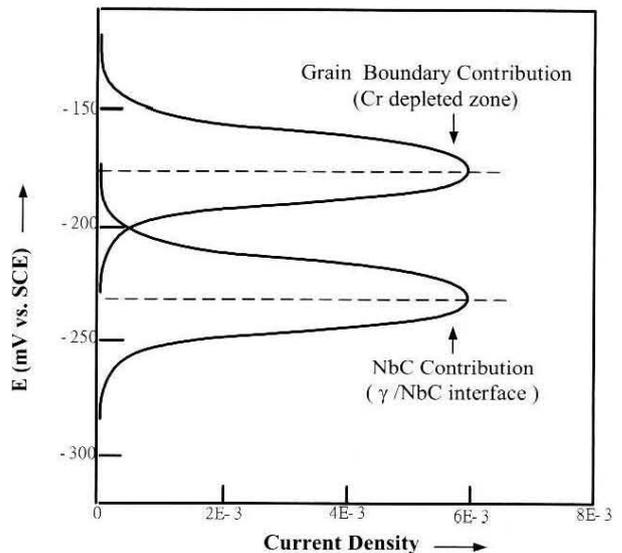
Fig. 12. Schematic diagram showing the shift of the reactivation peak potential for sensitized 304 SS and 347 SS in H₂SO₄ + KSCN solutions.
