# Study on Atmospheric Corrosion for Two Different Marine Environments in India

Jayanta Kumar Saha

*Institute for Steel Development & Growth  
Ispat Niketan, 52/1 A Bally Gunge Circular Road, Kolkata-700 019, India*

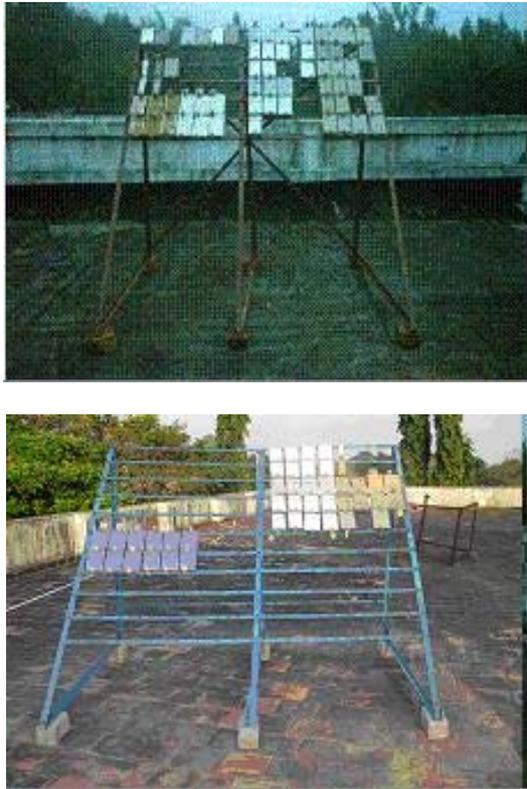
Fig. 1. View of Field Stations Digha (Left) & Chennai (Right)

The test coupons were exposed at an <45° facing south

and were fixed to the rack with the help of porcelain and brass nuts & bolts. Painted test coupons deployed in two conditions scribed and unscribed along with bare coupons. The typical field stations are shown in Fig. 1.

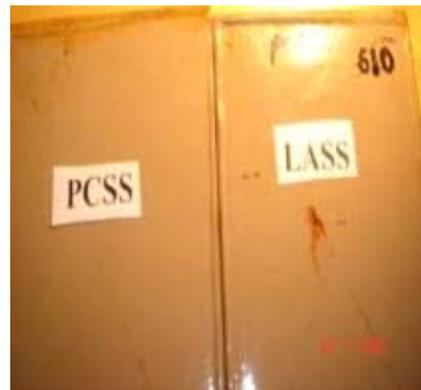
**Fig. 2. Salt Spray Exposure (5000 hrs)**

No change was noted during the first 1400 hrs of exposure on both the panels and after that spreading of rust was more for LAS. The spread of rust on PCS & LAS after 5000 hours of salt spray exposures is shown in Fig. 2 and it is evident that the spreading of rust is more severe on LAS than on PCS.

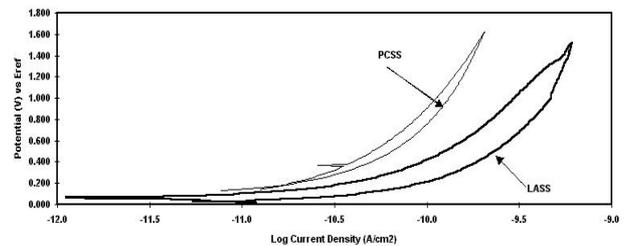
**Fig. 3. Cyclic Polarisation of Coated Steel After Salt Spray**

After salt spray exposure of 5000 hrs the samples were taken up for cyclic polarisation at scan rate of 0.5 mv/sec. The same samples the plot of LAS is observed to be in higher current density region than the plot of PCS. This indicates faster attack at the surface of LAS than PCS. This result corroborates the visual observations where surface of LAS was observed to deteriorate faster than the PCS as shown in Fig. 3.

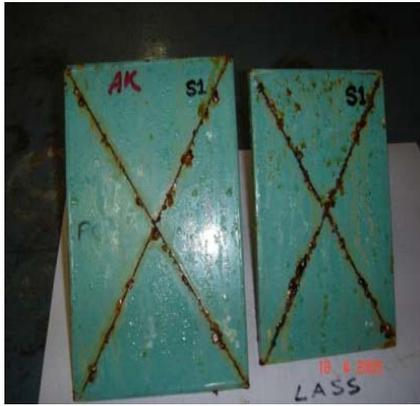
Fig. 4. Rust on PCS & LAS in SO<sub>2</sub>

This was carried out as per G87-84 to understand the phenomenon of deterioration and kinetic of corrosion of underneath surface. The moist SO<sub>2</sub> test generates high humidity and acid at the test panels and this condition is normally encountered in humid and industrial polluted environments. The photograph has shown in Fig. 4 the spread of rust across the scribe lines on PCS & LAS after 6400 hrs of exposure. The exposure of coated steels in humid SO<sub>2</sub> atmosphere also confirms the findings of salt spray tests. The appearance of rust on the surface of LAS was found within 700 hrs and same was 1500 hrs for PCS and also the spreading of rust was faster on LAS than on PCS.

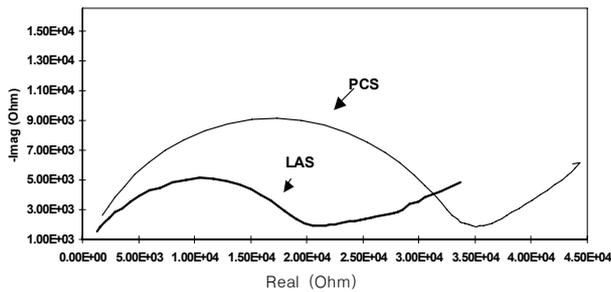
Fig. 5. Nyquist Plots of coated PCS & LAS after SO<sub>2</sub>

The SO<sub>2</sub> exposed samples were subjected to EIS and cyclic polarisation studies. Fig. 5 shows the EIS real vs imaginary impedance plots for both steels exhibit one incomplete semicircle at higher frequencies followed by a complete semicircle at intermediate and a diffusion tail at lower frequencies. The diameter of the intermediate fre-

quency semicircle corresponds to charge transfer reaction at the metal/rust/electrolyte interface. This is observed lower for LAS in comparison to PCS, indicating more deterioration of LAS than PCS.

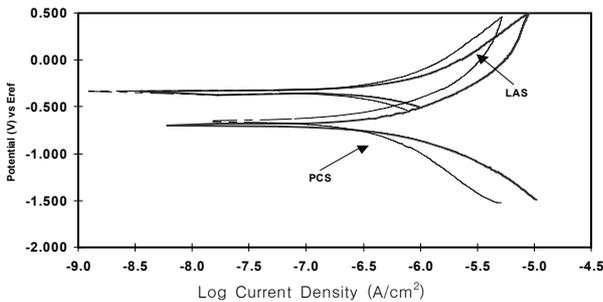
Fig. 6. Cyclic Polarisation coated LAS & PCS after SO<sub>2</sub> exposure

Fig. 6 shows cyclic polarisation where the curve of PCS falls in lower current density zone than for LAS. All these tests indicate that in accelerated tests LAS coated specimens deteriorate faster than PCS.

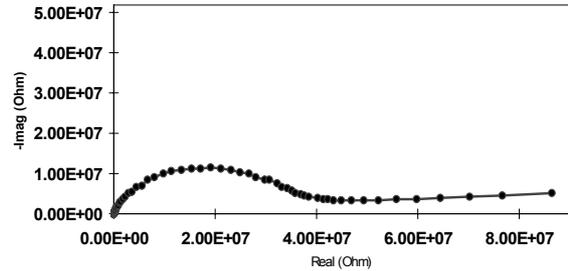
Fig. 7. Nyquist plot of coated PCS in Industrial Town

ronment both samples were exposed at industrial town Jamshedpur, India. Coupons were taken to EIS and polarization studies after 18 months of exposure. The EIS plots for the two-coated steels are shown in Figs. 7 and 8. For both the steels the plots exhibit semicircle of smaller diameter in high frequency range, which are attributed to the coating's properties. In intermediate ranges of frequency, the semicircles of diameter having considerable variations are observed for the two steels. The diameter on real impedance axis for LAS is appreciably bigger than of PCS. These observations suggest that LAS in normal industrial environment was performing far superior than PCS.

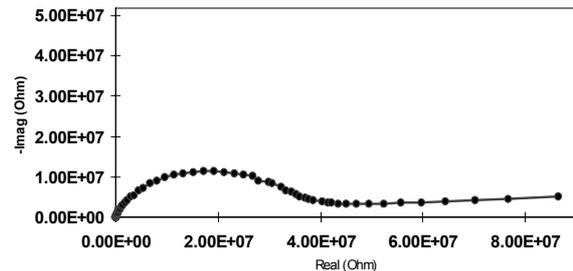
Fig. 8. Nyquist plot of Coated LAS in Industrial Town

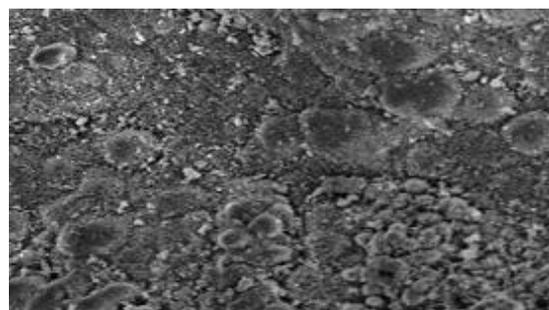
Fig. 10. Rust Morphology on PCS (Scale 20 μm)

It is also observed that steel surfaces were having pitting attack and its severity varied with the climatic conditions & steel chemistry. The LAS exhibits lesser pitting on its surface than PCS. These rusts were subjected to energy dispersive X-ray analysis (EDXA) to find the presence of elements and no traces of the presence of Cl, Cu or Cr, was noted in the rust. EDXA of these rusts showed in Figs. 9 & 10 the presence of Al, Mn, Si, and S. The absence of alloying elements of steels (Cu, Cr) and Chlorine in the rust is probably due to the limitations in detecting ability of the instrument. As the exposure of steels in the environments was only for a shorter duration (2 years), the micro alloyed elements (Cu & Cr) in rust should be present in ppm level. The instruments based

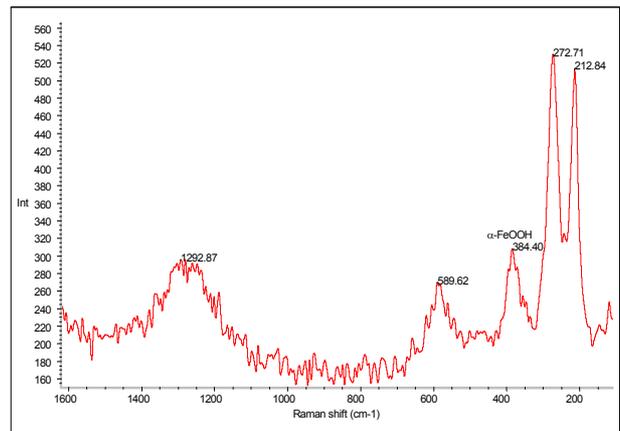
**Fig. 11. (a) Rust of LAS Collected from Chennai**

The rusts formed during the salt spray exposure of LAS and PCS were subjected to Raman Spectroscopy and the results are shown in Figs. 11 (a), (b) & Figs. 12 (a), (b) respectively.

In both the cases, peaks of  $\beta$ -FeOOH are recorded. This is in agreement with the results of earlier researchers who reported the formation of this type of rust in saline environments.

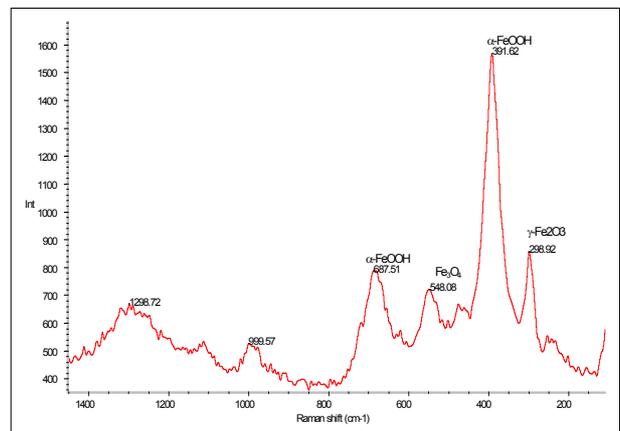
**Fig. 11. (b) Rust of PCS Collected from Chennai**

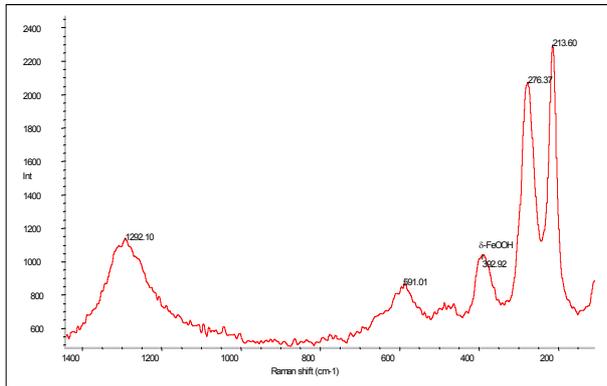
Fig. 12. (a) Rust of LASS Collected from Digha

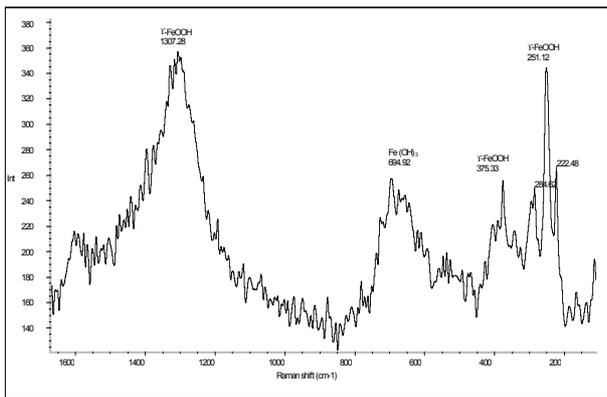
Fig. 12. (b) Rust of PCSS Collected from Digha
