Study on New Candidate Coating Materials to Challenge Rudder Cavitation Damage

H. I. Lee, M. S. Han, K. K. Baek[†], C. H. Lee, C. S. Shin, and M. K. Chung

*Hyundai Industrial Research Institute
Hyundai Heavy Industries Co. Ltd., 1 Jheonha-Dong, Ulsan, KOREA 682-792*

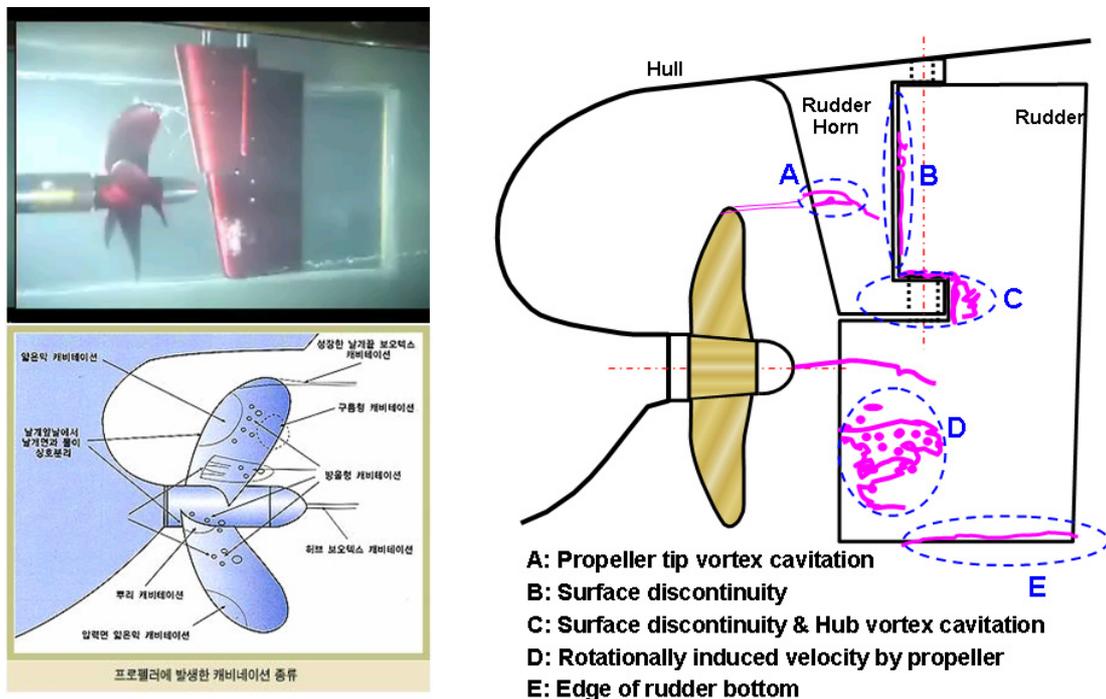
Fig. 1. Schematic diagram of the cavitation erosion part for semi-spade rudder²⁾

of fluid dynamics, cavitation at the rudder surface can be generated either by the local, negative loading or by the vortex at the rudder shoe, as schematically shown in Fig. 1.²⁾ The cavitation generated at the rudder surface will cause vibration and subsequent fatigue fracture of the rudder. As a countermeasure for these phenomena, several attempts have been made to optimize the fluid dynamic shape of the rudder, such as changing propeller design with minimized flow disturbance, elimination of surface discontinuity.

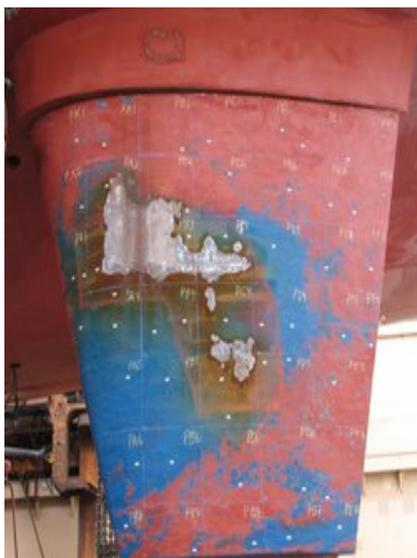
Fig. 2. Typical cavitation induced corrosion damage of ship's rudder¹⁾

Despite continuous efforts to reduce premature rudder damage for last decades, however, protective organic coating systems currently applied on the fast-going ships such as container carriers or naval vessel's rudders, propeller shaft struts, and other high-stress underwater hull areas often failed within a few months of their installation. Premature corrosion due to failure of these protective coatings in underwater hull areas has been one of several corrosion issues related to high speed marine vessels. Numerous on-site survey of the ships at the dry-dock revealed that the total affected area was typically up to ~40% of the total coated areas, and in most cases the most severe coating loss occurred in a localized area of the out-board sides of both rudders, as shown in Fig. 2.¹⁾

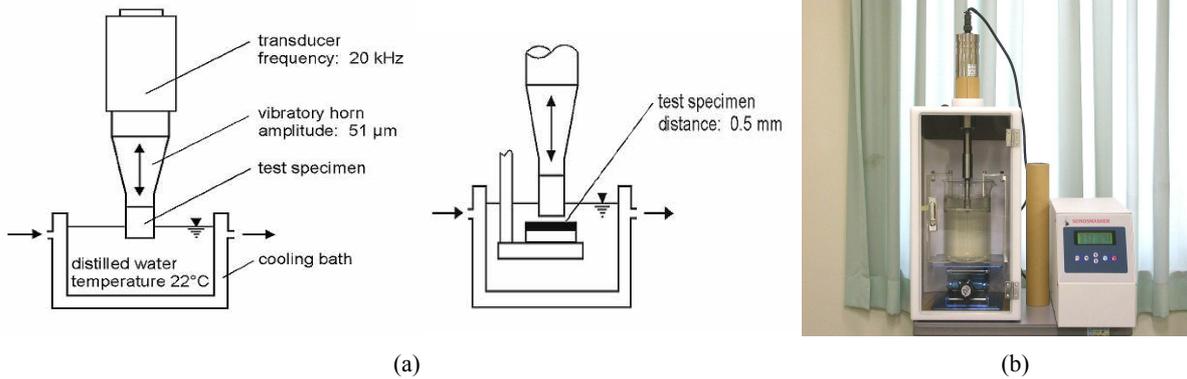
Fig. 3. (a) Schematic diagram, (b) photograph of vibratory cavitation erosion tester

Cavitation resistance of each coating sample was evaluated by using both an ultrasonic tester (modified ASTM G-32 method) and in-house built water jet tester. In case of the ultrasonic tester, as shown in Fig. 3(a), samples were placed 0.5 mm below the sonic generator, i.e., vibratory horn, to eliminate vibration induced damage to the coating layer. This arrangement has been known to provide more increased vibration amplitude to the surface to be tested. The actual tester, employed in this test, is shown

in Fig. 3(b).

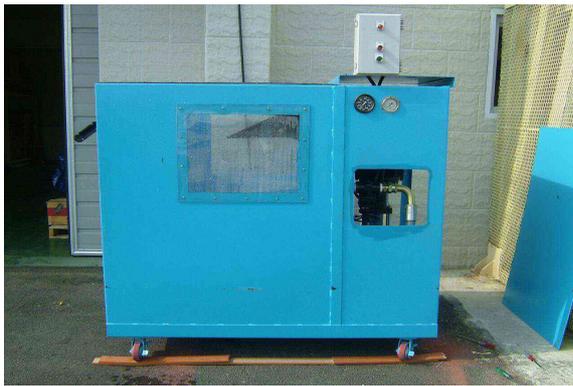
Fig. 4. Water-jet cavitation erosion tester

In order to simulate high impact cavitation expected from larger propellers, which were employed in actual ship operation, an in-house built water jet tester was also employed. The tester, as shown in Fig. 4, utilized a high pressure pump to generate high speed water jet impact in a vertical direction to the coating surface. In order to facilitate the erosion observation during the tests, monitoring window was installed directly on the water jet/coating surface contact area.

from 22 kg/cm^2 capacity high pressure pump operated by a 5.5 kW/7.5 HP motor. The water jet, formed in the water reservoir maintained at the temperature range of $25\pm 3^\circ\text{C}$, would vertically impact on the coating surface at the speed of ~ 60 knots through 6 mm diameter nozzle, in which the samples were located 150 mm apart from the nozzle's end.

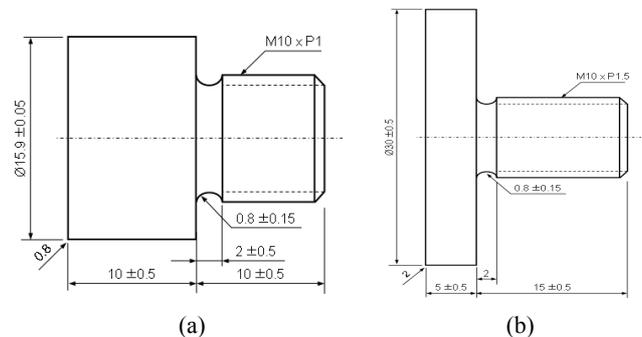
Fig. 5. Dimension of mounting set for cavitation erosion test; (a) ultra sonar, (b) water-jet

Testing samples were applied or sprayed on butt end of 316L stainless steel mounting sets, as shown in Fig. 5, following ASTM G 32-02 standard, of which diameter was 15.9 ± 0.05 mm, 10 ± 0.5 mm, for ultra sonic testing and water jet testing, respectively. Before application of each coating, the surface of each mounting set was grit blasted to ISO Sa 2.5 grade and degreased with acetone, then the coatings were sprayed following recommended dry film thickness. In Table 2, the mechanical properties of the selected coatings were summarized.

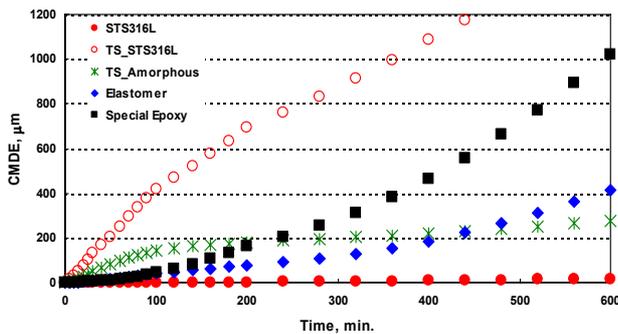
Fig. 6. Cumulative Mean Depth of coatings: ultra sonar test

Fig. 6 and Fig. 7 shows the ultra sonic test results for each coating after 10 hours of exposure in terms of MDE and erosion rate, respectively. As expected, the conventional organic coating suffered heavy erosion during the initial one hour duration, revealing its poor resistance of the coating layer. Other coatings also showed gradual progress of the erosion during the 10 hour test.

The expectant useful life of each coating against erosion, as calculated by measuring the time required for the CMDE value to reach 100 µm and 200 µm, revealed the similar result in terms of each coating's erosion resistance characteristics. The soft, conventional coatings (EH3250™ + AF795H™) reached to 100 µm CMDE value only in 4 minutes, and other coatings took longer time to reach that depth in the following order; 316L stainless steel by HVOF metal spray (24 min.) < Amorphous alloy coating by HVOF metal spray (63 min.) < Epoxy adhesive (155 min.) < Elasto-ceramic polymer (264 min.) < 316 stainless

To reach 200 μm of the CMDE value, it took a little longer for each coating, but the trend was only slightly different; Conventional coatings (6 min.) < 316L stainless steel by HVOF metal spray (307 min.) < Epoxy adhesive (236 min.) < Amorphous alloy coating by HVOF metal spray (155 min.) < Elasto-ceramic polymer (415 min.) < 316 stainless steel plate (7,906 min.).

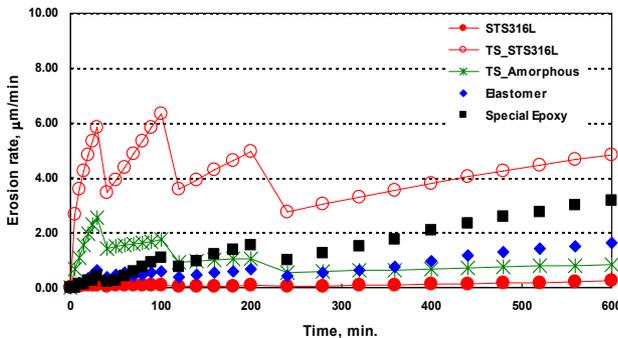
Fig. 7. Erosion rate of coatings: ultra sonar test

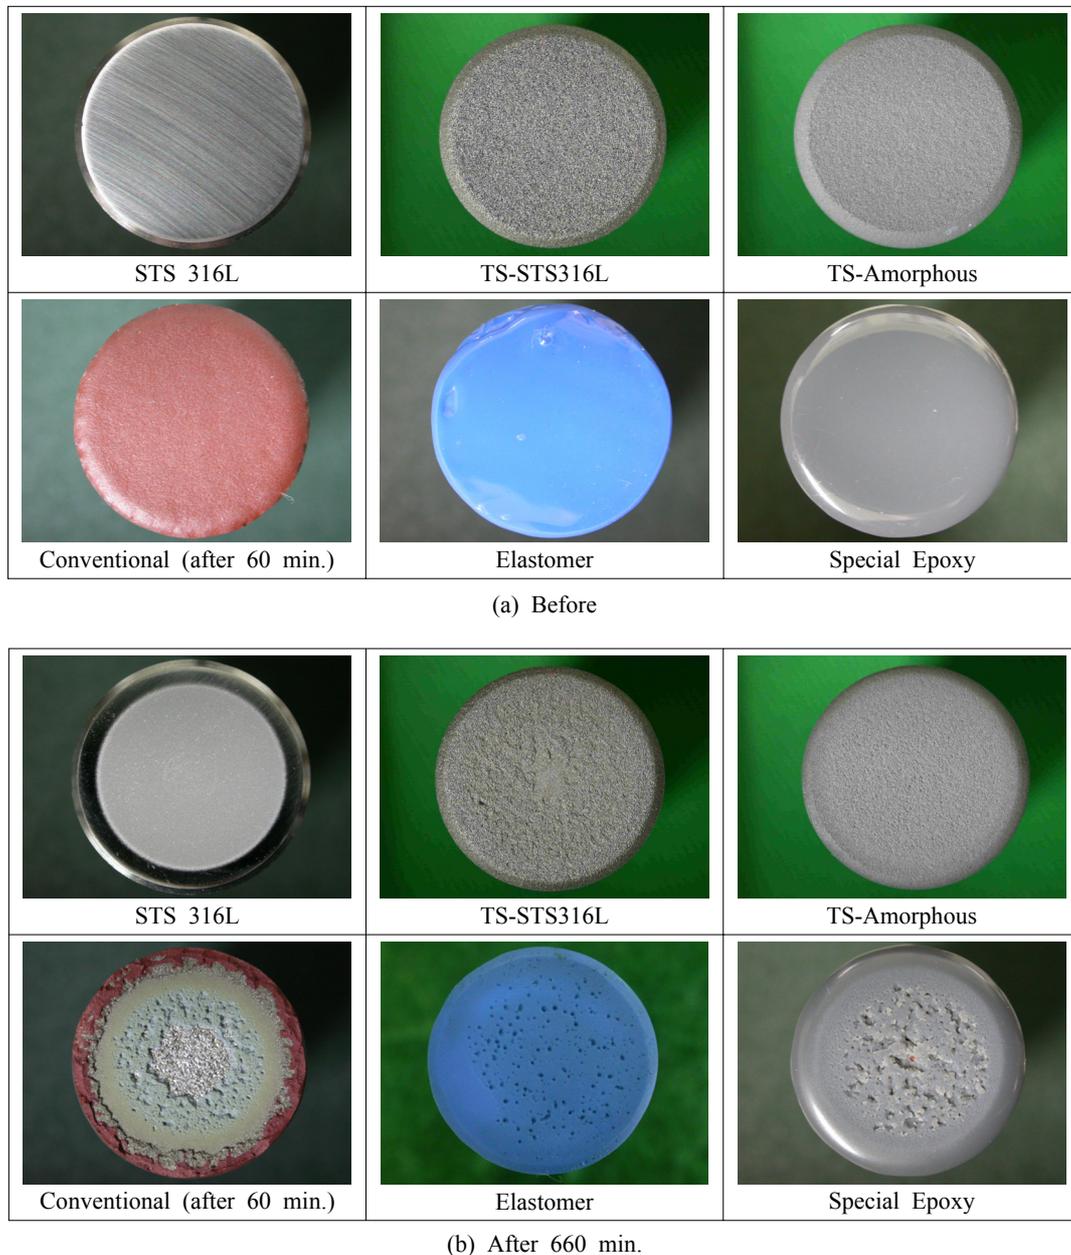
Fig. 8. Appearance of coatings before and after vibratory erosion test

Fig. 8 shows the surface of each coating in the as-sprayed condition and after 10 hour ultra sonar tests. All coating samples showed a sign of erosion damage around their center, and the degree of erosion was different with each coating. As expected, among all coatings, the soft, conventional coatings (EH3250™ + AF795H™) suffered the most severe erosion, exposing more than 20% of bare metal substrate after the test. This partially confirmed that the erosion condition of the current acceleration test is quite intensive in comparison with actual ship's service condition. The 316L stainless steel coating applied by HVOF metal spray (Diamalloy 1104) also experienced a partial loss of coated layer, partially exposing bare metal substrate after the erosion test. On the other hand, only slight erosion was observed for both 316 stainless steel plate and amorphous alloy coating applied by HVOF metal spray (Amacor-M), whereas more intensive erosion on the coating layer were observed for coatings made of an elasto-ceramic polymer (DuraTough™ DL) and an epoxy adhesive (ScotchWeld™ 2216). Partial delamination of coating was also observed for the epoxy adhesive coating.

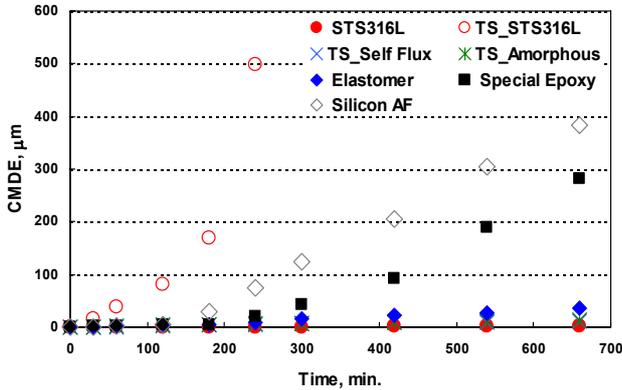
Fig. 9. Cumulative mean depth of coatings: water-jet test

Fig. 9 and Fig. 10 shows cumulative Mean Depth of Erosion (MDE) and erosion rate of each coated sample measured from weight loss ΔW , after 11 hours of water jet test. The basic trend was quite similar to that already

The expectant useful life of each coating against erosion, as calculated by measuring the time required for the CMDE value to reach 100 µm and 200 µm, confirmed the similar result in terms of each coating erosion resistant characteristics. The soft, conventional coatings (EH3250TM + AF795HTM) reached to 100 µm CMDE value in 4 minutes, and other coatings took longer time to reach that depth in the following order; 316L stainless steel by HVOF metal spray (166 min.) < Si-AF coating (271 min.) < Epoxy adhesive (430 min.) < Elasto-ceramic polymer (1,814 min.) < Amorphous alloy coating by HVOF metal spray (4,920 min.) < TS self flux alloy coating by HVOF metal spray (5,782 min.) < 316 stainless steel plate (29,438 min.).

To reach 200 µm of the CMDE value, it took a little longer for each coating, but the trend was only slightly different; Conventional coatings (7 min.) < 316L stainless steel by HVOF metal spray (186 min.) < Si-AF coating (413 min.) < Epoxy adhesive (552 min.) < Elasto-ceramic polymer (3,587 min.) < Amorphous alloy coating by HVOF metal spray (9,895 min.) < TS self flux alloy coating by HVOF metal spray (11,596 min.) < 316 stainless steel plate (58,850 min.).

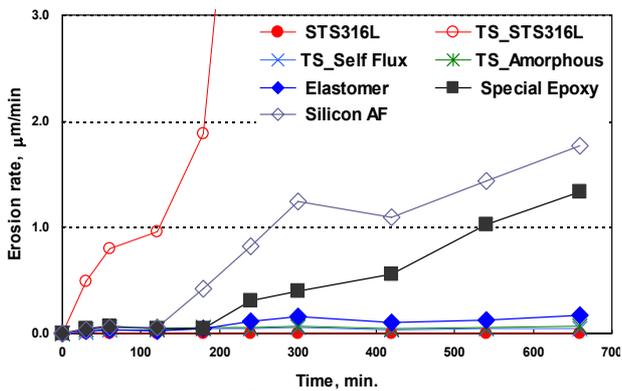
Fig. 10. Erosion rate of coatings: water-jet test
