# Use of Hydrazine for Pitting Corrosion Inhibition of Copper Sprinkler Tubes: Reaction of Hydrazine with Corrosion By-Products

The feasibility of using hydrazine for inhibiting pitting corrosion in copper sprinkler tubes was investigated by examining microscopical and structural evolution of corrosion by-products with SEM, EDS, and XRD. Hydrazine removed dissolved oxygen and reduced CuO and Cu<sub>2</sub>O as well. The stable phase was changed from CuO to Cu<sub>2</sub>O or Cu depending on hydrazine concentration. Hydrazine concentration of 500 ppm could convert all CuO corrosion by-products to Cu<sub>2</sub>O. In a tightly sealed acrylic tube filled with aqueous solution of 500 ppm hydrazine, octahedral Cu<sub>2</sub>O particles were formed while plate-like structures with high concentration of Cu, O, N and C were formed near a corrosion pit. The inside structure of a corrosion pit was not altered by hydrazine aqueous solution. Uniform corrosion of copper was almost completely stopped in aqueous solution of 500 ppm hydrazine. Corrosion potential of a copper plate was linearly dependent on *log* (hydrazine concentration). The concept of stopping pitting corrosion reaction by supp

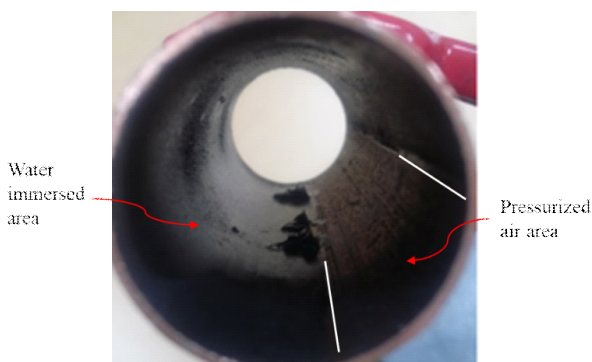
**Fig. 1** Inner surface of a failed copper sprinkler tube with mounds of corrosion by-products formed near the water-air line.

Fig. 1 shows the inner surface of a copper sprinkler tube which suffered from water leakage due to pitting corrosion. There are three big mounds of corrosion by-products observed just below a white line which looks like a boundary between the water immersed area and the pressurized air area, suggesting that the waterline corrosion should be blamed for pitting corrosion failure of this sprinkler tube. The water immersed area has a black color, indicative of formation of a  $CuO/CuO_2$  layer.

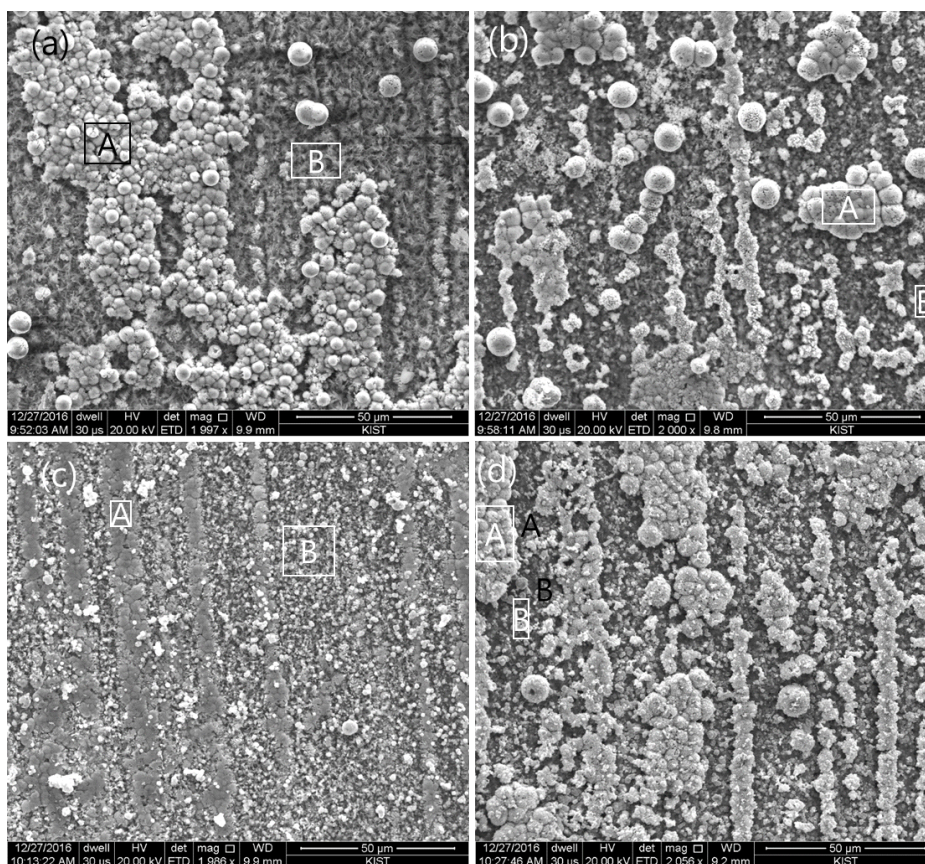
Fig. 2 SEM images of (a) the as-cut specimen of a failed copper sprinkler tube, and the specimens immersed for 6 days in aqueous solutions of hydrazine monohydrate concentrations of (b) 50 ppm, (c) 500 ppm, and (d) 5000 ppm.

Fig. 2a-d show the SEM images of the as-cut specimen of a failed copper sprinkler tube and the specimens (size:

8 mm x 8 mm) which were cut from the same tube and immersed for 6 days in aqueous solutions of increasing hydrazine monohydrate (called here as hydrazine for simplification) concentrations of 50, 500, and 5000 ppm, respectively. Table 1 shows the EDS analysis results of the as-cut specimen and the specimens immersed in aqueous solutions of different hydrazine concentrations.

Fig. 3a-d show the XRD spectra of these specimens. There are two kinds of materials observed in the as-cut specimen: spherical particles gathered together forming bands (the area A) and the black base layer (the area B) with a feather-like structure. The spherical particles seem to be formed in the later stage of service of the sprinkler system and attached on the black base layer which were

formed in the early stage of service. The area A's composition is in the middle of CuO and Cu<sub>2</sub>O. The base layer B's composition corresponds to Cu<sub>2</sub>O with a high Si composition from 3 to 7 at%. Sand particles (SiO<sub>2</sub>) might have entered the copper tubing with water during installation, causing pitting corrosion. The XRD spectrum of this specimen (Fig. 3a) also shows that the surface consists of CuO and Cu<sub>2</sub>O.

The EDS analysis result of the specimen immersed in the 50 ppm hydrazine aqueous solution shows that the compositions of the base layer (the area B) and the spherical particles (the area A) have not changed much. The XRD spectrum of this specimen (Fig. 3b) also is not very much different from that of the as-cut specimen. When

the hydrazine composition was increased to 500 ppm, the area A which used to consist of spherical particles in the as-cut specimen became flattened, forming bands of Cu<sub>2</sub>O composition. It seems that when CuO was reduced to Cu<sub>2</sub>O by hydrazine, oxygen atoms were expelled from the structure, forming bands of Cu<sub>2</sub>O. On the other hand, the base layer is maintaining the Cu<sub>2</sub>O composition. The XRD spectrum of this specimen (Fig. 3c) consists of only Cu and Cu<sub>2</sub>O peaks, indicative of complete reduction of CuO to Cu<sub>2</sub>O.

When the hydrazine composition was increased to 5000 ppm, the morphology becomes very similar to what was obtained with the 50 ppm hydrazine concentration. There are bands of congregating spherical particles still remaining. However, the spherical particles have the completely different composition of almost Cu. Most of the base layer was also changed to Cu. The XRD spectrum of this specimen (Fig. 3d) shows only peaks of Cu, confirming almost complete reduction of CuO and Cu<sub>2</sub>O to Cu.

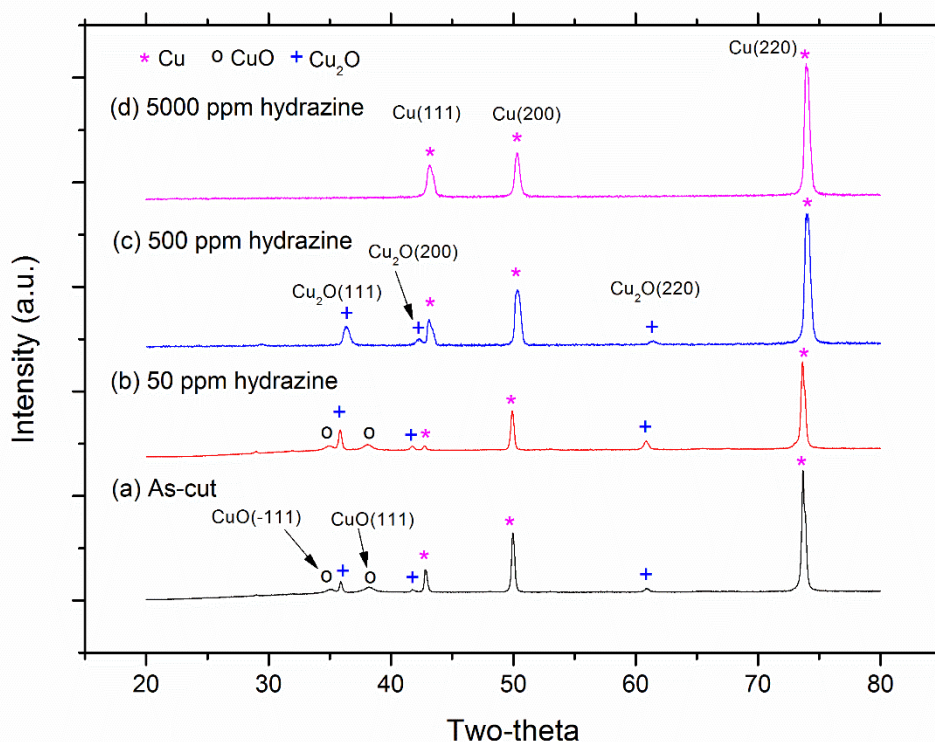
Fig. 3 XRD spectra of (a) the as-cut specimen of a failed copper sprinkler tube, and the specimens immersed for 6 days in aqueous solutions of hydrazine monohydrate concentrations of (b) 50 ppm, (c) 500 ppm, and (d) 5000 ppm.

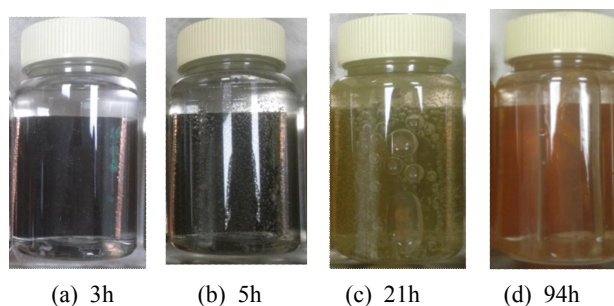
Fig. 4 Visual demonstration of nitrogen gas generation from a failed copper sprinkler specimen immersed in an aqueous solution of 500 ppm hydrazine in a 100 ml plastic bottle: (a) 3 hours, (b) 5 hours, (c) 21 hours, and (d) 94 hours after start of the experiment.

A significant amount of nitrogen gas is generated when hydrazine reacts with CuO and Cu<sub>2</sub>O according to equations (2), (3), and (4). Fig. 4 demonstrates visually gen-

eration of nitrogen gas from a failed copper sprinkler specimen immersed in an aqueous solution of 500 ppm hydrazine in a 100 ml plastic bottle. The side of the bottle was left on the table so that water might leak through the cap when the pressure builds up inside the bottle. This is a kind of semi-open system because the cap cannot completely inhibit water leakage caused by the pressure build-up. The reaction started immediately and lasted for more than 7 days. The volume of nitrogen gas generated depends on the inner surface area of the specimen and

CuO thickness. For this experimental condition, the final volume of nitrogen gas was approximately 5% of the bottle. It should be also noticed that the black color of the inner surface of the specimen was changed to the brown color due to transformation of CuO to Cu<sub>2</sub>O. If this reaction continues in a closed system such as the wet sprinkler system, nitrogen gas generated will increase the pressure in the tubing. If the sprinkler water is pressurized for operation before the reaction of hydrazine with the corrosion by-products is completed, the pressure may rise to higher than 2 MPa, which may lead to rupture of copper tubing. Therefore, the pressure build-up in the tubing during the hydrazine reaction should be carefully managed in order to use hydrazine in the sprinkler system.

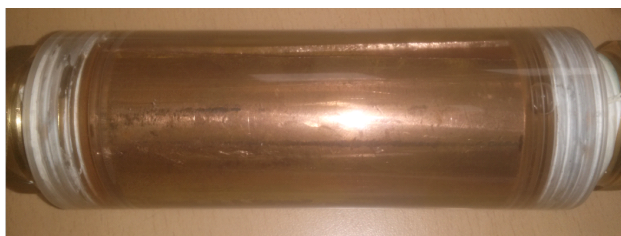
**Fig. 5** A closed model system made of an acryl tube and brass fittings for performing experiment of hydrazine reaction and corrosion inhibition. Notice the brightness of the tube surface and edge even after 10 months of experiment.

In order to study the phenomena occurring in the aqueous solution of hydrazine and on the surface of the copper tubing and see whether corrosion of the copper sprinkler tube can be inhibited by the hydrazine treatment, a model system made of an acryl tube and brass fittings were designed (Fig. 5). After two halves of a failed sprinkler tube specimen were inserted into the acryl tube, hydrazine aqueous solution of 500 ppm was filled into the acryl tube up to the valve inlet and the valve was closed so that no air entered the acryl tube. The pressure inside the acryl tube went up to a highest gauge pressure of 0.4 MPa two days later and then slowly came down to 0.05 MPa after 10 months due to small leakage through the fittings. It should be noticed that the outer surface and the sawing cross section of the copper tube remains bright even after this long time of experiment, indicative of the very low level of dissolved oxygen inside the acryl tube and the effectiveness of hydrazine in inhibiting uniform corrosion.

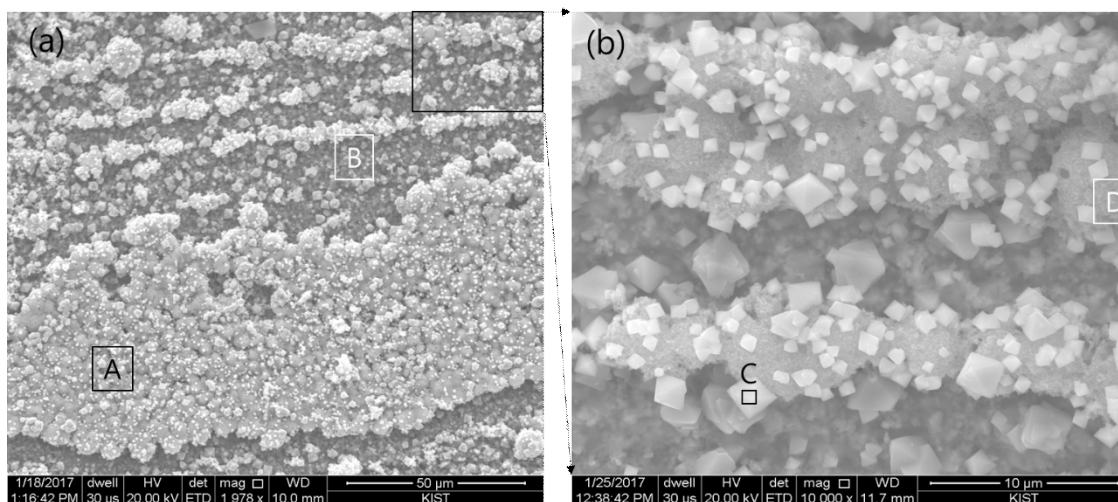
**Fig. 6** (a) SEM image of an area far from a corrosion pit on a copper sprinkler tube immersed for 15 days in an hydrazine aqueous solution in an acryl tube, (b) the enlarged SEM image of the rectangular area of (a).

Another experiment in the acryl tube with the same experimental conditions as the above continued for 15 days and the copper tubing was taken out and examined by SEM and EDS. The dissolved oxygen concentration of the water in the acryl tube was too low to be measured by the DO meter. Fig. 6 and Table 2 are the SEM images and EDS results, respectively, of an area a few centimeters away from a corrosion pit. Both the areas A and B in Fig. 6 have the composition of Cu<sub>2</sub>O. As for the composition, a similar result was obtained in the semi-open system (see Fig. 2c and Table 1). However, the enlarged image

**Table 2 EDS analysis results at the positions indicated in Fig. 6 for a copper sprinkler tube immersed for 15 days in an hydrazine aqueous solution in an acryl tube (at%)**

of this specimen shows a different and interesting morphology consisting of many octahedral particles sitting on a porous band structure. The octahedral particles were identified as  $\text{Cu}_2\text{O}$  crystallites by EDS. The porous band has a composition close to pure copper. It looks like that some of  $\text{CuO}$  materials on the bands were recrystallized as  $\text{Cu}_2\text{O}$  crystallites on top of the bands. It seems that somehow the high nitrogen concentration in the solution helped nucleation of octahedral  $\text{Cu}_2\text{O}$  crystallites

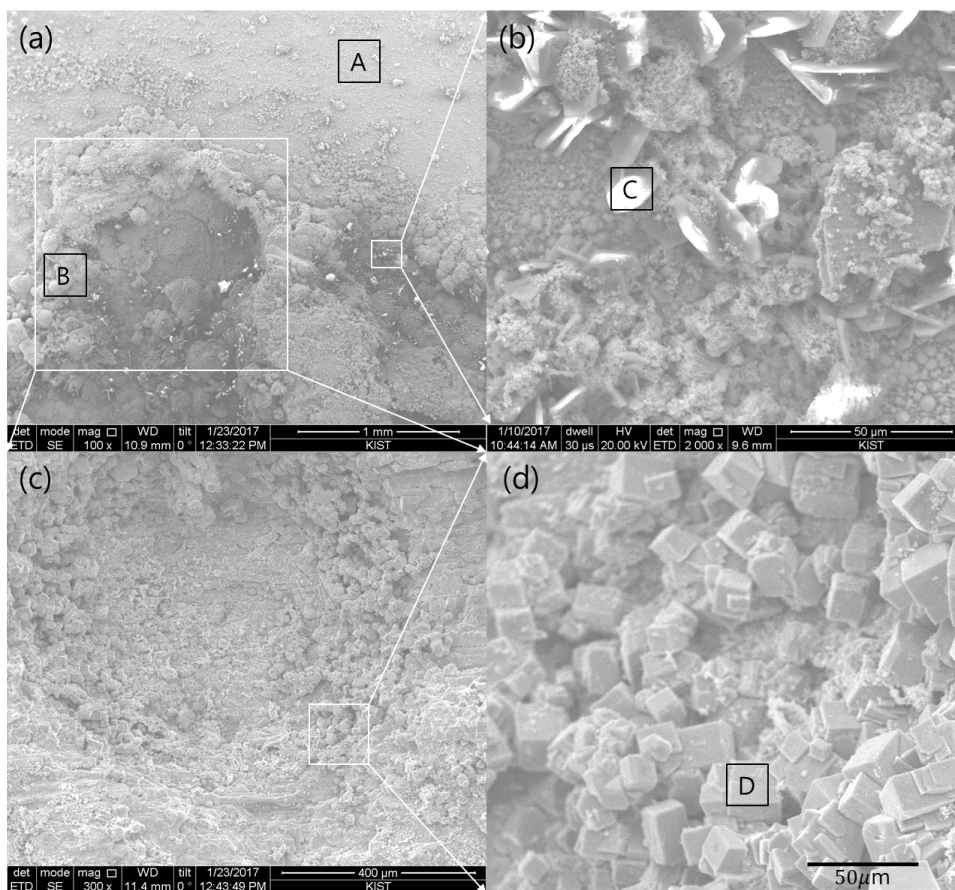
**Fig. 7 (a) low magnification SEM image of a corrosion pit without the cap removed, (b) high magnification SEM image of an area near the corrosion pit showing plate-like structures, (c) SEM image of the corrosion pit with the cap removed, and (d) high magnification SEM image of the square of the image (c). The specimen was immersed in an hydrazine aqueous solution of 500 ppm for 15 days in an acryl tube.**

a pitting corrosion area in the closed system. Fig. 7a shows a low magnification image of a corrosion pit. The flat area A has a  $\text{Cu}_2\text{O}$  composition while the bubble-shaped material B on the corrosion pit has a high concentration of carbon C, indicative of existence of the malachite [ $\text{Cu}_2(\text{OH})_2\text{CO}_3$ ] structure. It should be noticed that there are white plate-like structures around the corrosion pit. Fig. 7b is the high magnification image of one of those areas. Many plate-like structures are scattered in this area. One of those plates (the area C) was analyzed to contain high concentrations of Cu, O, N, and C. It is not clear how this plate-like structure was formed.

The cap of the corrosion pit was removed and the inside structure was examined by SEM and EDS. Fig. 7c and d are the low and high magnification images taken with the cap removed. The inside structure consists of cuboid  $\text{Cu}_2\text{O}$  particles (see Table 3 for the composition of the particle D), as usually observed in the corrosion pit of copper [2]. There is no change of the morphology, and

**Table 3 EDS analysis results of the positions in Fig. 7 (at%)**

all the particles have flat surfaces without any evidence of chemical reaction. This result is expected because  $\text{Cu}_2\text{O}$  is the stable phase in the hydrazine aqueous solution of 500 ppm. It is concluded that the inside structure of the corrosion pit is not altered by hydrazine solution of this concentration even though there is a slight change of the outside structure of the corrosion pit.

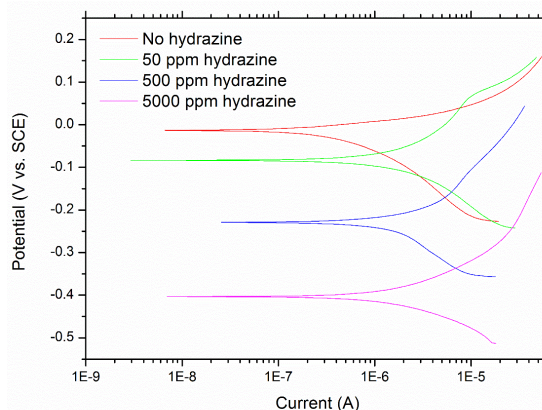
**Fig. 8 Potentiodynamic polarization curves of a copper plate obtained with the aqueous solutions of different hydrazine concentrations of 0, 50, 500, and 5000 ppm.**

As shown in section 3.1, when the hydrazine concentration is increased from 50 ppm to 500 ppm,  $\text{Cu}_2\text{O}$  phase instead of  $\text{CuO}$  phase becomes the stable phase. The stable phase is changed from  $\text{Cu}_2\text{O}$  to  $\text{Cu}$  as the hydrazine concentration is further increased to 5000 ppm. To understand the evolution of the stable phase with increasing hydrazine concentration, potentiodynamic polarization curves of a copper plate (Fig. 8) were obtained one day after aqueous solutions of different hydrazine concentrations were prepared, and the corrosion potential,  $E_{\text{corr}}$  obtained from the potentiodynamic polarization curves was plotted as a function of the hydrazine concentration in Fig. 9.  $E_{\text{corr}}$  decreases with  $\log$  (hydrazine concentration) almost with a linear dependence.

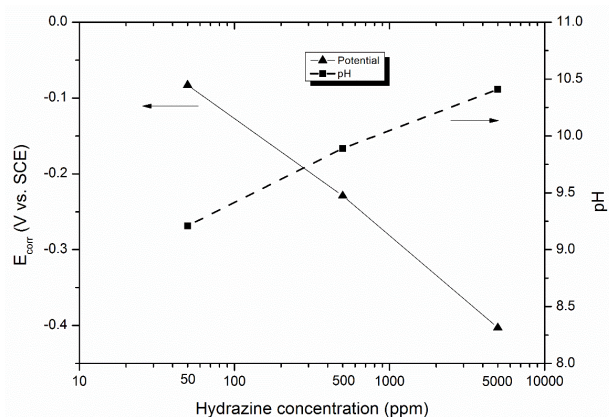
**Fig. 9 Change of  $E_{\text{corr}}$  and pH with hydrazine concentration.**

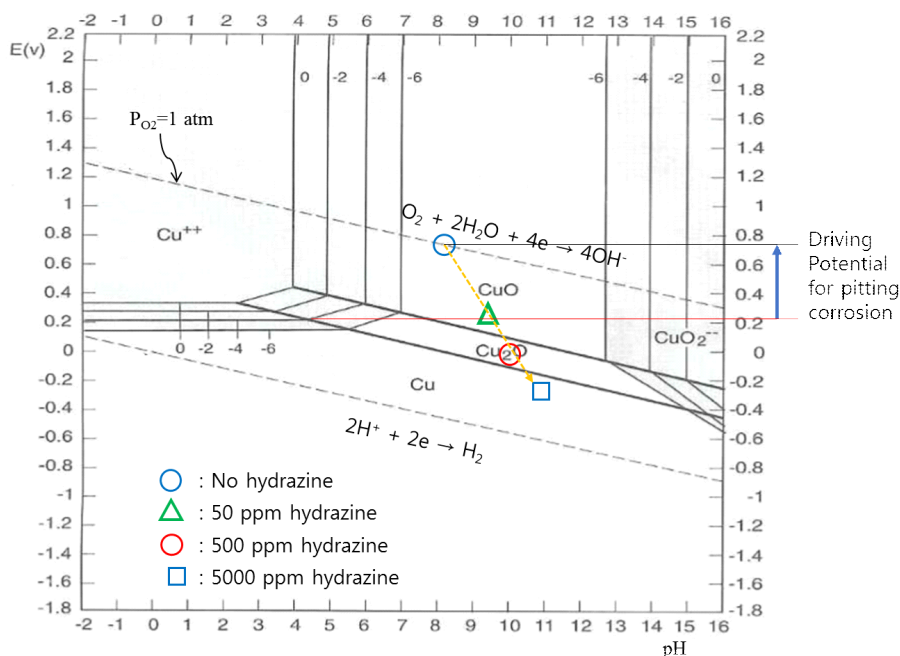
Fig. 10 Pourbaix equilibrium diagram of copper-water [6], showing the regions where each of  $\text{CuO}$ ,  $\text{Cu}_2\text{O}$ ,  $\text{Cu}^+$ , and  $\text{Cu}$  is the stable phase. 0, -2, -4, -6 represents base-10 log of ion activity. The states of the aqueous solutions of different hydrazine concentrations were drawn in the Pourbaix diagram.

$\text{CuO}$  and  $\text{Cu}_2\text{O}$ , to  $\text{Cu}$  with increasing hydrazine concentration and the pH values at different hydrazine concentrations, the potential and pH coordinates at the different hydrazine concentrations were roughly indicated on the Pourbaix diagram (potential-pH diagram) of the copper-water system (Fig. 10) [6]. The coordinate follows the yellow dotted line from  $\text{CuO}$  to  $\text{Cu}_2\text{O}$  and  $\text{Cu}$  stable regions as the hydrazine concentration increases.

The upper dotted line in the Pourbaix diagram Fig. 10 of the copper-water system is the plot of the cathode reaction potential when  $p_{\text{O}_2} = 1 \text{atm}$ . The potential of the anode reaction which takes place at the low oxygen concentration region such as inside a corrosion pit is given by equation (9).

Here, 0.34 V is the standard reduction potential of Cu. The horizontal red line is the anode reaction potential when  $[\text{Cu}^{2+}] = 10^{-4} \text{M}$ . The potential  $\Delta E$  of the corrosion reaction of Cu (equation (5)) is the summation of equations (8) and (9).

$[\text{Cu}^{2+}] = 10^{-4} \text{M}$  is calculated as 0.53 V from equation (10). The reaction potential  $\Delta E$  which drives pitting corrosion can be obtained graphically as well from the Pourbaix diagram. The upward blue arrow line in Fig. 10 is the graphically obtained  $\Delta E$  with the same condition as above. It should be noticed that there is no difference between the analytically calculated potential  $\Delta E$  and the graphically obtained one.

If the state of water in terms of the potential and pH is located lower than the red line which is the boundary between Cu and  $\text{Cu}^{++}$  regions for the  $10^{-4}$  mole concentration of  $\text{Cu}^{++}$ , the pitting corrosion will not occur because of the negative potential for pitting corrosion. Therefore, if we reduce DO to such a low level that  $\text{Cu}_2\text{O}$  becomes the stable phase (the red circle in Fig. 10), pits will not be nucleated, and it is very possible that even the already existing pits will stop growing. To have such a state in which the DO concentration is very low, the hydrazine concentration should be high enough, i.e. around 500 ppm to transform all the CuO corrosion by-products into  $\text{Cu}_2\text{O}$ .
