# Corrosion Performance of Cu Bonded Grounding-Electrode by Accelerated Corrosion Test

Natural degradation of grounding-electrode in soil environment should be monitored for several decades to predict the lifetime of the grounding electrode for efficient application and management. However, long-term studies for such electrodes have many practical limitations. The conventional accelerated corrosion test is unsuitable for such studies because simulated soil corrosion process cannot represent the actual soil environment. A preliminary experiment of accelerated corrosion test was conducted using existing test standards. The accelerated corrosion test that reflects the actual soil environment has been developed to evaluate corrosion performances of grounding-electrodes in a short period. Several test conditions with different chamber temperatures and salt spray were used to imitate actual field conditions based on ASTM B162, ASTM B117, and ISO 14993 standards. Accelerated degradation specimens of copper-bonded electrodes were made by the facile method and their corrosion performances were investigated. Their corrosion rates were calculated to 0.042  $\mu\text{m}/\text{day}$ , 0.316  $

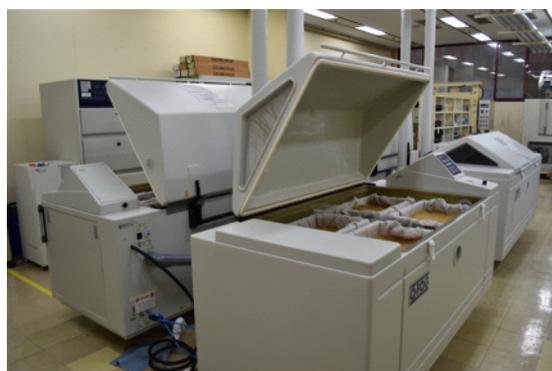
**Fig. 1 Cycle corrosion testers.**

The commercialized cycle corrosion tester (CCT, Q-FOG, Q-LAB, USA) has been applied to develop the accelerated corrosion test methods reflecting the soil environment in Fig. 1. They were installed to be able to implement various soil conditions by installing soil baskets inside. Using the CCT, it is available to adjust the corrosive ion concentration as chloride and sulfur oxides can be continuously sprayed, and provide the fixed humidity and constant temperature conditions.

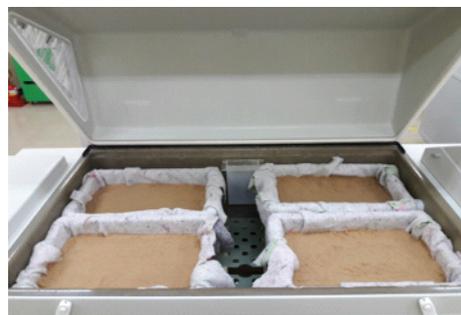
**Fig. 2 Inside of improved cycle corrosion tester with the soil baskets.**

The standard soil of Jumunjin in Korea was used and baskets carrying the soil were installed in the CCT to simulate the corrosion in Fig 2. The reliability of the experimental conditions was verified because the location of the grounding electrodes could affect the test results if salt water were not uniformly sprayed on the soil surface contained in the basket. After running for 432 hours regarding ASTM B117 standard, relative moisture content and pH with depth from the soil surface were measured with a soil monitoring sensor (WT-2000, RF sensor, Korea). The results for each depth were obtained from the average of 15 measurement points divided in the plane direction of the soil surface and the results are shown in Fig. 3. The relative moisture increased while the pH decreased with an increase of depth due to the inverse relationship between the relative moisture content and the pH under the same salt-spraying condition. It was confirmed that the relative moisture content and the pH were constant at a depth of 80 mm to 120 mm (marked with a dashed box in Fig. 3), and the samples of the copper-bonded electrodes were placed at a depth of 100 mm to prepare the accelerated corrosion test.

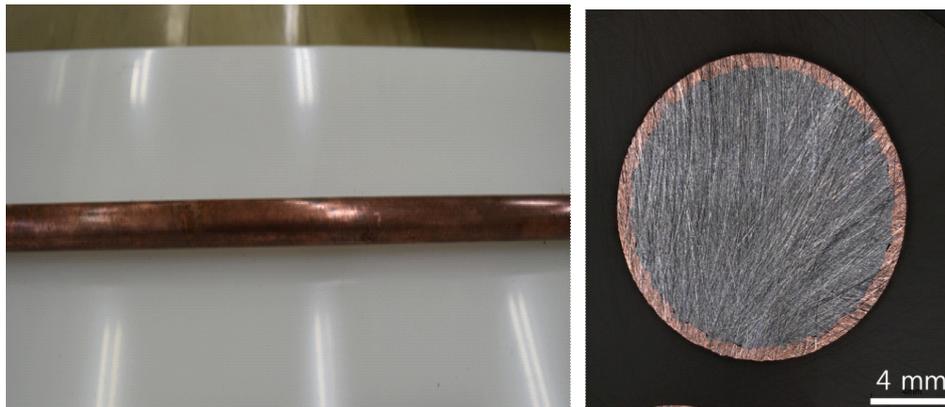
Fig. 4 Naturally degraded copper bonded grounding material after cleaning and cross-section image.

Fig. 4 shows the surface and cross-section images of a naturally 5-year aged copper bonded grounding material in soil environment after surface cleaning to remove remained soil and released corrosion products. The cross-section image depicts that the copper layer plays an excellent in protecting the inner carbon steel core from corrosion in long-term exposure. Since the thickness of the copper coating is generally about 0.5 mm, the measured corrosion depth (pitting) of the 5-year aged sample is 0.038 mm, which indicates that the inner core and the surface copper coating area are sufficiently protected from corrosion. In order to evaluate the characteristics of corrosion products
