Ni Plating Technology for PWR Reactor Vessel Cladding Repair

Seong Sik Hwang[†] and Dong Jin Kim

Korea Atomic Energy Research Institute, 989-111 Daedeok-daero, Yuseong, Daejeon, Korea, 34057

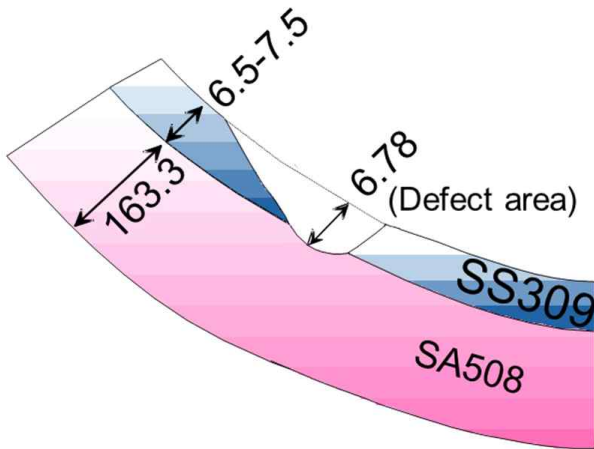
Fig. 1 Schematic of the cladding damage.

Because of the detachment of the thermal sleeve from the primary coolant nozzle in a PWR plant, the stainless steel cladding at the bottom of the reactor vessel was damaged due to the vibration of the thermal sleeve. The base metal of the SA 508 reactor vessel steel had been exposed to the primary coolant for over 16 years after the accident, as shown in Fig. 1.

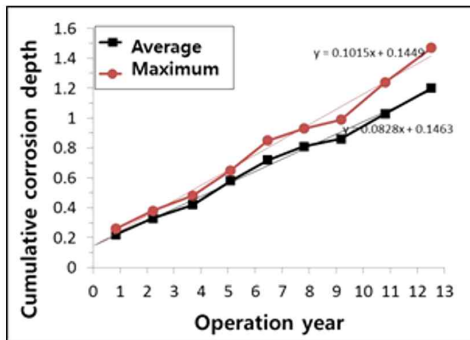
Fig. 2 Corrosion rate of the damaged area.

The corrosion trend on the damaged area was monitored by using the replication method for 16 years. As shown

in Fig. 2, the average corrosion depth of the flaw was 0.0828 mm/year.

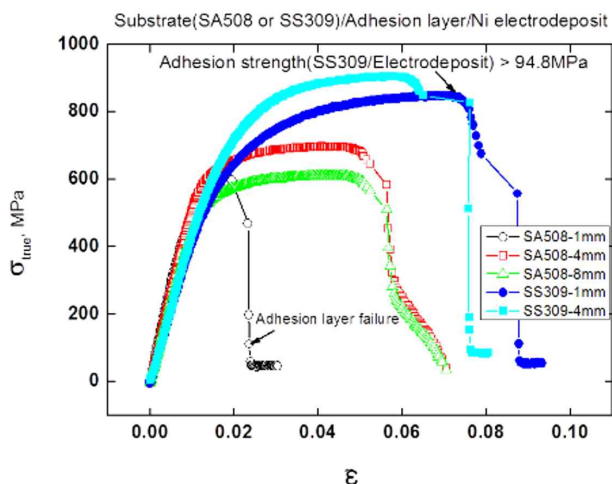
Fig. 5 Stress-strain curves with various adhesion areas.

The tensile strength of the ECD layer using the SS309 substrate was measured to be 94.8 MPa or more, as shown in Fig. 5. Due to this strength, the deposit layer adhered to the SS309 substrate after the tensile test. The measured bond strength was considered suitable for the proper integrity of the ECD for plant operation or service conditions.

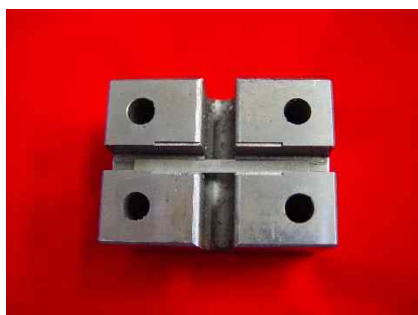
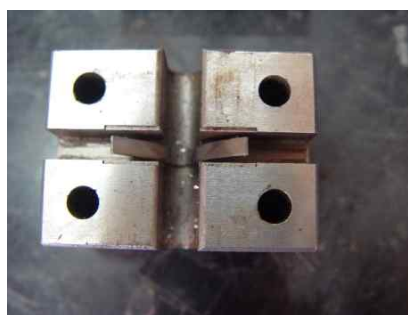
Fig. 6 Side bend test jigs and a bent sample in the jig.

the ECD deposit on the substrate. The side bend specimens were prepared on two different substrate materials, SS309 and SA508, with a 5- μ m strike layer. After the formation of the ECD deposit, the specimens were bent with a side-bend test jig based on the ASME section IX, QW-466.1, as shown in Fig. 6 [5].

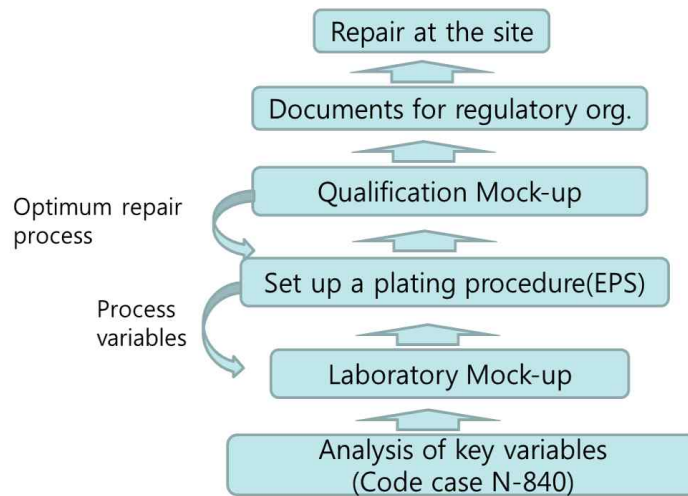
Fig. 8 General scheme of the project for field application.

It is also necessary to develop a practical Ni plating system that can allow the operator to control the deposition variables remotely in a high-radiation operating reactor condition. The plant utility launched a new research project that includes all steps from setting up the electro-deposition variables to resolving the regulatory issues with a plan to repair damaged areas, as shown in Fig. 8.
