Journal of Corrosion Science Society of Korea
Vol. 9, 4, Dec., 1980

Corrosion and Erosion Related to the In Situ Processing of Tar Sands

M. H. Swain and K. K. Orr*

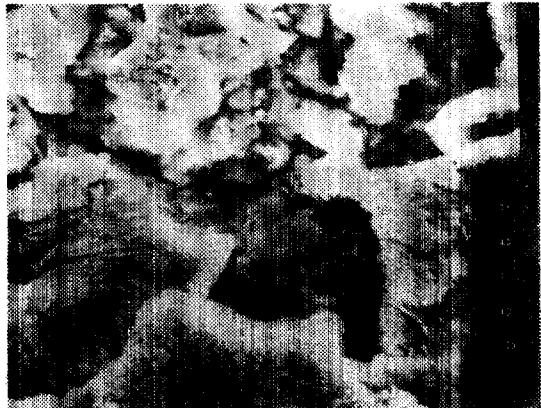
Figure 23. AISI 1020 Specimen from Side after Run #4. 2000X.

Figures 22 and 23 are typical views of AISI 1020 steel after 40 hours of exposure to the tar sand processing environment. In the upper left corner of the picture the surface shading of the oxide is due to the microstructure. There are also patches where the oxide is thicker and jagged regions where the oxide has cracked and fallen away. The upper right hand regions show more severe damage. A thicker oxide with many more cracks and pits is present, Figure 23 is an enlarge-

ment from upper right of Figure 22 and shows considerable surface roughness. Close inspection reveals pitting or cracking occurring at a faster rate in some regions, probably along grain boundaries.

SEM micrographs of the first six materials of Table 8 bear out the above observations. AISI 1020 (Figures 22 and 23) show heavy general oxidation and breaking away of the oxidized layers. This corresponds to the highest weight loss rate. Resistance improves as we progress through AISI 1045, AISI 4140, and AISI 8620 (Figures 24 through 29). It is important to note that local pitting and grain boundary attack was clearly evident even in AISI 8620. This would lead to little overall weight loss, but the presence of stress raisers at the grain boundaries can significantly degrade toughness and strength. It is important therefore to consider the surface damage mechanism shown by optical and SEM analysis as well as the easier weight change measurements.
