터보발전기에서 수랭식 고정자의 부식으로 인한 유량 감소 기구

A Mechanism of Corrosion-induced Flow Degradation in Water-cooled Stator of Turbogenerators

Water-cooled stator windings of large turbogenerators experience flow blockages due to the localized accumulation of corrosion products in their hollows copper strands. Stator flow degradation phenomenon at a nuclear power plant has been studied to develop a mechanistic understanding. A physico-chemically scaled corrosion loop test showed that arrays of flower-shaped Cu_2O flakes developed on copper surface in water flow direction with about 200 ppb of dissolved oxygen at 60°C. Simulations of air in-leakage triggered massive release of the oxide flakes followed by a gradual increase in the strand hydraulic resistance. Examination of the inner surface of strands revealed the evolution of blocky CuO layer underneath the released oxide flakes. Although a severe corrosion of copper occurred in 200 ppb water, the flow degradation was not developed in the loop, in contradiction to the earlier belief. Therefore, it is the large increase in redox potential due to air leakage that is identified as the primary cause for producing the water-borne oxide flakes and flo

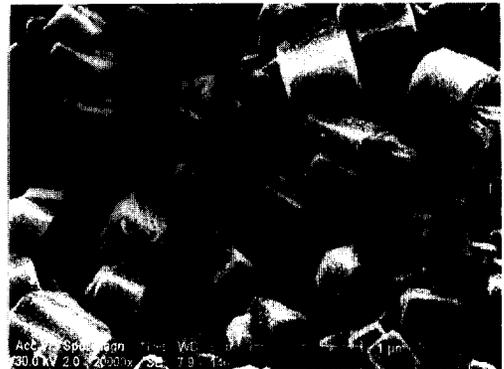
Fig. 10. SEM Photograph of Blocky Copper Oxide Structure Observed after Passivation Experiment in Aerated Flowing Steam at 150°C.

dle shape with about 1 μm length which appear to match the remnants of released oxide flakes on CuO layer of Fig. 10. The sharp increase in the particle number density upon the aeration at 390 hours of Fig. 8 indicates that Cu_2O oxide flakes are destabilized due to a redox potential jump to the CuO stability regime. The continued aeration of the loop water showed fairly high particle number density over a long period, starting from about 570 hours of Fig. 8.
