Corrosion of Commercially Pure Titanium in a Sea Water Electro-Chlorination Equipment

Ki-Tae Kim

Korea Electric Power Research Institute
103-16 Munji-dong, Yuseong-gu, Taejeon 305-380, KOREA

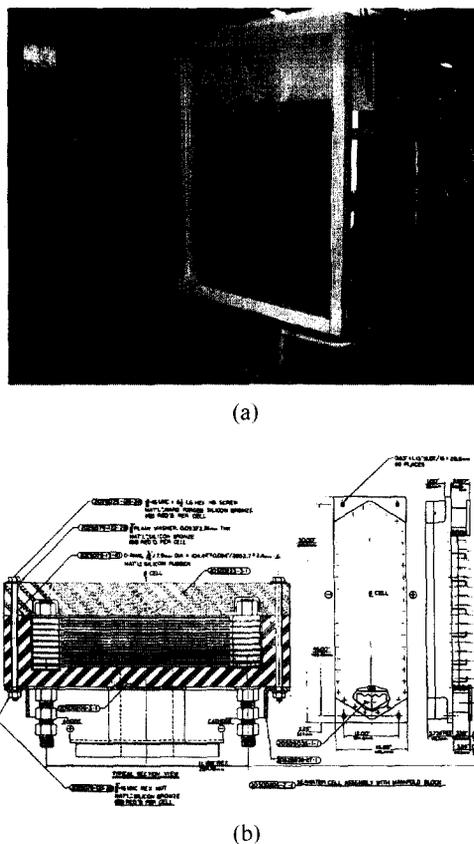
Of the several commercial types of electro-chlorination equipment, most of the Korea Electric Power Corporation (KEPCO) power plants are using the so called 'plate cell' type equipment. One example of this type electro-chlorination equipment is shown in Fig. 1. The equipment is composed of several consecutive 'cell's, in which are vertically stacked plates of alternate anodes and cathodes as shown in Fig. 1(b).

Fig. 1. A 'plate cell' type sea water electro-chlorination equipment. (a) external view, (b) schematic cross cut diagrams of a 'cell' appropriate remedial measures are also suggested based
