## Failure Evaluation Plan of a Reactor Internal Components of a Decommissioned Plant

*Korea Atomic Energy Research Institute, 989-111 Daedeok-daero, Yuseong-gu, Daejeon 34057, Korea*  
(Received July 02, 2021; Revised July 09, 2021; Accepted July 09, 2021)

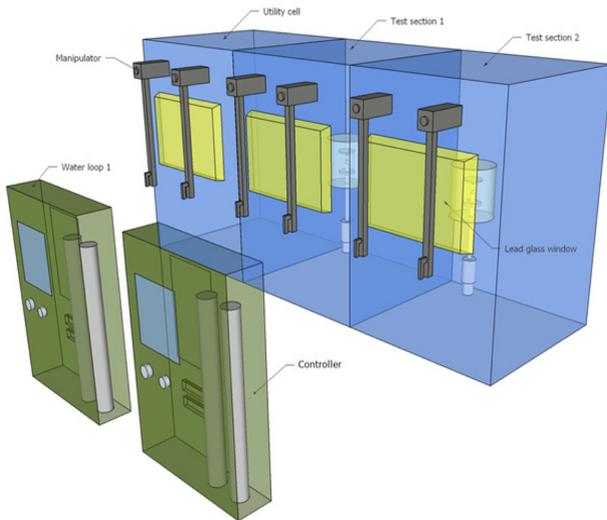
**Fig. 1. Schematic of the verification test facility for IASCC**

The development of the demonstration test technology for IASCC is a study using materials taken from the decommissioned nuclear power plant. Considering foreign cases, it is understood that LIDEC of France and SCK-CEN of Belgium, Studsvik of Sweden have built and operated one stop service-enabled facilities, ranging from precision processing of irradiated materials to precision testing and evaluation and technical support. However, as the neutron irradiated materials transporting cost is more expensive abroad than the evaluation costs itself, and difficulties in utilizing foreign facilities, such as the limitations of the test specimen's fluence, size and volume, we plan to establish the IASCC verification test facilities in Korea as shown in Fig. 1.

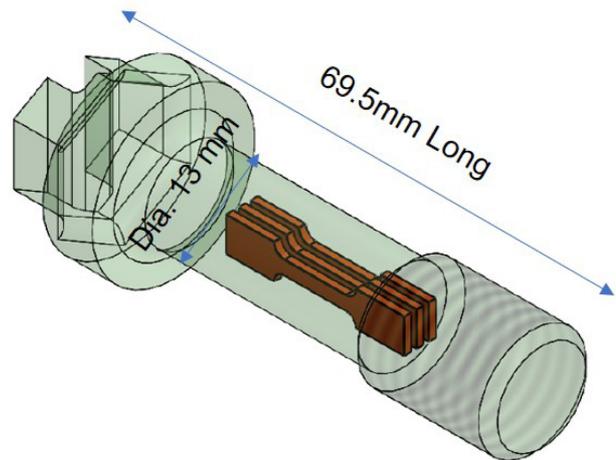
**Fig. 2. Schematic of small size tensile test specimen**

tensile specimen of the shape shown in Fig. 2. The detail dimension of the bolt sample is shown in Fig. 3.

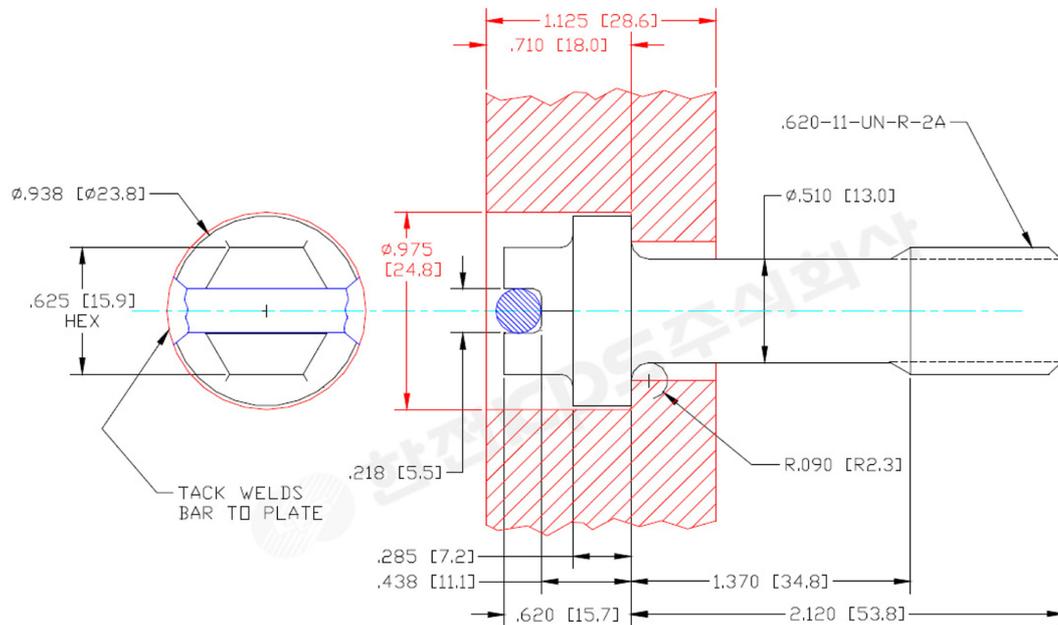
**Fig. 3. Dimension of baffle former bolt of the Korean plant [7]**

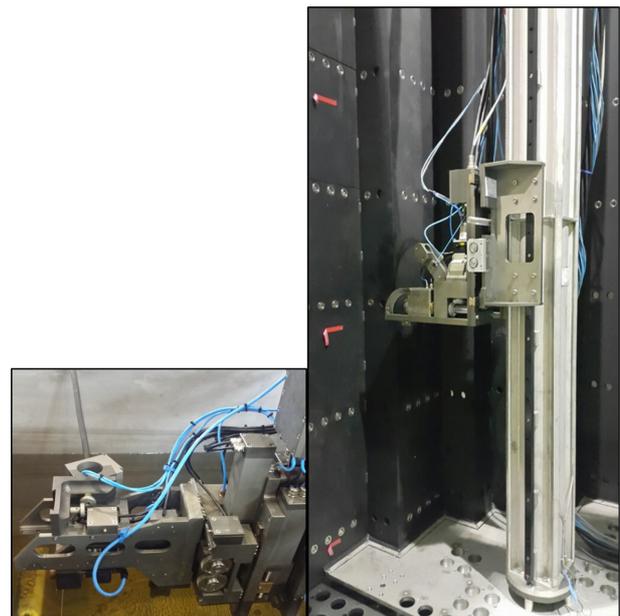
**Fig. 4. Replacement facility for BFB from the Korean plant [10]**

Defect bolt withdrawal will be carried out by utilizing the equipment developed during a government project in the past as shown in Fig. 4 below [10].

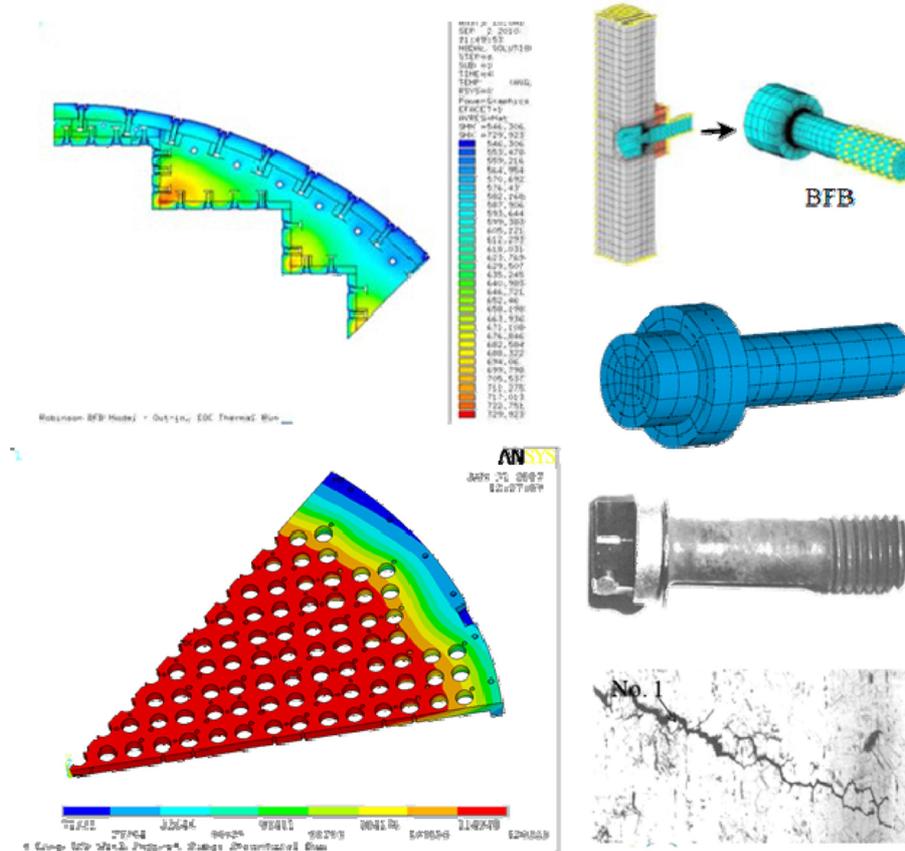
Fig. 5. Expected evaluation result for IASCC susceptibility

USNRC in the USA presents temperature and fatigue caused by flow induced vibration, IASCC, etc. as the main causes of damage to the reactor internal structures, including BFBs. This study will also assess the integrity of the key components of the reactor internal structure from the perspective of fatigue and IASCC. The main parts of the reactor internal structure that could be damaged will be derived and the effects of the flow induced vibration and fatigue and the IASCC will be assessed comprehensively. Fig. 5 shows a preliminary analysis result on stress distribution on the bolt. The picture of the defective bolt included in this Fig. 5 was obtained from a study case [11] at an overseas power plant, and it was judged that a similar defect would be observed in this study, so it was included in the figure as reference data.

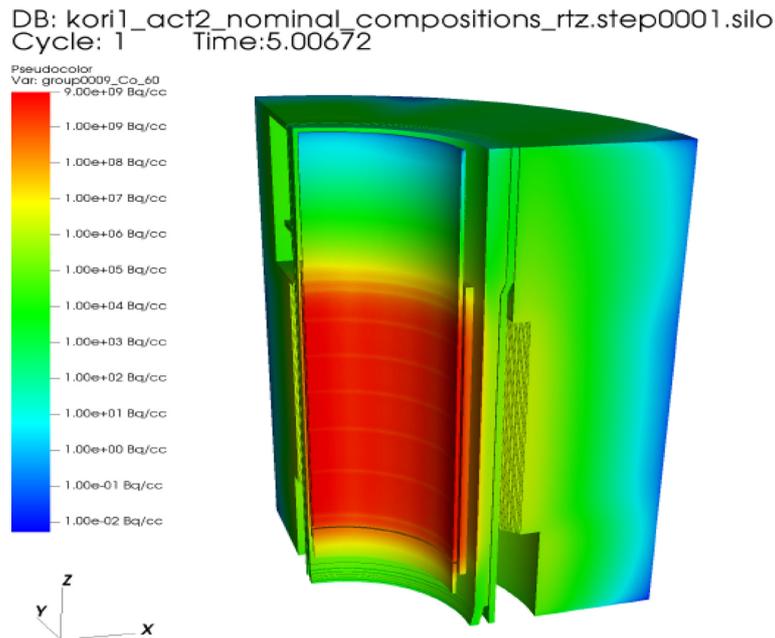
**Fig. 6. Radiation level of Co-60 in 5 years after final operation**

Fig. 6 shows a preliminary evaluation of the expected distribution of Co-60 radiation levels five years after the permanent shutdown of the Korean plant.
